# AE propagation velocity calculation for stiffness estimation in Pier Luigi Nervi's concrete structures\*\*

**Abstract:** In the present paper, the acoustic emission (AE) device is used with an innovative approach, based on the calculation of P-wave propagation velocity ( $v_p$ ), to detect the stiffness characteristics and the diffused damage of in-service old concrete structures. The paper presents the result of a recent testing campaign carried out on the slant pillars composing the vertical bearing structures designed by Pier Luigi Nervi in one of his most iconic buildings: the Hall B of Torino Esposizioni. In order to investigate the properties of these inclined pillars, localizations of artificial sources (hammer impacts), by the triangulation procedure, were performed on three different inclined elements characterized by stiffness discrepancies due to different causes: the casting procedures, executed in different stages, and the enlargement of the hall happened a few years later the beginning of the construction. In the present work, the relationship between the velocity of AE signals and the elastic characteristics (principally elastic modulus,  $E$ ) is evaluated in ord

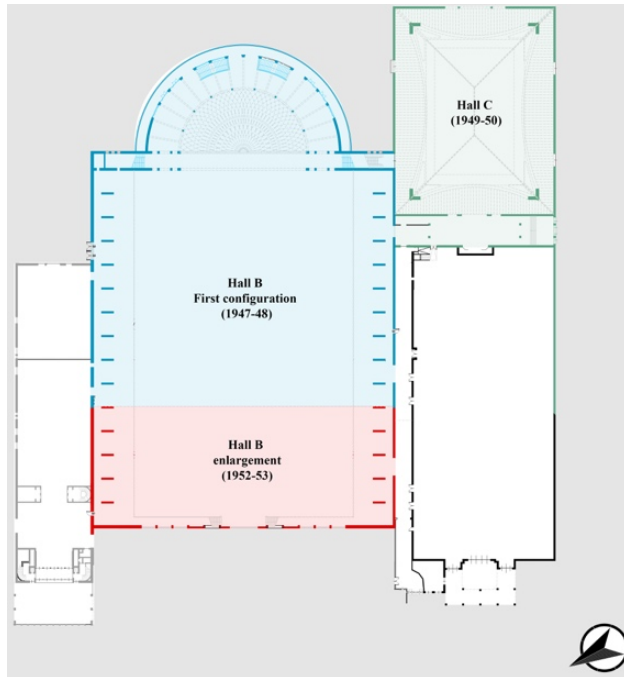
**Figure 1:** (a) Torino Esposizioni plan: the large hall with the semi-circular apse is Hall B built in 1948 (in blue) and enlarged in 1953 (in red), and the smaller Hall C built in 1950 (in green). (b) An interior of Hall B after completion in 1948 (photo by Aldo Moisisio)

Hall B was inaugurated on 15 September 1948. The hall consists of a nave covered by an undulated vault, and of an apse with a ribbed semispherical dome. Hall B represents a milestone in the history of 20<sup>th</sup> century engineering and architecture. Moreover, in the literature on contemporary architecture, it is frequently referred to as Nervi's iconic masterpiece and as one of his most skillful examples of structural art. The Hall B in the Turin Exhibition center offered Nervi the first great occasion to apply to a large-scale project the principle of structural prefabrication, a method he experimented during the war years on small-scale building [14]. It is reported a plan of the whole complex in the Figure 1a, and an interior of the hall in the Figure 1b.

success of the Nervi's system. This characteristic makes the building a rare case of concrete application of the so-called “modular flexibility”, and as Greco points out [17], this aspect has been neglected by critics. In order to reconstruct the construction stages of the building, Figure 1a, reports them in plan.

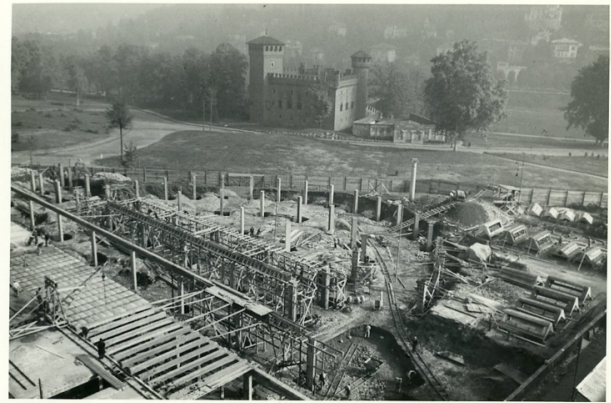
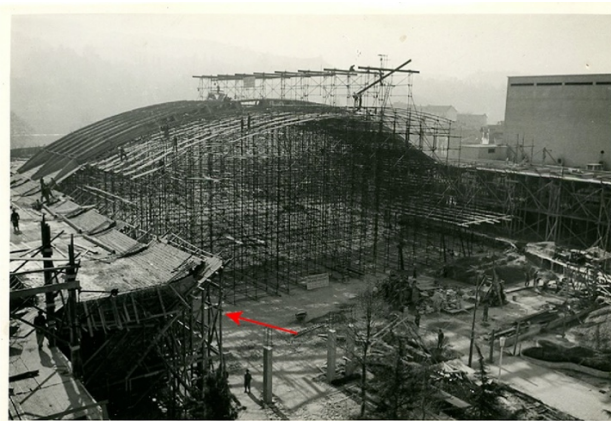
**Figure 2:** (a) A picture showing the initial stage of the construction site of hall B, which started from the apse. It is also possible to notice the prefabricated elements in ferrocement built simultaneously. (b) Advancement of the construction site, in which the red arrow indicates a pillar that has not been cast yet, while the ones closer to the apse are in a more advanced stage (photos by Riccardo Moncalvo)

The construction site started from so-called “apse”, the round element with the ribbed half dome (Figure 2a). At the same time, workers started to build the prefabricated ferrocement elements of the undulated vault (Figure 2a).

ingly. In Figure 2b, a red arrow indicates a pillar that has not been cast, while the ones closer to the apse are in a more advanced stage. In fact, the scaffolding of the first section of the vault was built from the apse, and it was moved sequentially in the direction of the main façade. The scaffolding was moved only when the undulated elements

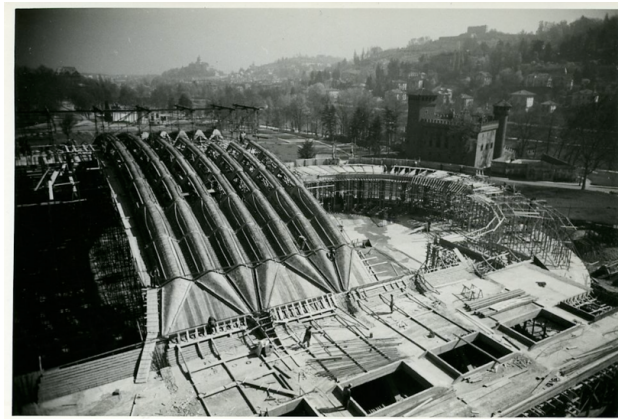
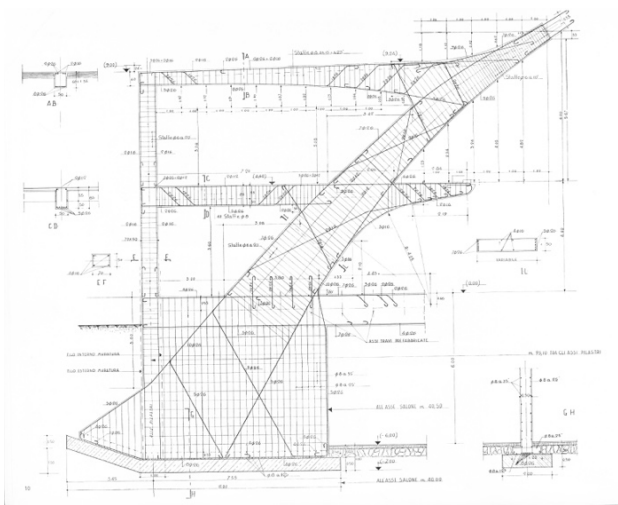
**Figure 3:** (a) Advancement of the construction site with the elevation of the first portion of the undulated vault (photos by Riccardo Moncalvo). (b) Detail of the reinforcing of the pillars and the connections with the slabs at the various levels and the fanned elements [18]

of a set of arches were set (Figure 3a). In the last stages, it was poured the concrete for the connections of the fanned elements and the pillars; subsequently, also elements of the undulated vault were completed with the casting of the ribs. Figure 3b reports the detail of the reinforcing of the pillars and the connections with the slabs at various levels and the fanned elements.

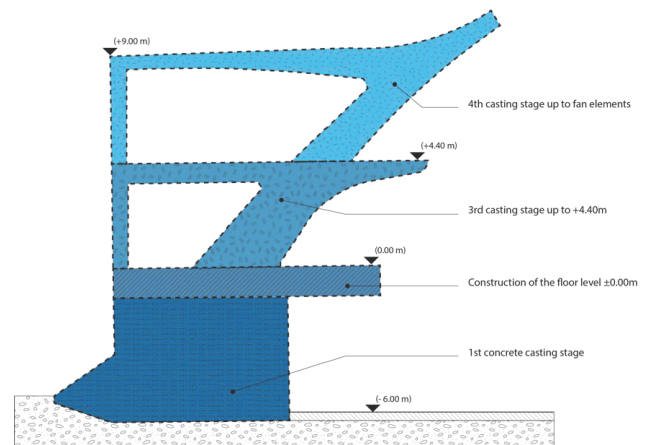
**Figure 4:** (a) Scheme of the various casting stages of pillars. (b) Detail of the interiors just after the completion of the hall (photo of Aldo Moisisio)

The supporting structures of the vault were instead built in four different stages, in which the concrete was poured sequentially in different months. Figure 4a shows a section of an inclined pillar reporting a scheme of the various casting stages, while Figure 4b shows a picture of the interiors just after the completion of the hall.

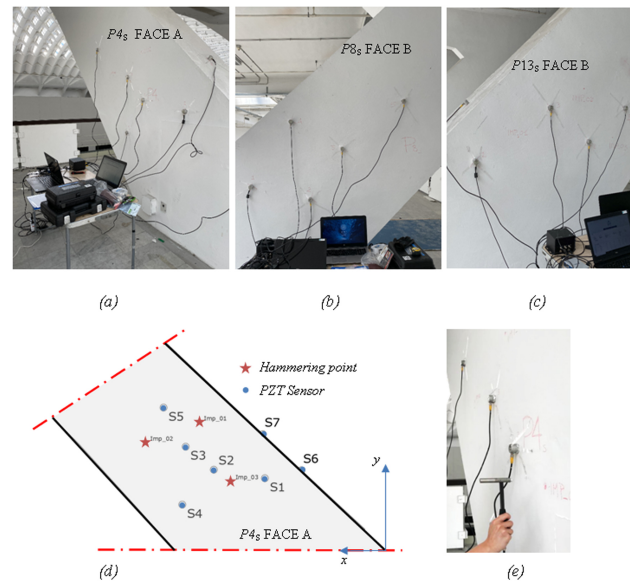
**Figure 5:** Application of the sensor array to the slant pillar (a)  $P4_S$ , (b)  $P8_S$ , (c)  $P13_S$ . (d) Detail of the sensor positions for  $P4_S$ . (e) Hammering performed on the surface of the pillar

In order to carry out these tests, the ND procedures were performed by a technique coming from the impact-echo, allowing to obtain, as a parameter of estimation of the damage, the P-wave propagation velocity inside the monitored element. To this purpose, an array of 7 sensors has been placed on the surfaces of the pillars in correspondence to the last level (between quote +4.40 m and 9.00 m) represented in Figure 4a. In Figure 5a–5c, it is reported the arrangement of the sensors on the three slanted pillars and their arrangement on the monitored surface is reported. In Figure 5d the position of the sensors respect to the positions of the impact points of the hammering can be observed.

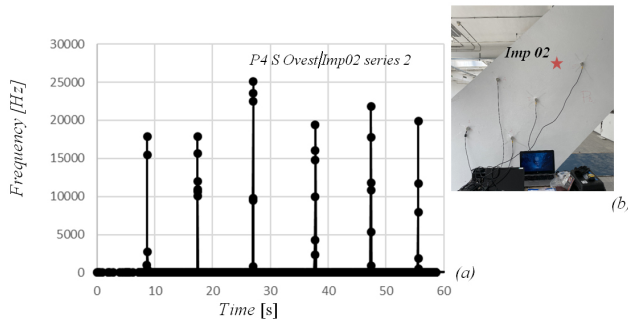
**Figure 6:** (a) Frequency vs time graph related to the acquisition of the acoustic signals due to the hammering in position imp02 (b)

of the signals. In the present study, a threshold of  $1 \times 10^3$  Hz is considered. Signals acquired below this value were neglected because they definitely belonged to the background noise. The whole procedure is described in the flow-chart reported in Figure 7. The beginning of the acquisition is characterized by the generation of the artificial sources. In general, they may originate from a natural phenomenon (crack propagation or formation of micro-cracks) or from an artificial cause (impacts produced by a digital hammer). In the present case, the AE sources are generated by hammering on the external surface of the slanted pillars. During the perturbation created by the impact in the positions Imp01, 02 and 03 for each pillar, the AE signals were recorded. The acquisition is carried out for a duration of 60 s for each hammering sequence. After this, the first filtering is applied to AE signals (Figure 7). As previously mentioned, in the present experiments, only AE with a mean frequency greater than  $1 \times 10^3$  Hz were considered. After this preliminary phase, the recognition of the data sets consistent with the localization procedure was performed. For the localizations, all pairs, triplets, quatrains, and so on that have the differences in the arrival times to sensors in the range  $\Delta t_j - \Delta t_0 < 10 \times 10^{-4}$  s were considered belonging to the same event (impact). In the analyzed case, the event generating the signals is the rhythmic hammering in the impact positions. Once these data sets are selected, a system of equations of the type of Eq. (2) can be written. The localization adopted is based on the triangulation technique and the improved AIC-method, as reported in Carpinteri *et al.* [23]. Once localized sources are obtained, and after verifying that the obtained results are localized close to the artificial source created ad hoc (maximum error accepted = 1%), the value of the p-wave propagation velocity ( $v_p$ ) is extracted. Finally, through Eq. (10), it is possible to estimate the value of the elastic module (E) associated with the velocity  $v_p$  just calculated with the described method (Figure 7). In Figure 8a and 8b, the calculated  $v_p$  and the elastic

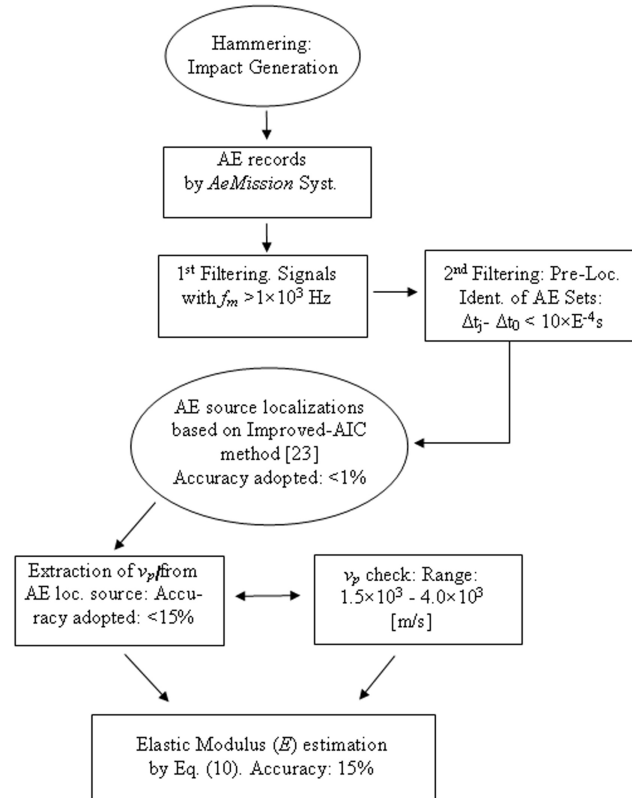
**Figure 7:** Flow-chart of the elastic modulus estimation by  $v_p$  measurements. Different steps are performed to reduce measurement errors. The localization procedure leading to the  $v_p$  values is based on the improved Akaike algorithm Criterion as reported in [23]

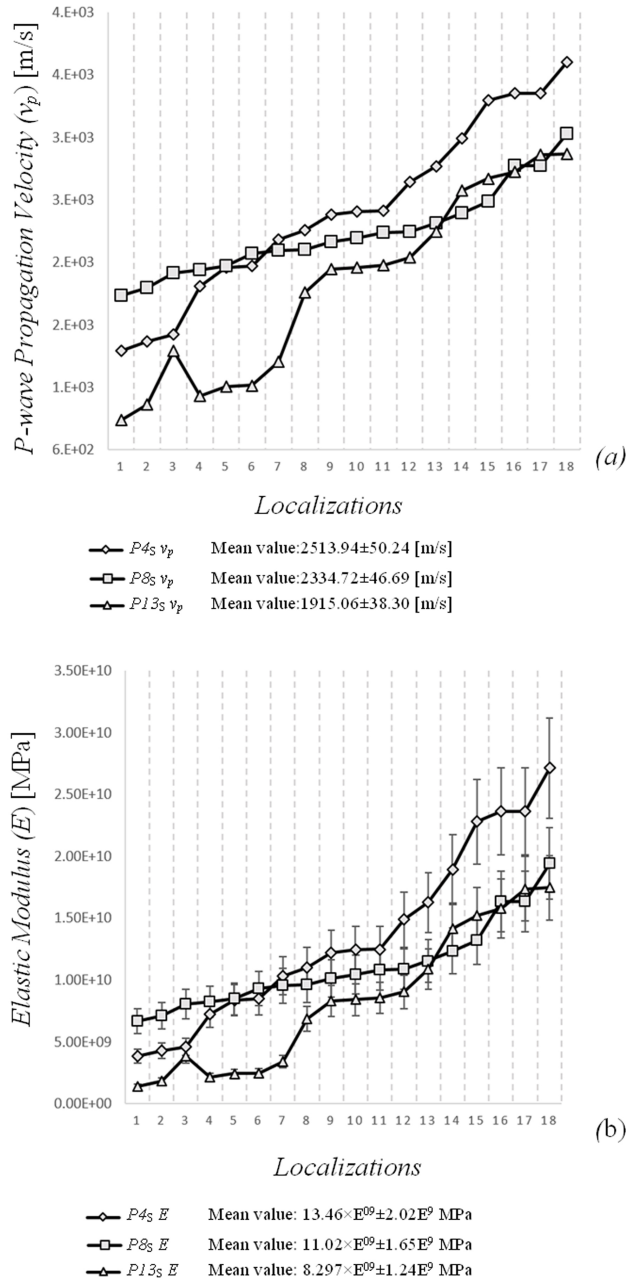
**Figure 8:** P-wave propagation velocities obtained by 54 localizations on the three slanted pillar P4S, P8S, P13S. The values were reordered considering increasing values for each series (a). P4S resulted in being the element with the highest speed values corresponding to a higher level of stiffness characteristics (E) (b)

Figure 8 shows the results for velocity values obtained by 54 localizations on the three slanted pillar P4<sub>S</sub>, P8<sub>S</sub>, and P13<sub>S</sub>. The values are reordered from the lower to the higher for each series. P4<sub>S</sub> resulted in being the element with the highest values in terms of  $v_p$  that corresponds to a higher level for the stiffness characteristics (E, G). The values reported for the P4<sub>S</sub> pillar start from very low values around  $1.4 \times 10^3$  m/s up to values of about  $3.7 \times 10^3$  m/s. The average velocity obtained from the localization of AE due to hammering is  $2.5 \times 10^3$  m/s for P4<sub>S</sub>. Similar considerations can be made for pillar P8<sub>S</sub>. The velocity values for P8<sub>S</sub> range from values of around  $1.8 \times 10^3$  m/s to  $3.1 \times 10^3$  m/s. The average velocity obtained from the localizations of AE signals is about  $2.3 \times 10^3$  m/s for the P8<sub>S</sub> pillar, slightly lower than that of pillar P4<sub>S</sub>. Finally, as regards the values obtained for P13<sub>S</sub>, different values are obtained. For the minimum set values, the lowest was about  $0.9 \times 10^3$  m/s to a maximum value of about  $2.9 \times 10^3$  m/s. The average velocity obtained in this case is equal to  $1.9 \times 10^3$  m/s for pillar P13<sub>S</sub>. It is evi-

dent that the averaged values of  $E$ , that will be calculated by Eq. (10) will be slightly under-estimated. This effect is certainly due to the presence of a layer of about 20 mm on the external surface of the three slant pillars formed by the plaster layer and the coating. This value can be considered with a reduction of the final value of about 1%. This reduction is estimated considering the proportion between the

Equations (11a) and (11b) have shown a reduction in the stiffness characteristics of the monitored concrete structures of about 13.8% and 42.0%, respectively, for P8S and P13S pillars with respect to P4S. This evidence confirmed the hypotheses put forward in the context of the historical reconstruction of the building phases for Hall B. In particular, the first construction phases (P13s and P8s) are characterized by jets with a less performing conglomerate compared to the portion of the building concerning the last expansion.
