Development of a low-cost monitoring system for open 3d printing

Development of a low-cost monitoring system for open 3d printing / Khandpur, M S; Galati, M; Minetola, P; Marchiandi, G; Fontana, L; Stiuso, V. - In: IOP CONFERENCE SERIES: MATERIALS SCIENCE AND ENGINEERING. - ISSN 1757-8981. - ELETTRONICO. - 1136:(2021), p. 012044. (Intervento presentato al convegno International Conference on Advances in Materials, Mechanics, Mechatronics and Manufacturing (IC4M 2021) tenutosi a Madhya Pradesh, India nel 6th-7th March 2021) [10.1088/1757-899x/1136/1/012044].

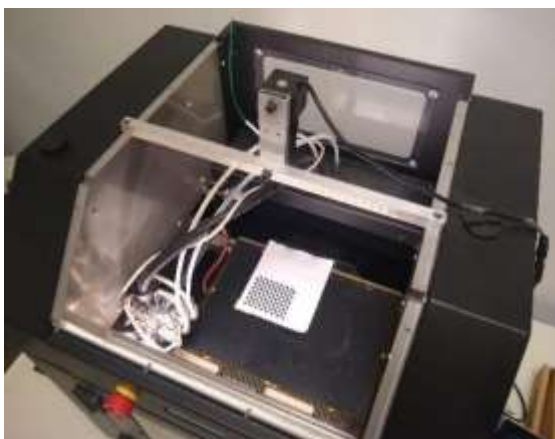
Figure 1. Printer setup with the Svpro camera and checkerboard pattern.

To acquire a picture of the current layer, the camera was installed on the top of the printer bed using an aluminium support bar. For this purpose, the top cover of the printer was removed, as shown in figure 1. With this configuration of the camera, the acquired images are always perpendicular to the print bed and part cross-section. This approach ensures minimal modification to the printing process and its subsystem, such as the print head.

The system calibration to correct the distortion in images is implemented using a checkerboard pattern printed on plain paper (figure 1). An L-shaped 3D printed reference part is used to align the checkerboard pattern with the bed axes (figure 2). Using the procedure described by Fetic et al. [12], the camera parameters are computed starting from the acquired image of the checkerboard pattern. With the information from the G-code, the system can automatically perform adjustments to select the region of interest and recognize the positional coordinates on the printing bed.

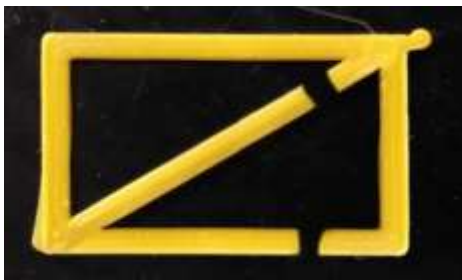
Figure 8. Printed sample with artificial defects.

To validate the monitoring system capabilities for automatic detection of defects, a defective sample part is printed by manually decreasing the feed of the extruder head for overdeposition of ABS material. Moreover, when printing is complete, two small portions of the printed part are slashed out to generate two zones with missing material. The monitoring system captures the printed layer image with the two defects, as shown in figure 8. This image is processed and compared to the reference image of the same layer (figure 7). The overall result of the comparison is shown in figure 9, wherein the green colour is used for referring to the deposited filament that was correctly printed.
