Development of a low-cost monitoring system for open 3d printing

Abstract. 3D printers for Rapid Prototyping and Additive Manufacturing have been widely accepted by large and small-scale industries or by many hobbyists. Due to its nature of layer by layer addition of material, identifying defects between the layers can be a crucial strategy to determine the quality of a 3D printed product by carefully monitoring the layerwise process during part building. This kind of approach gives an advantage in the applications where 3D printing of products requires high customization without compromise on part quality. In this work, a low-cost camera is installed in an open 3D printer, and computer vision algorithms are used to implement an in-situ monitoring system. The defects can be evaluated by comparing the printed layer to the deposition path of the open ISO G-code. The G-code printing file is modified to introduce the image capture step after each layer. The value of the area of missing or exceeding material is returned to the user with the corresponding images. A decision can be made to abort the job in case of important defects to avoid unnecessary waste in material, time, and costs.

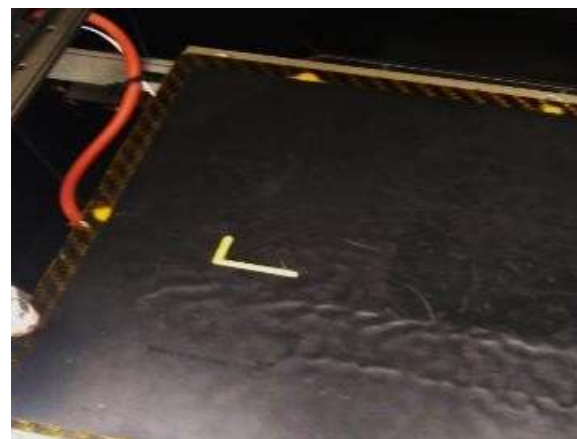
Figure 2. L-shaped reference used to align the checkerboard pattern on the print bed.

The system calibration to correct the distortion in images is implemented using a checkerboard pattern printed on plain paper (figure 1). An L-shaped 3D printed reference part is used to align the checkerboard pattern with the bed axes (figure 2). Using the procedure described by Fetic et al. [12], the camera parameters are computed starting from the acquired image of the checkerboard pattern. With the information from the G-code, the system can automatically perform adjustments to select the region of interest and recognize the positional coordinates on the printing bed.

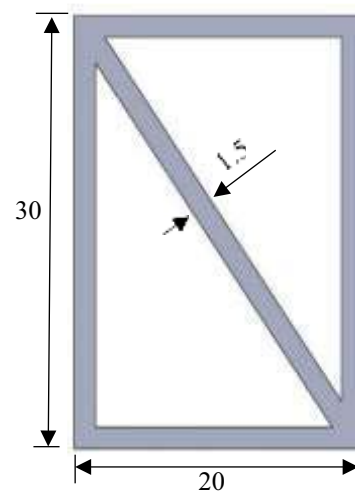
Figure 5. Geometry of the test sample with main dimensions in millimetres.

To validate the monitoring system for the analysis of defects occurring during printing, a simple rectangular test sample (figure 5) is used. The two sides of the rectangle measure 20 mm and 30 mm respectively with a single diagonal. The sample has a thickness of 1.5 mm and its total height is 0.5 mm perpendicular to the bed. It was printed with a yellow colour filament of ABS material using the process parameters in table 1.

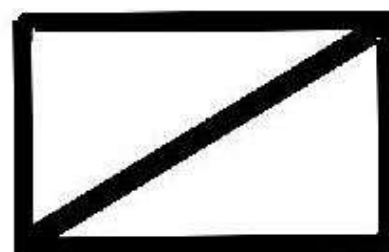
Figure 6 shows the printing path generated by Kisslicer software in the G-code file, while the reference image created with the marker from the printing path is shown in figure 7.

Figure 7. Reference image for the rectangular sample.

The detection of 3D printing defects in each layer is done by comparing the actual layer image to its corresponding reference image. For each layer, the reference image is generated from the original G-code file. This image is formed by a marker that replicates the printing nozzle's action on a blank image and draws the printing paths. The marker estimates the width W of the deposited filament by equating the mass flowing inside and outside the nozzle by equation 1:
