Development of a low-cost monitoring system for open 3d printing

M S Khandpur¹, M Galati¹, P Minetola¹, G Marchiandi¹, L Fontana¹ and V Stiuso¹

¹ Dept. Management and Production Engineering (DIGEP), Politecnico di Torino, Corso Duca degli Abruzzi 24, 10129 - Torino, Italy

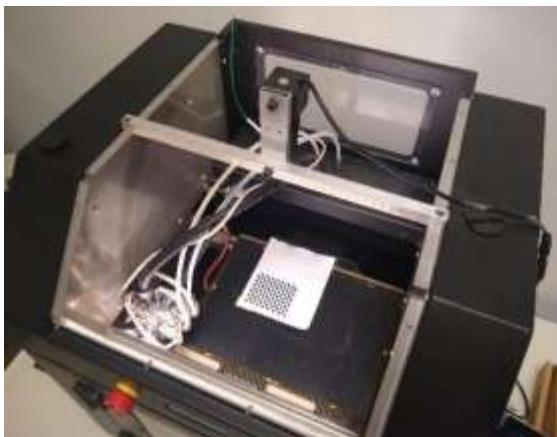
To acquire a picture of the current layer, the camera was installed on the top of the printer bed using an aluminium support bar. For this purpose, the top cover of the printer was removed, as shown in figure 1. With this configuration of the camera, the acquired images are always perpendicular to the print bed and part cross-section. This approach ensures minimal modification to the printing process and its subsystem, such as the print head.

Figure 1. Printer setup with the Svpro camera and checkerboard pattern.

The system calibration to correct the distortion in images is implemented using a checkerboard pattern printed on plain paper (figure 1). An L-shaped 3D printed reference part is used to align the checkerboard pattern with the bed axes (figure 2). Using the procedure described by Fetic et al. [12], the camera parameters are computed starting from the acquired image of the checkerboard pattern. With the information from the G-code, the system can automatically perform adjustments to select the region of interest and recognize the positional coordinates on the printing bed.

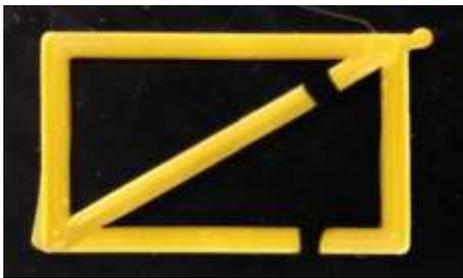
To validate the monitoring system capabilities for automatic detection of defects, a defective sample part is printed by manually decreasing the feed of the extruder head for overdeposition of ABS material. Moreover, when printing is complete, two small portions of the printed part are slashed out to generate two zones with missing material. The monitoring system captures the printed layer image with the two defects, as shown in figure 8. This image is processed and compared to the reference image of the same layer (figure 7). The overall result of the comparison is shown in figure 9, wherein the green colour is used for referring to the deposited filament that was correctly printed.

Figure 8. Printed sample with artificial defects.
