Development of a low-cost monitoring system for open 3d printing

Abstract. 3D printers for Rapid Prototyping and Additive Manufacturing have been widely accepted by large and small-scale industries or by many hobbyists. Due to its nature of layer by layer addition of material, identifying defects between the layers can be a crucial strategy to determine the quality of a 3D printed product by carefully monitoring the layerwise process during part building. This kind of approach gives an advantage in the applications where 3D printing of products requires high customization without compromise on part quality. In this work, a low-cost camera is installed in an open 3D printer, and computer vision algorithms are used to implement an in-situ monitoring system. The defects can be evaluated by comparing the printed layer to the deposition path of the open ISO G-code. The G-code printing file is modified to introduce the image capture step after each layer. The value of the area of missing or exceeding material is returned to the user with the corresponding images. A decision can be made to abort the job in case of important defects to avoid unnecessary waste in material, time, and costs.

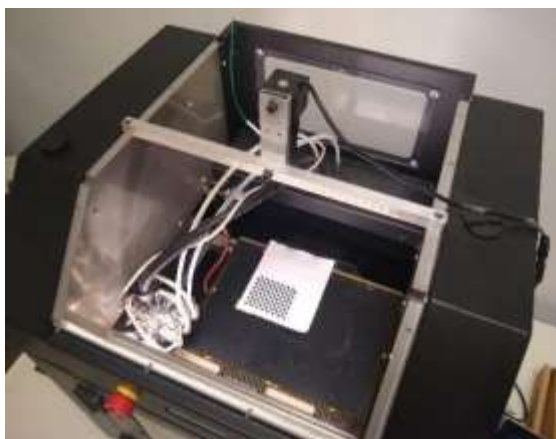
Figure 1. Printer setup with the Svpro camera and checkerboard pattern.

To acquire a picture of the current layer, the camera was installed on the top of the printer bed using an aluminium support bar. For this purpose, the top cover of the printer was removed, as shown in figure 1. With this configuration of the camera, the acquired images are always perpendicular to the print bed and part cross-section. This approach ensures minimal modification to the printing process and its subsystem, such as the print head.

The system calibration to correct the distortion in images is implemented using a checkerboard pattern printed on plain paper (figure 1). An L-shaped 3D printed reference part is used to align the checkerboard pattern with the bed axes (figure 2). Using the procedure described by Fetic et al. [12], the camera parameters are computed starting from the acquired image of the checkerboard pattern. With the information from the G-code, the system can automatically perform adjustments to select the region of interest and recognize the positional coordinates on the printing bed.

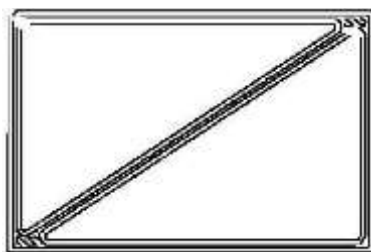
Figure 6. Printing path of the rectangular sample without considering the extrusion width.

Figure 6 shows the printing path generated by Kisslicer software in the G-code file, while the reference image created with the marker from the printing path is shown in figure 7.

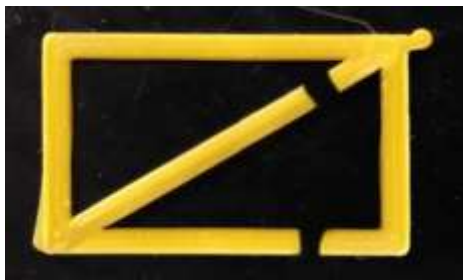
Figure 8. Printed sample with artificial defects.

To validate the monitoring system capabilities for automatic detection of defects, a defective sample part is printed by manually decreasing the feed of the extruder head for overdeposition of ABS material. Moreover, when printing is complete, two small portions of the printed part are slashed out to generate two zones with missing material. The monitoring system captures the printed layer image with the two defects, as shown in figure 8. This image is processed and compared to the reference image of the same layer (figure 7). The overall result of the comparison is shown in figure 9, wherein the green colour is used for referring to the deposited filament that was correctly printed.

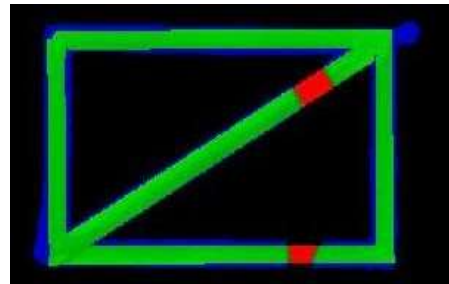
Figure 9. Result of the Process monitoring system for detection of printing defects.

Moreover, two more images are generated to singularly identify the area corresponding to the two target defects of (i) lack of material deposition or (ii) undesired material deposition. The area of first target defect is shown in figure 10 but also visible with red colour in figure 9. The area of the second defect is shown in figure 11 but also outlined in blue colour in figure 9.

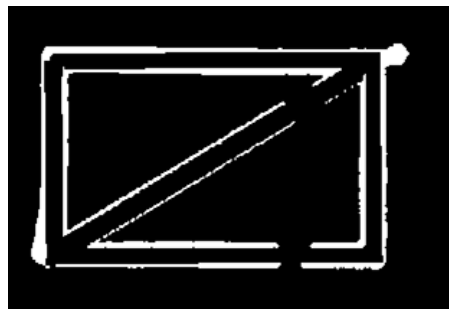
Figure 11. Undesired filament deposition across the edges of the rectangular test sample.

With information about the system configuration and resolution, the area corresponding to each colour can also be measured. Hence, the monitoring system reports that an area of 8.7 mm² corresponds to the first defect of missing material. The second defect of undesired filament deposition covers an area of 77.78 mm² due to overextrusion.
