Title No. 118-S117

# Improving Distributed Fiber-Optic Sensor Measures by Digital Image Correlation: Two-Stage Structural Health Monitoring

by Maurizio Morgese, Marco Domaneschi, Farhad Ansari, Gian Paolo Cimellaro, and Daniele Inaudi

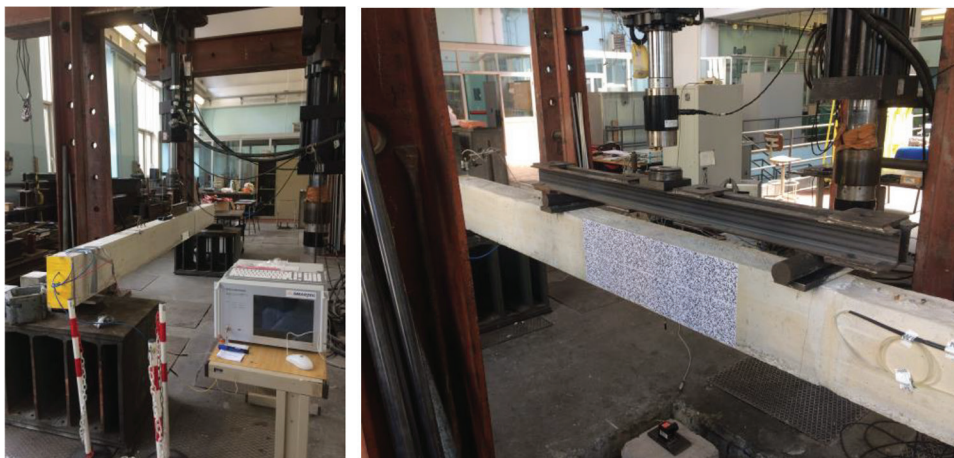
Different types of FOSs were embedded in the specimens before concrete placing and afterwards glued onto the external surface of the beams once the beams completed the curing period. The first type (Sensor 1) is a unique FOS used for the evaluation of distributed strain and temperature over several kilometers, using different scattering technologies (Brillouin and Raman). It contains four single-mode and two multi-mode optical fibers embedded in plastic material. Sensor 2 is composed of two bonded and two free single-mode optical fibers protected by a polyethylene thermoplastic profile. Temperature measurements were made by free fibers (not physically attached to concrete), and strains by bonded fibers. Sensor 3 is a single-mode optical fiber embedded in a glass fiber-reinforced polymer/epoxy tape, typically used for surface installation or embedding directly into composites. Sensor 4 is an optical fiber in a plastic matrix with a high Young's modulus. The fifth and last sensor (Sensor 5) was exclusively employed for temperature measurement. Figure 8 depicts the configuration of sensors within the specimens, and Fig. 9 pertains to the test setup.

Fig. 9—Test setup.
