Harmonic Drive Gear Failures in Industrial Robots Applications: An Overview

Andrea Raviola¹, Andrea De Martin², Roberto Guida³, Giovanni Jacazio⁴, Stefano Mauro⁵ and Massimo Sorli⁶

^{1,2,3,4,5}*Politecnico di Torino, Department of Mechanical and Aerospace Engineering, Torino, 10129, Italy*

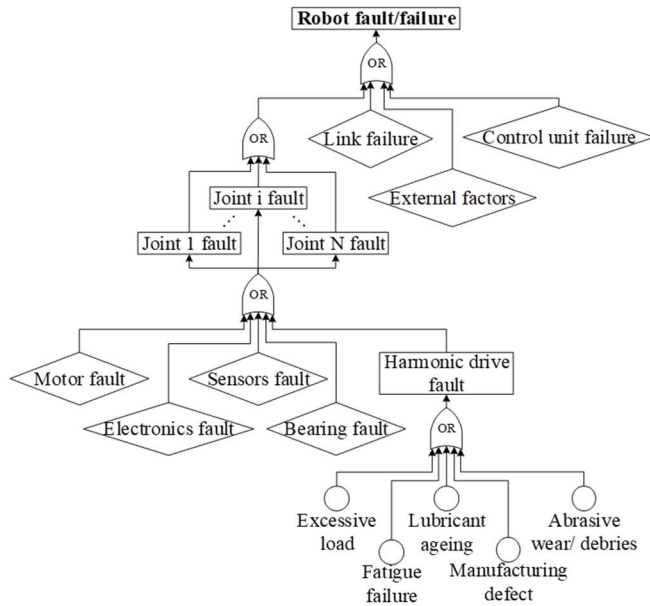
industrial manipulator is highlighted. So, in the FTA diagram reported in Figure 2, only the branch related to the gearbox will be discussed, while the other ones, represented with diamonds, have been left undeveloped.

Figure 2. Robot arm fault tree analysis.

Such a deductive top-down approach is based on a tree-structure which relates, through logic gates, the Top Level Event (TLE) with the intermediate (rectangles) and the basic ones (circles). The aim is to identify the minimal combination of components faults or failures (cut sets) that can lead to a degradation of the robot performance. Thus, if a branch contains few events or elements with a high failure rate, this could result in an unreliable system. A more detailed overview about the state-of-the-art in FTA and how it works is provided by Ruijters and Stoelinga (2015).

External factors like collisions, human errors, and accidental damages are not considered critical for the correct functioning of the robot since they could be easily avoided through a correct installation and usage of the machine. Moreover, empirical experience suggests that link breakage and control unit failures are not common events. So, they are not as relevant as a damage to one of the robot joints, which is more likely to happen due to their high complexity and load history. Since each of them has a key role in the manipulator motion, a single malfunctioning could comprise the entire task. For this reason, they are all connected through an OR gate. The same logic applies to describe the interactions among the joint sub-components and their possible failure modes, with a particular focus on the HD ones.

This analysis shows how even a single fault on one gearbox in one joint of the robot arm could jeopardize the entire application. It is then necessary to have a clear insight on

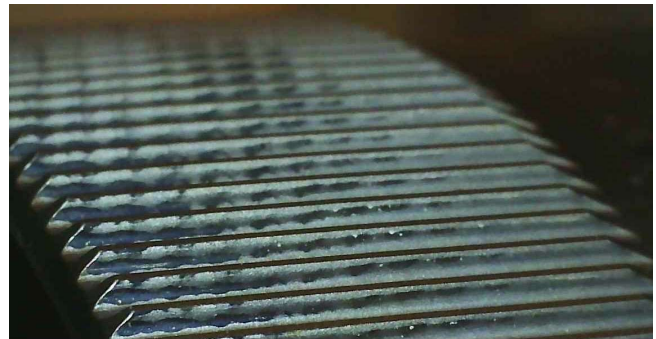
Since industrial manipulators are primarily used to execute repetitive tasks, each joint is subjected to a specific load history and different levels of wear. During a pick and place application, for example, it is more likely that the first three joints of the robot arm moves within predefined ranges, while the ones of the wrist are almost still since they usually have to maintain a constant orientation of the Tool Center Point (TCP). This could lead to improper lubrication of the FS and CS teeth, causing adhesive wear. As shown in Figure 5, the FS teeth are subjected to an uneven wear distribution along their length.

Figure 5. Effect of the coning angle on the flexspline tooth wear.

The damage is greater closer to the FS input than towards the rear cross section. This is caused by the coning angle generated by the insertion of the WG into the FS. This phenomenon is related to the fact that only the input section of the FS is deformed into an ellipse by the WG, while the output one, closer to FS boss, remains circular. This leads to an uneven engagement of the FS and CS teeth along the rotation axis, as schematized in Figure 6.
