Residual Properties in Damaged Laminated Composites through Nondestructive Testing: A Review

Keywords: laminated composites; nondestructive techniques; damage severity assessment; residual properties; damage index

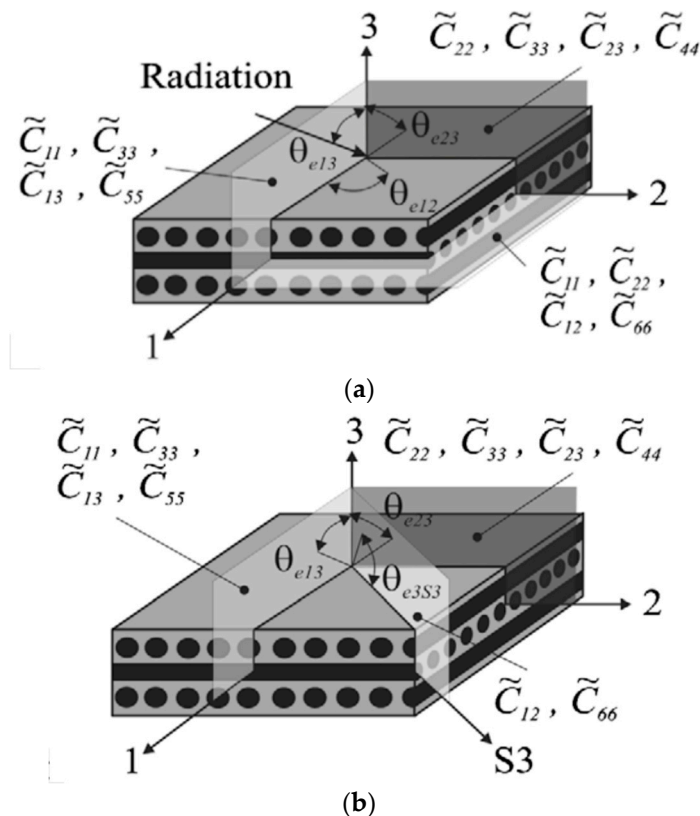
Figure 1. Determination of stiffness matrix coefficients by measurement in (a) symmetry planes and (b) non-symmetry planes [26].

Measurements in non-symmetry planes are, however, controversial due to practical problems [26]. Indeed, the determination of the time-of-flight data is complicated by the severe distinction between the phase velocity and the group velocity, i.e., the velocity of propagation of the wave packet, in non-principal planes [24]. Further, it is worth noticing

that the methodology assumes an orthorhombic symmetry in the material [25]. Therefore, apart from the special case of cross-ply symmetric laminates, material constants of angle-ply laminates cannot be determined.
