# Residual Properties in Damaged Laminated Composites through Nondestructive Testing: A Review

**Abstract:** The development of damage tolerance strategies in the design of composite structures constitutes a major challenge for the widespread application of composite materials. Damage tolerance approaches require a proper combination of material behavior description and nondestructive techniques. In contrast to metals, strength degradation approaches, i.e., the residual strength in presence of cracks, are not straightforwardly enforceable in composites. The nonhomogeneous nature of such materials gives rise to several failure mechanisms and, therefore, the definition of an ultimate load carrying capacity is ambiguous. Nondestructive techniques are thus increasingly required, where the damage severity is quantified not only in terms of damage extension, but also in terms of material response of the damaged region. Based on different approaches, many nondestructive techniques have been proposed in the literature, which are able to provide a quantitative description of the material state. In the present paper, a review of such nondestructive techniques for laminated composites is pre

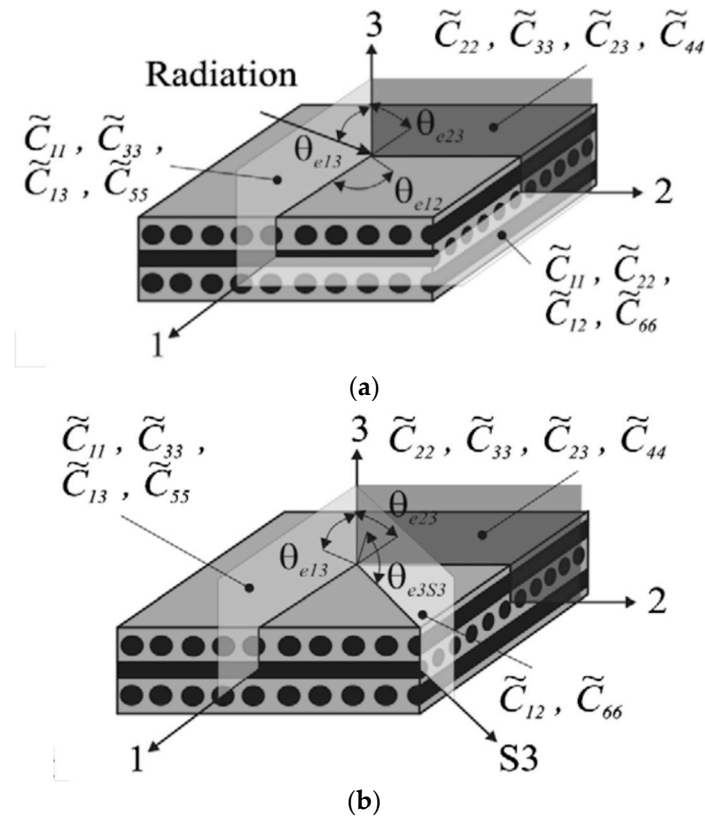
**Figure 1.** Determination of stiffness matrix coefficients by measurement in (a) symmetry planes and (b) non-symmetry planes [26].

Measurements in non-symmetry planes are, however, controversial due to practical problems [26]. Indeed, the determination of the time-of-flight data is complicated by the severe distinction between the phase velocity and the group velocity, i.e., the velocity of propagation of the wave packet, in non-principal planes [24]. Further, it is worth noticing

that the methodology assumes an orthorhombic symmetry in the material [25]. Therefore, apart from the special case of cross-ply symmetric laminates, material constants of angle-ply laminates cannot be determined.

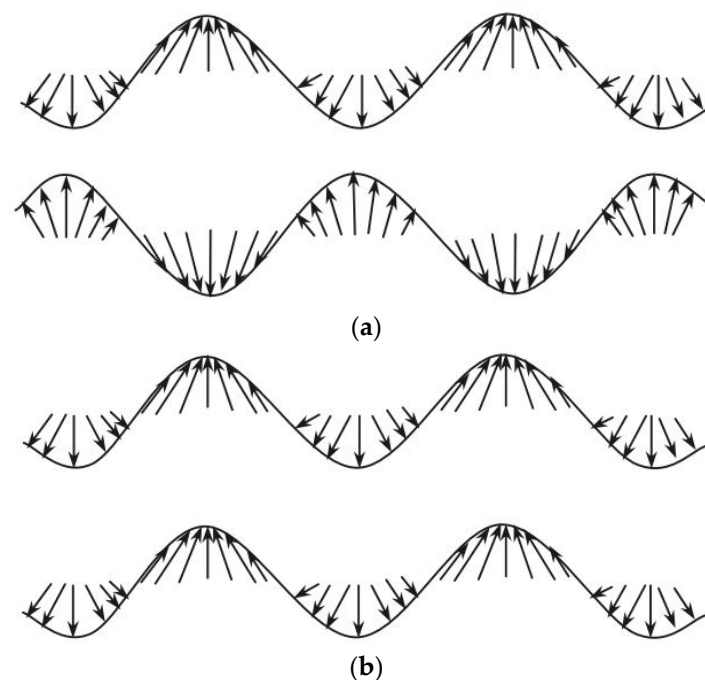
**Figure 2.** Symmetric (a) and anti-symmetric (b) Lamb waves [29].

Multiple propagating modes can be excited for the nondestructive inspection. Usually, the investigating frequency range is limited and only the first two fundamental modes are observed: the anti-symmetric mode, called  $a_0$  and the symmetric mode, called  $s_0$ , which are shown in Figure 2, taken from [29].

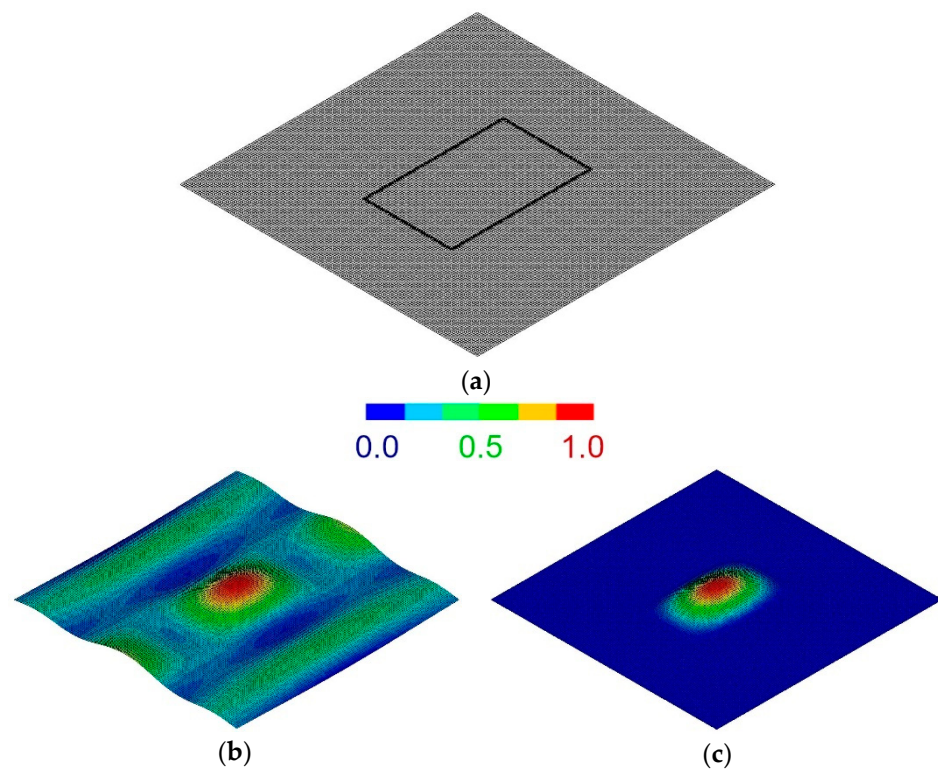
**Figure 3.** Comparison of local simply supported and clamped boundaries: (a) finite element model with highlighted path of constrained nodes; (b) modal analysis results with simply supported boundaries; (c) modal analysis results with clamped boundaries [55,56].

The technique is able to localize the vibrational response of the system by adopting the proper equipment. In particular, the boundaries of the region under investigation are nondestructively clamped. By clamping the boundaries of the region, the Authors showed that a vibrational mode which is specific of the retained region can be excited. The resultant first resonant frequency is thus only a function of the elastic characteristics of the inspected region. Figure 3, taken from [56], shows the results of a finite element modal analysis where simply supported (Figure 3b) and clamped (Figure 3c) boundaries are alternatively

retained for the path of nodes highlighted in Figure 3a. When fully clamped boundaries are adopted, a specific mode which involves only the inspected region can be excited.

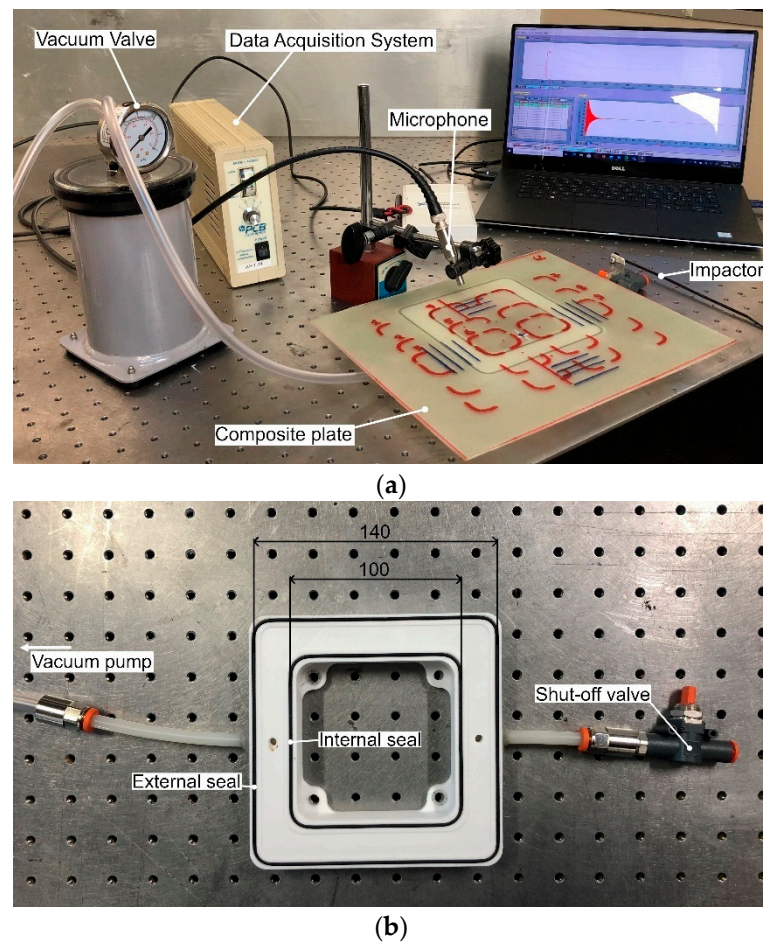
**Figure 4.** Experimental setup (a) and clamping device (b) of the local vibrational analysis technique.

The technique has been recently extended to the analysis of damaged laminates. In particular, as the observations performed within the nondestructive testing are usually limited to only the exposed surface of the component, an innovative clamping system has been proposed, which adopted a vacuum to obtain the clamping effect. As shown in Figure 4, the inspected region is framed by a vacuum chamber whose air is aspirated through a vacuum pump. The frame chamber is delimited by internal and external rubber seals, which prevent any air escape.

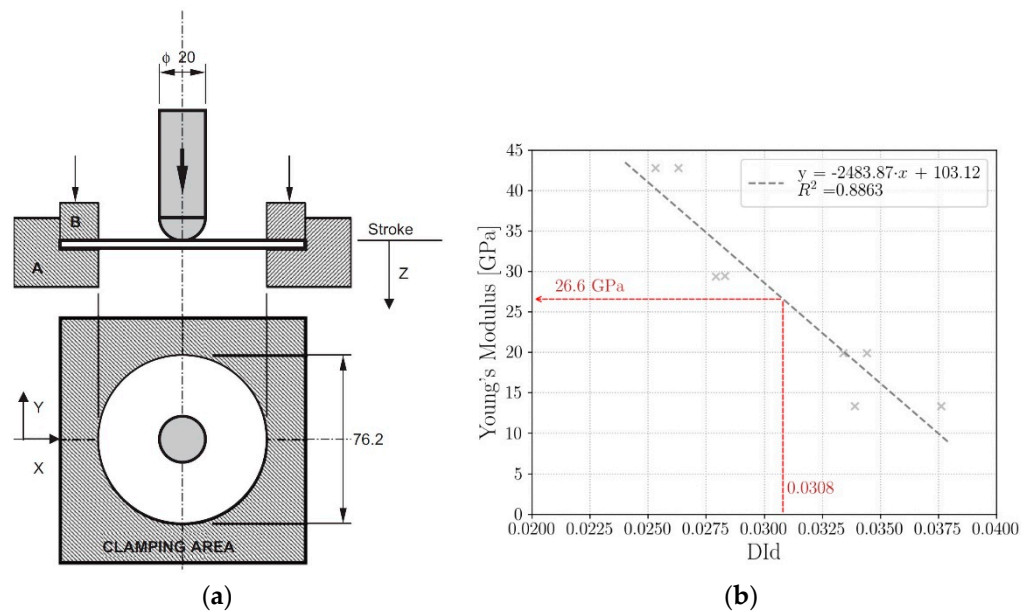
**Figure 5.** (a) Scheme of the testing fixture of the  $DI_d$  technique [61]; (b) relationship between the residual elastic properties and the  $DI_d$  parameter [64].

As the residual energy absorption aptitude is evaluated for a circumscribed region of the component, local elastic constants are assessed. Figure 5a shows the testing fixture. By clamping the boundaries through a properly provided uniform pressure, the impact response concerns only the circumferential region whose diameter is 76.2 mm.

The double impact set involves two impact tests on each plate. A new set of composite plates is initially impacted at increasing energy levels and then impacted again on the damaged area at the threshold impact energy  $E_{th}$ . The damage index parameter  $DI_d$  is thus calculated according to Equation (6). The double impact set allows to correlate the  $DI_d$  parameter to the impact energy. Combining this information with the results of the single impact set, where the residual elastic properties are correlated to the incident energy, the residual elastic properties can be expressed as a function of the  $DI_d$  parameter, as shown in Figure 5b.

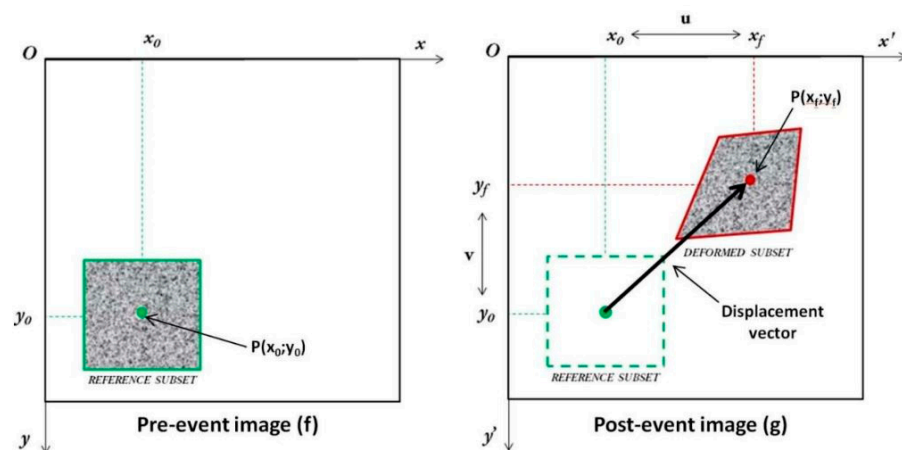
Figure 6. Scheme of DIC basic principle [70].

images under the application of external loads. In this way the DIC allows also to locally capture deformation originated by material inhomogeneities [68]. In particular, in the post-processing phase, a virtual mesh is generated on the surface of the component whose main parameters are the subset size and the step size. The surface of the component is divided into squared subsets whose dimension is defined by the subset size. With the step size parameter, the distance between the subset centers, i.e., the shift between subsets, is assumed. Generally, each subset should contain at least three speckles and step size should be at least 1/3 of the subset size [69]. Both the step size and the subset size are measured in pixels. As shown in Figure 6, taken from [70], subset displacements are sequentially tracked with reference to their center.

Indeed, DIC assumes that the deformation within the subset is constant. The position of each subset is determined in each digital image by minimizing a correlation function. Several correlation functions have been proposed in the literature and the reader can refer to [69] for a comprehensive description.

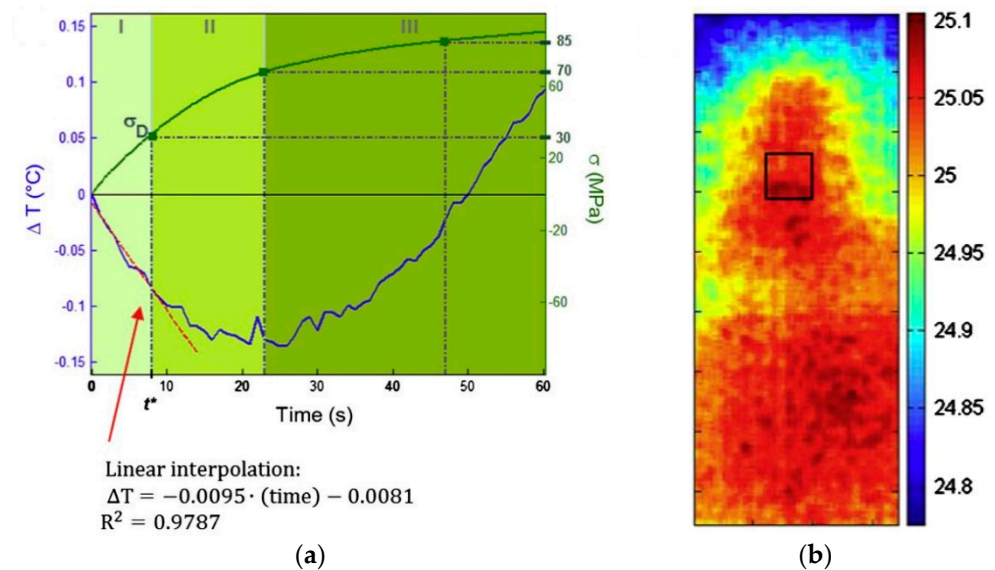
**Figure 7.** (a) Temperature trend and stress trend of the  $[+45^\circ, -45^\circ]_s$  specimen. Deviation from linearity indicates the damage onset, specifically at time  $t^*$  and stress  $\sigma_D$ ; (b) thermal map of the specimen at  $t^*$ . The black box is the region where the average temperature is calculated [79].

Damage evolution in static tests has been investigated with passive thermography. In [79], the Authors performed quasi-static tests on glass-fiber reinforced specimens. Three configurations were retained: unidirectional laminate loaded in the fiber direction, unidirectional laminate transversely loaded, and symmetric laminates with stacking sequence  $[+45^\circ, -45^\circ]_s$ . The temperature profiles showed three distinct phases. An example, taken from [79], is reported in Figure 7.

In the first phase a linear decrement of the surface temperature with the applied stress is observed, in accordance with the Kelvin's law, Equation (10). The second phase is characterized by a nonlinear decrement of the temperature, as the damage has onset. At the end of the second phase a minimum in the temperature decrease is reached. The minimum might also represent the high cycle fatigue limit of the material [80], while the true endurance limit is represented by the damage initiation stress. However, the definition of a fatigue limit for composites is still discussed [81]. Finally, the third phase is characterized by an almost linear increment of the temperature. Indeed, as the damage proceeds, the mechanical energy stored in the material is released leading to an increment of the temperature. The slope of the third-phase temperature profile seems correlated with the damage development: the more the damage expands before the final fracture, the higher the slope of the temperature increase [79].
