Residual properties in damaged laminated composites through nondestructive testing: A review / Boursier Niutta, C.; Tridello, A.; Paolino, D. S.; Belingardi, G.. - In: MATERIALS. - ISSN 1996-1944. - STAMPA. - 14:16(2021), p. 4513. [10.3390/ma14164513]

# Residual Properties in Damaged Laminated Composites through Nondestructive Testing: A Review

**Keywords:** laminated composites; nondestructive techniques; damage severity assessment; residual properties; damage index

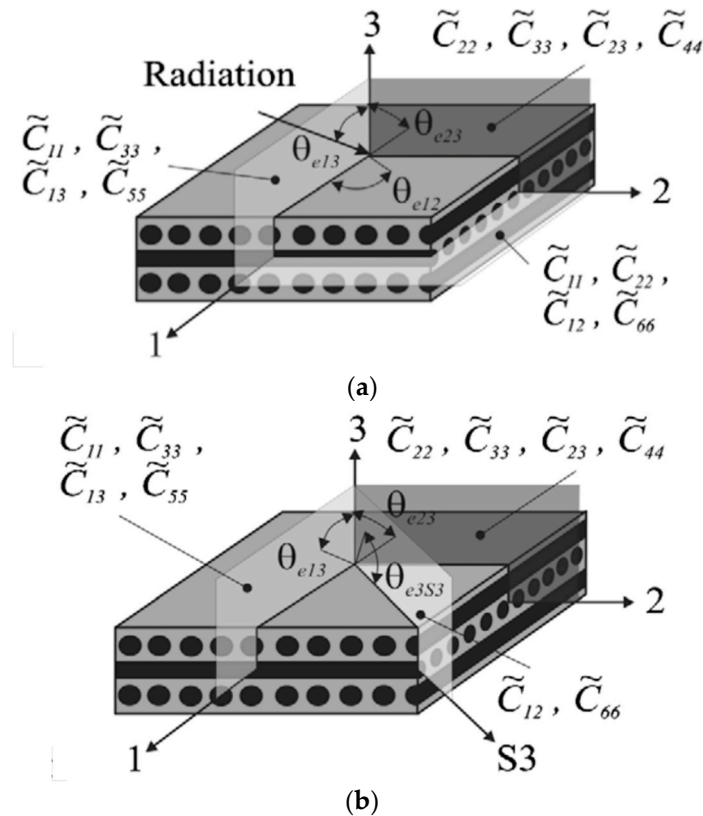
**Figure 1.** Determination of stiffness matrix coefficients by measurement in (a) symmetry planes and (b) non-symmetry planes [26].

Measurements in non-symmetry planes are, however, controversial due to practical problems [26]. Indeed, the determination of the time-of-flight data is complicated by the severe distinction between the phase velocity and the group velocity, i.e., the velocity of propagation of the wave packet, in non-principal planes [24]. Further, it is worth noticing

that the methodology assumes an orthorhombic symmetry in the material [25]. Therefore, apart from the special case of cross-ply symmetric laminates, material constants of angle-ply laminates cannot be determined.

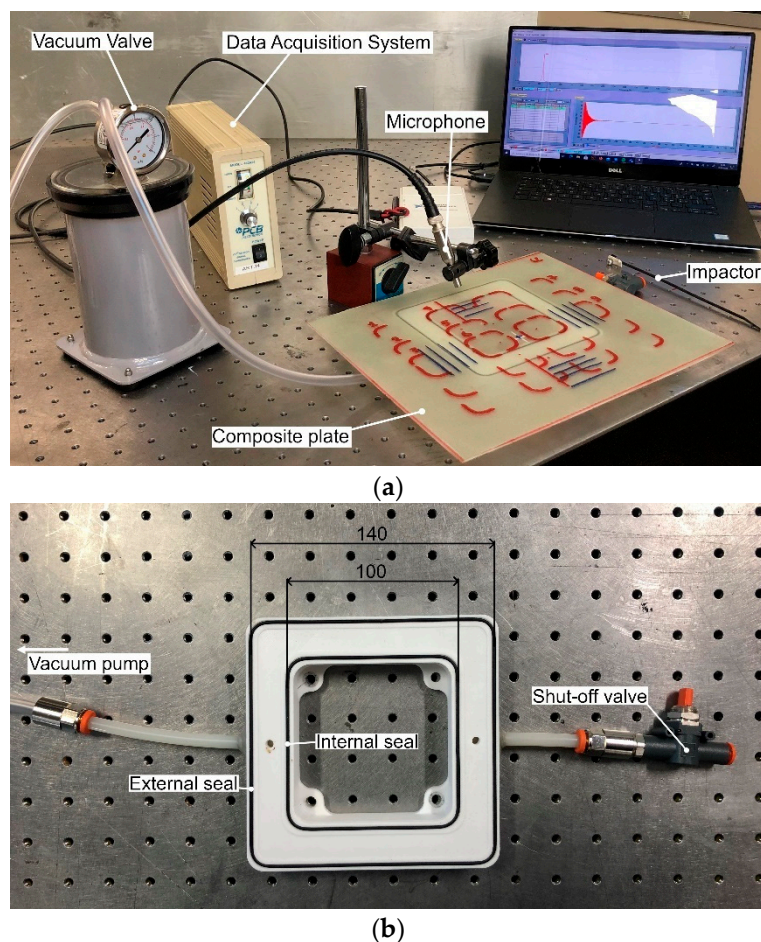
**Figure 4.** Experimental setup (a) and clamping device (b) of the local vibrational analysis technique.

The technique has been recently extended to the analysis of damaged laminates. In particular, as the observations performed within the nondestructive testing are usually limited to only the exposed surface of the component, an innovative clamping system has been proposed, which adopted a vacuum to obtain the clamping effect. As shown in Figure 4, the inspected region is framed by a vacuum chamber whose air is aspirated through a vacuum pump. The frame chamber is delimited by internal and external rubber seals, which prevent any air escape.

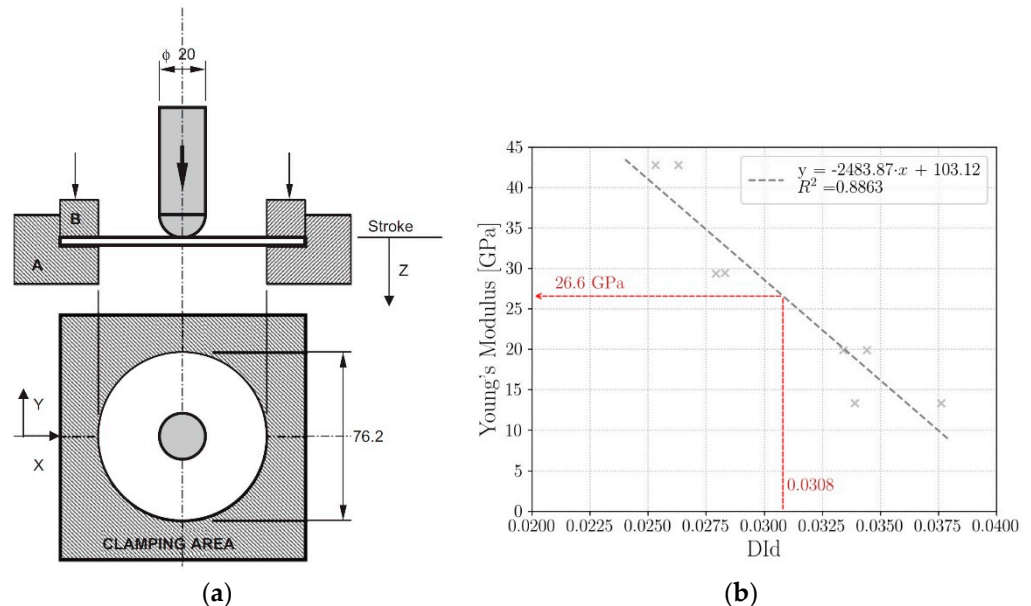
**Figure 5.** (a) Scheme of the testing fixture of the  $DI_d$  technique [61]; (b) relationship between the residual elastic properties and the  $DI_d$  parameter [64].

As the residual energy absorption aptitude is evaluated for a circumscribed region of the component, local elastic constants are assessed. Figure 5a shows the testing fixture. By clamping the boundaries through a properly provided uniform pressure, the impact response concerns only the circumferential region whose diameter is 76.2 mm.

The double impact set involves two impact tests on each plate. A new set of composite plates is initially impacted at increasing energy levels and then impacted again on the damaged area at the threshold impact energy  $E_{th}$ . The damage index parameter  $DI_d$  is thus calculated according to Equation (6). The double impact set allows to correlate the  $DI_d$  parameter to the impact energy. Combining this information with the results of the single impact set, where the residual elastic properties are correlated to the incident energy, the residual elastic properties can be expressed as a function of the  $DI_d$  parameter, as shown in Figure 5b.
