# Procedure for technological diagnosis of oily residuals management in Cubans distributed generation power plants

## Abstract

**Keywords:** Distributed generation power plant; environmental audit; FMEA; oily residuals.

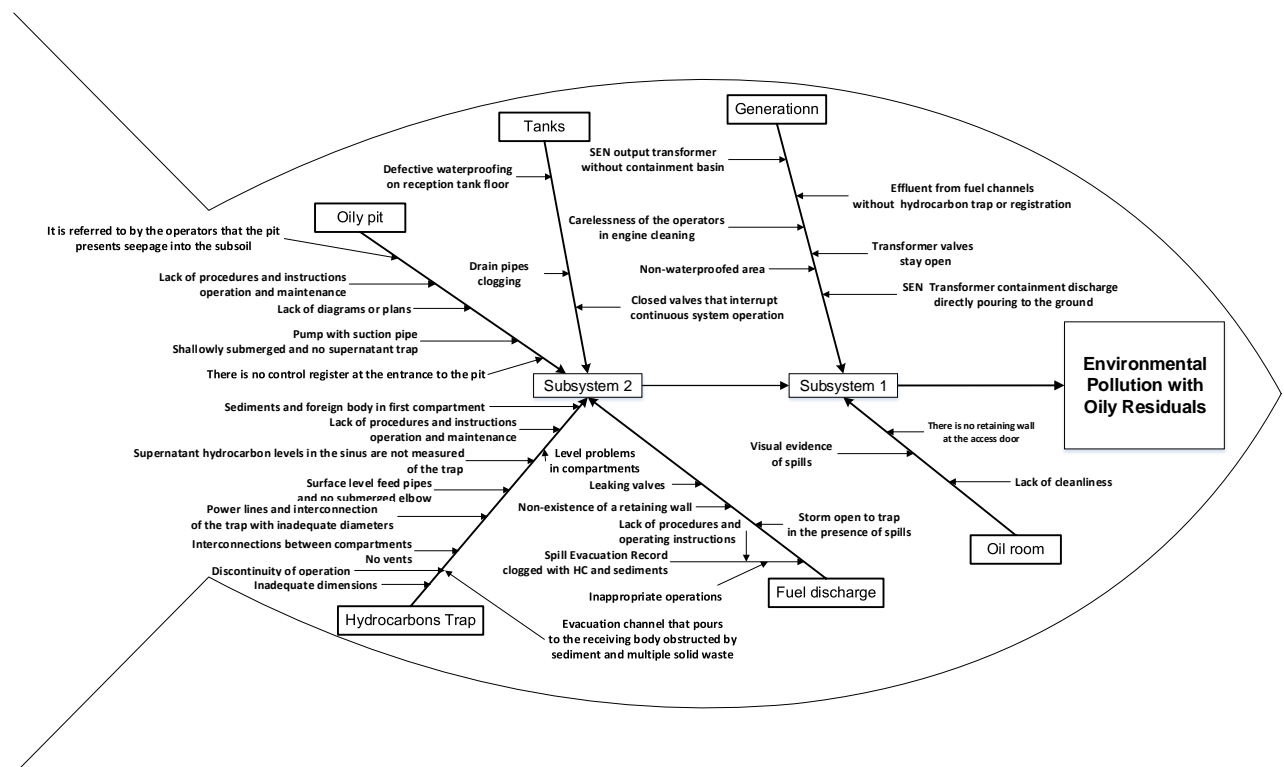
## Appendix B. Cause-Effect diagram by subsystem in the Cruces generation power plant.

The findings determination allowed to find the potential associated causes (see an example in appendix B), which immediately were deployed throughout the failures modes and effects analysis obtained the most critical causes according to the RPN. Were identified more than 150 independents causes totaling all power plants. Particularly, it is remarkable that a set of common causes inherent to each power plant with RPN higher than 600 were identified. These group is listed below:
