Procedure for Technological Diagnosis of Oily Residuals Management in Cubans Distributed Generation Power Plants

# Procedure for technological diagnosis of oily residuals management in Cubans distributed generation power plants

*Keywords:* Distributed generation power plant; environmental audit; FMEA; oily residuals.

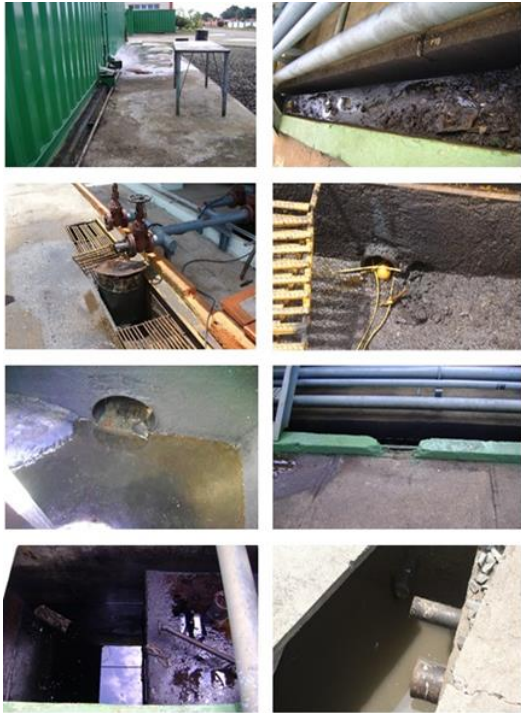
**Appendix A. Some graphical evidence from on-site audit activities in different power plants.**

From an exhaustive diagnosis in the power plants subsystems, attending to the criteria of design requirements, technical status, functional performance, operating conditions, and maintenance aspects; an abundant amount of evidence was documented. This evidence was collected among pictures, sketches, check sheets, reports, and notes. In the Appendix A is shown a sampled of some pictures as primary evidence collected in the power

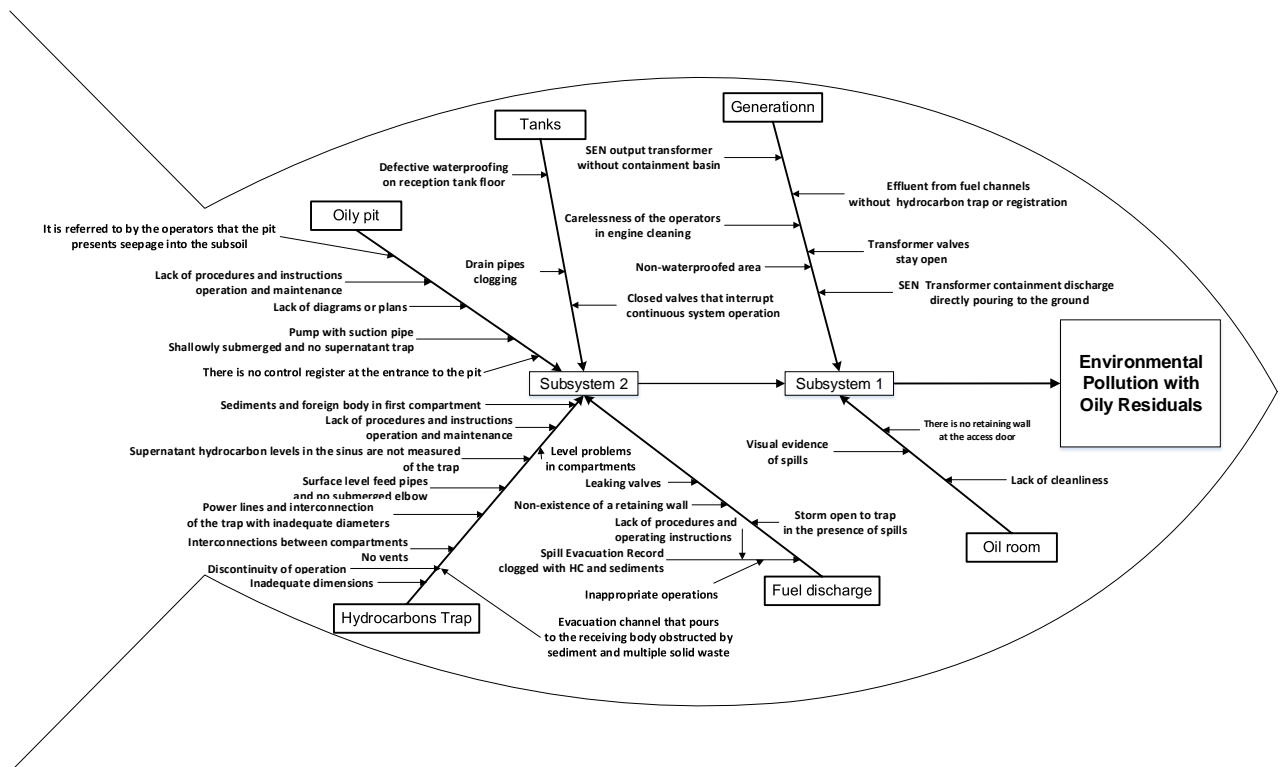
**Appendix B. Cause-Effect diagram by subsystem in the Cruces generation power plant.**

The findings determination allowed to find the potential associated causes (see an example in appendix B), which immediately were deployed throughout the failures modes and effects analysis obtained the most critical causes according to the RPN. Were identified more than 150 independents causes totaling all power plants. Particularly, it is remarkable that a set of common causes inherent to each power plant with RPN higher than 600 were identified. These group is listed below:
