Procedure for Technological Diagnosis of Oily Residuals Management in Cubans Distributed Generation Power Plants

# Procedure for technological diagnosis of oily residuals management in Cubans distributed generation power plants

**Keywords:** Distributed generation power plant; environmental audit; FMEA; oily residuals.

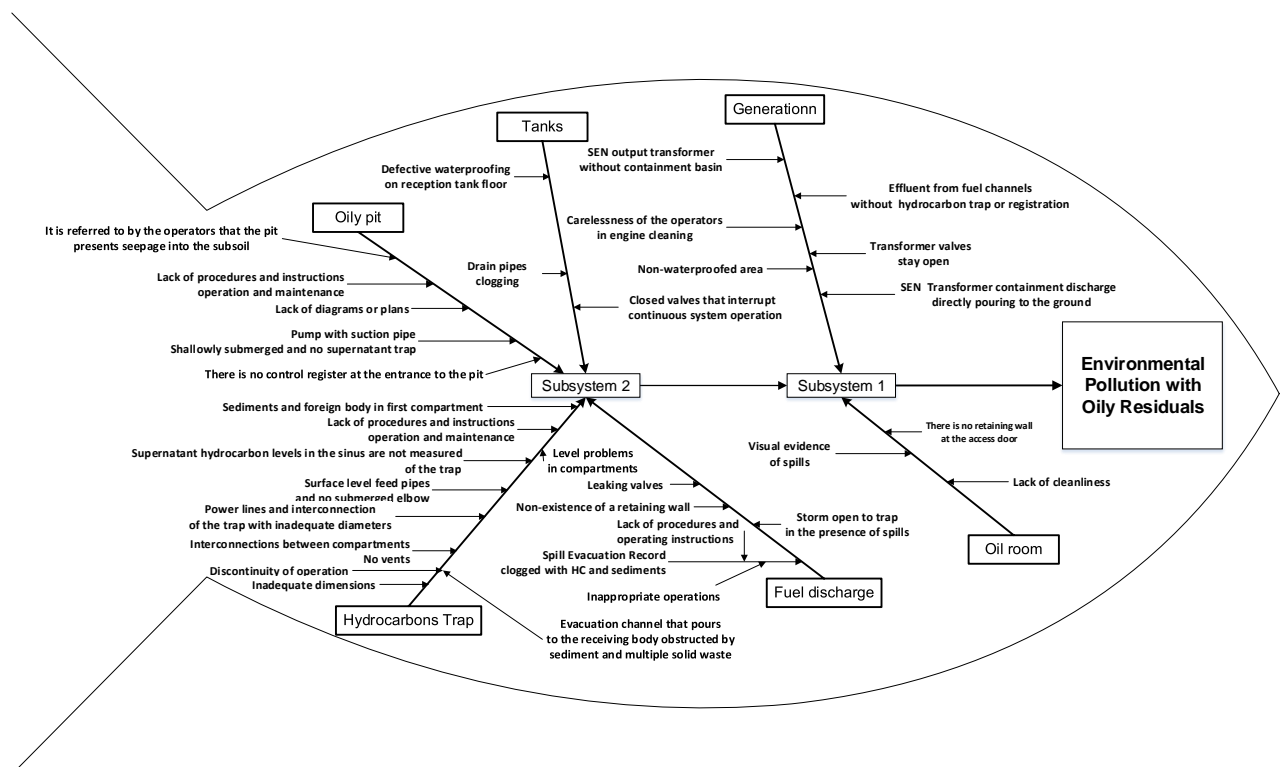
## Appendix B. Cause-Effect diagram by subsystem in the Cruces generation power plant.

The findings determination allowed to find the potential associated causes (see an example in appendix B), which immediately were deployed throughout the failures modes and effects analysis obtained the most critical causes according to the RPN. Were identified more than 150 independents causes totaling all power plants. Particularly, it is remarkable that a set of common causes inherent to each power plant with RPN higher than 600 were identified. These group is listed below:
