MIG and TIG Joining of AA1070 Aluminium Sheets with Different Surface Preparations

Abstract: In this work, AA1070 aluminium alloy sheets are joined using TIG and MIG welding after three different edge preparations. Shearing, water jet and plasma-cut processes were used to cut sheets, subsequently welded using ER5356 and ER4043 filler metals for TIG and MIG, respectively. Mechanical properties of the obtained sheets were assessed through tensile tests obtaining a relation between sheet preparation and welding tightness. Micro-hardness measures were performed to evaluate the effects of both welding and cutting processes on the micro-hardness of the alloy, highlighting that TIG welding gives rise to inhomogeneous micro-hardness behaviour. After tensile tests, surface fractures were observed employing scanning electron microscopy to highlight the relation between tensile properties and edge preparations. Fractures show severe oxidation in the water jet cut specimens, ductile fractures and gas porosities.

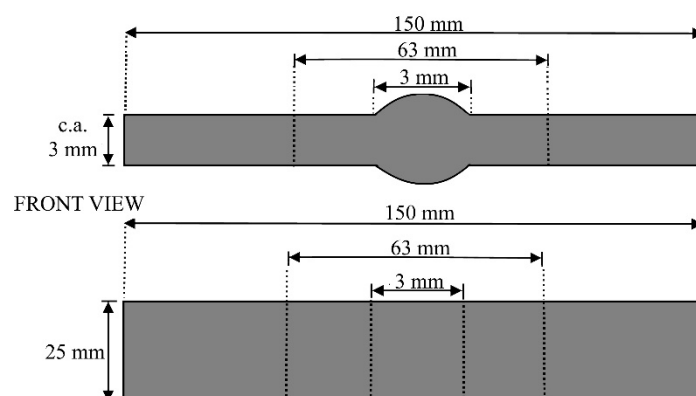
Specimens for tensile tests were milled following the UNI EN ISO 4136:2012 standard (Figure 1): gauge length 120 mm, length 150 mm, width 25 mm, thickness 3 mm. Test parameters used were preload 50 N, test speed $8 \text{ N/mm}^2\text{s}^{-1}$ before yielding point $R_{p0.2}$ and $0.008 \text{ N/mm}^2\text{s}^{-1}$ after yielding point $R_{p0.2}$. Each welded sheet contained eleven specimens: five specimens had a protruding weld, while in the other six samples the weld was milled, as drawn in Figure 2. In fact, a protruded weld could be detrimental to the mechanical resistance, and it is commonly considered a weld-shape defect. Tensile tests were performed by a Zwick-Roell machine (Zwick-Roell BT1-FR100, Zwick Roell S.r.l., Genova, Italy).

Figure 1. Drawing of specimens for tensile tests. Welding length: 3 mm; gauge length: 60 + weld length; thickness: ca. 3 mm; width: 25 mm; total length 150 mm.

Tensile tests were performed on samples shown in Figures 1 and 3.

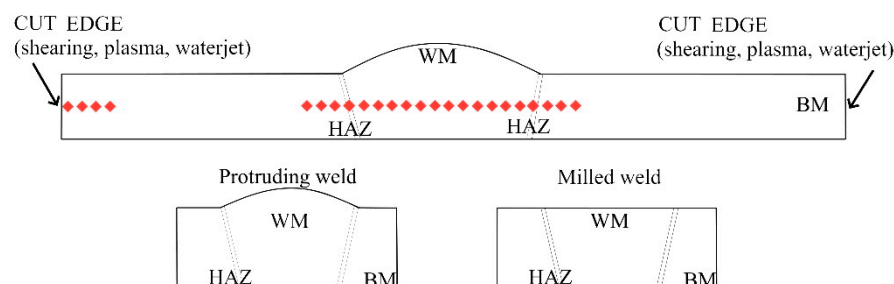
Figure 2. Drawing of micro-hardness measures path (red-diamond) along with BM, HAZ and WM and near the edges. Representation of the weld in the protruded and in the milled state.

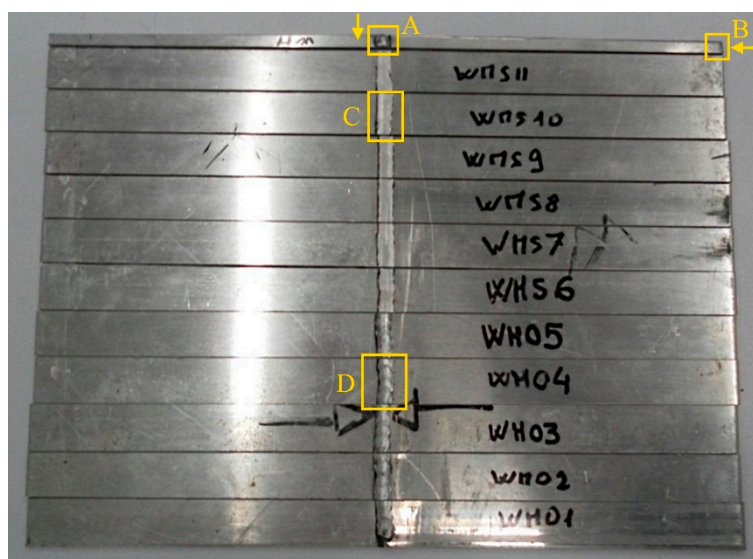
Figure 3. Sheets after waterjet cutting and MIG welding. The welded sheets were cut to obtain tensile test specimens and samples for microstructural observation and micro-hardness measures. A: Sample for weld observation and micro-hardness; the arrow indicates the side of observation. B: Sample for edge observation and micro-hardness; the arrow indicates the side of observation. C: Milled weld. D: Protruding weld.

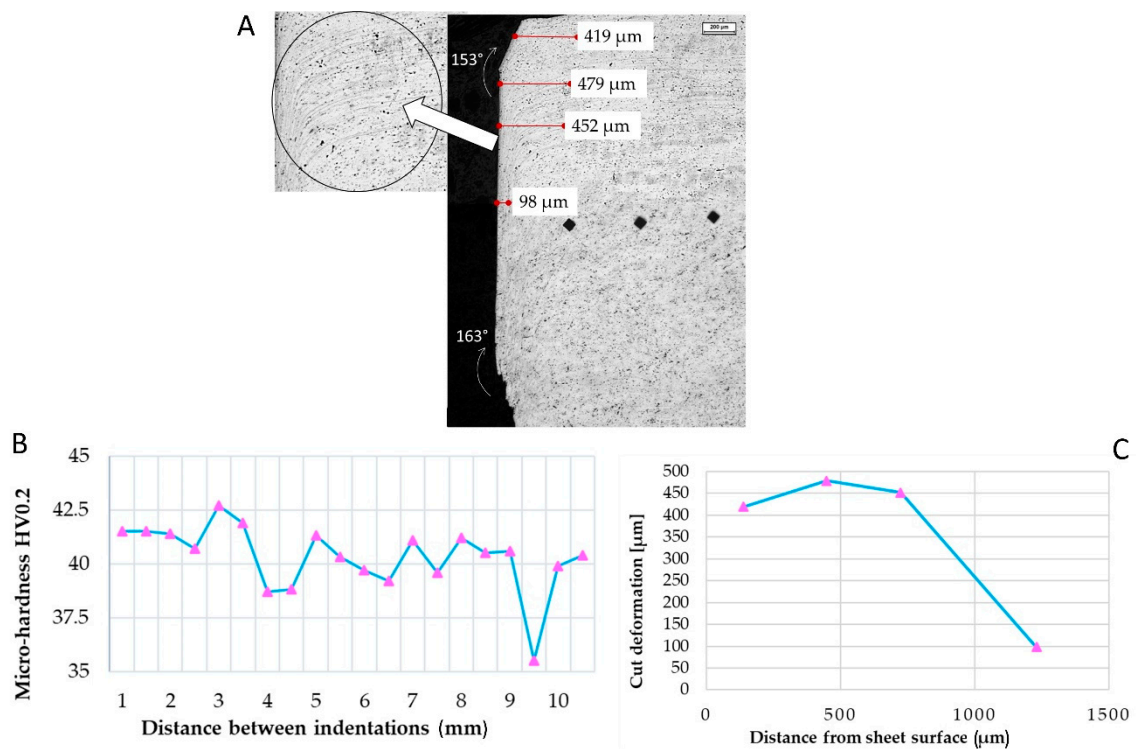
The aluminium sheets after the shearing process appear to have almost linear edges, as clearly noticeable from Figures 4A and 5. The sheet microstructure is oriented along the rolling direction (horizontal direction); after the chemical etching, the distortion of the microstructure at the edges appears evident.

Figure 4. (A) Microscope image of the shearing cutting trace on AA1070 sheet. (B) Distortions in the first 1200 μm were documented. (C) Micro-hardness measured along the first 10 mm starting from the cut edge. Marker: 200 μm.

Some microstructural measures were performed through image analysis software (LEICA QWin, version 3.5, Leica Microsystems, Heerbrugg, Switzerland) to evaluate the microstructural distortions. Shearing caused damage to the sheet's edges and material removal. Deformation angles were 27° (top sheet) and 17° (bottom sheet), while distortions decreased from 419 on the top to 98 μm in the middle of the sheet (Figure 4B).

Micro-hardness measured along the edge after shearing did not show an increase caused by plastic deformation near the edge; the micro-hardness resulted almost constant along with the sheet (Figure 4B).

In terms of weldability, this configuration may affect the filler metal penetration, causing inadequate welding penetration during the welding process. On the other hand, despite the sheet edge shown in Figure 4 not being wholly planar, there was a proper welding penetration in both the welding processes (TIG and MIG). After TIG, specimens prepared by shearing resulted in the best mechanical values (along with water jet). On the other hand, mechanical tests showed similar behaviour for shearing-cut specimens and plasma-cut specimens after MIG processing.

Krinninger et al. [27] underlined that aluminium alloys' adhesive tendency (galling) is possible. Hence, the cutting surface in Figures 4 and 5 do not display the galling, while the cutting surfaces result in being relatively planar.

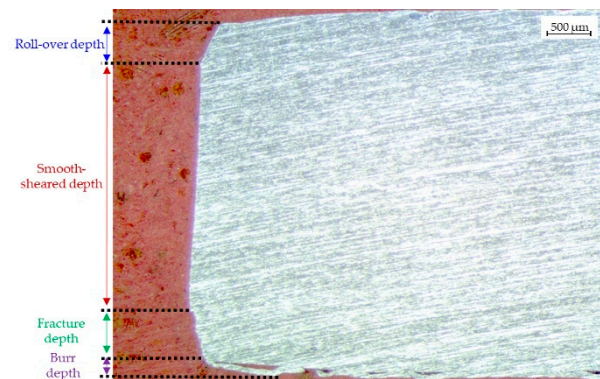
Figure 5. Different zones of the edges after shearing.

Conversely, various authors studied sheets' shearing, such as Hambli et al. in [24] and Tekiner et al. [25]. Mainly, they highlight four different zones after the shearing, as shown in Figure 5; the clearance between the punch and the die will affect the precision of the sheet shape and extension of these zones.

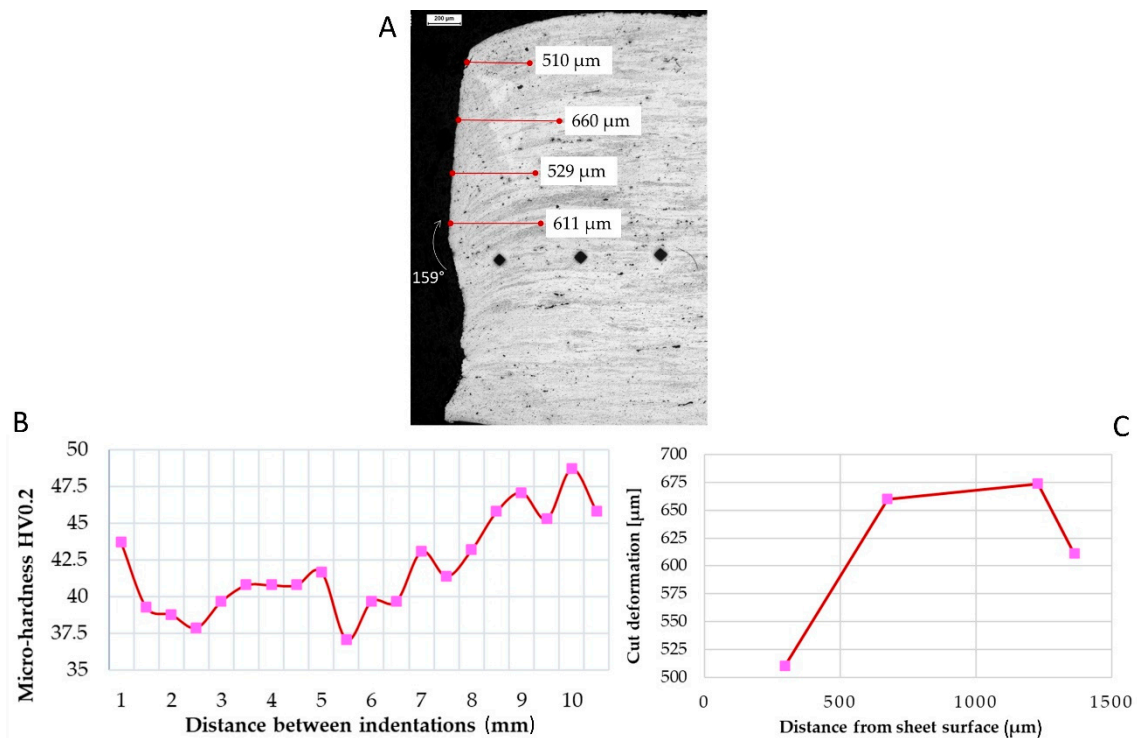
Plasma cutting (Figure 7A) caused higher specimen edge and microstructure orientation distortions. The distortion near the surface was 510 µm and at the mid-thickness 611 µm (Figure 7B).

A slight increase in micro-hardness was detected near the sheet's edge (Figure 7B).

Figure 7. (A) Microscope image of the plasma cutting trace on AA1070 sheet. (B) Distortions in the first 1400 μm were documented. (C) Micro-hardness measured along the first 10 mm starting from the cut edge. Marker: 200 μm.

From the literature, plasma cutting is considered the worst in terms of microstructural modification; moreover, heat-affected zones may develop if plasma power is too high [12]. Figure 7 shows the sheet microstructure after the plasma process. High microstructural distortions were noticed in the first half-width of the sheet. A consistent material removal was observed in the lowest part of the sheet, with a measured angle of 159° (21° of deformation in respect to the planar surface). With regards to micro-hardness, the first indentation (near the sheet edge) resulted in ca. 44 HV0.2, probably caused by strain hardening, then the micro-hardness decreased. In the first 7 mm, a slight heat-affected zone was noticed, micro-hardness decreased to 37 HV0.2; away from the edge, the micro-hardness increased up to 45–47 HV0.2.

Near the edges, different cutting processes caused different effects on both microstructures and micro-hardness measured. Plasma cutting affects the micro-hardness near the edges: the first micro-hardness value was slightly higher (ca. 40 HV0.2), while in the next 7 mm, the plasma effect occurs, resulting in a HAZ (see Figure 7).

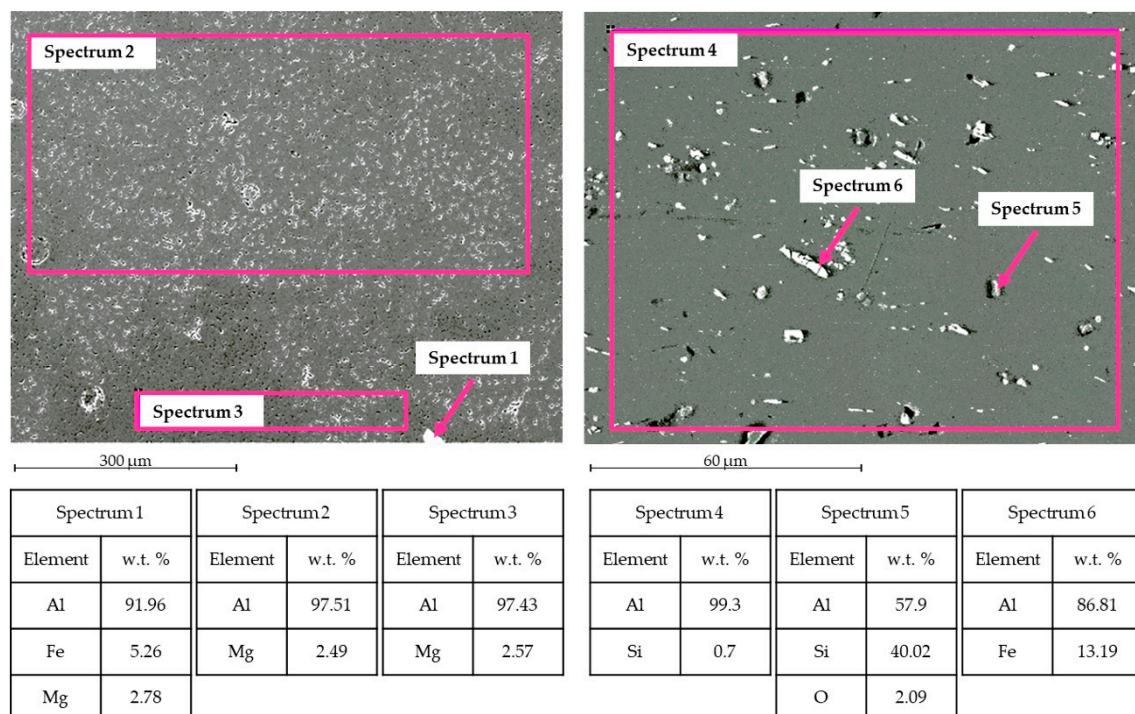
Figure 8 shows SEM-EDS analysis for TIG welding. In the WM, Al and Mg were observed, as expected, in the filler metal ER5356. Some intermetallic phases were observed, for instance, the phase Al-Fe-Mg [15] in Spectrum 1. In the HAZ zone, Al-Si and Al-Fe intermetallic phases were noticed [16].

Figure 8. TIG welding analysis. Left side: SEM image and EDS in WZ. Right side: SEM image and EDS in HAZ.

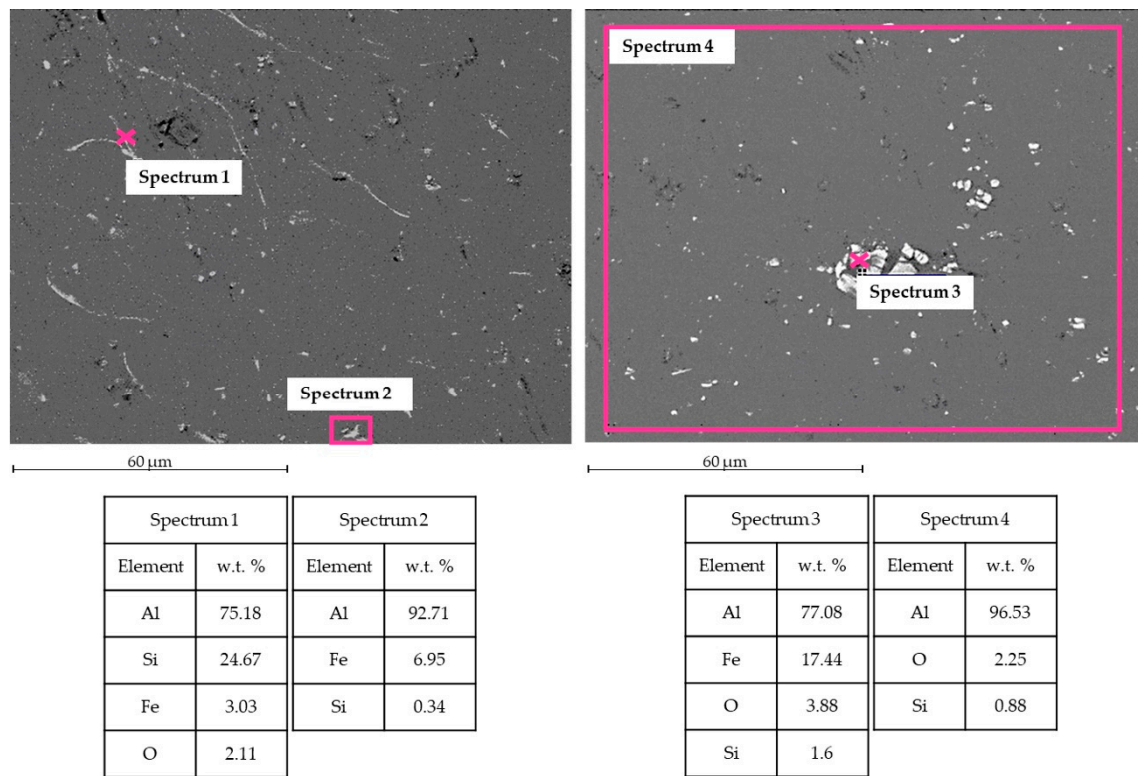
Figure 9 shows SEM-EDS analysis for MIG welding. Into the WM, it was possible to observe the presence of Al and Si, typical elements for the filler metal ER4043. Some intermetallic phases are found; for instance, in Spectrum 1 and Spectrum 3, the phase

Al-Fe-Si is in the form of acicular phase β and polygonal phase α [17]. Even Al-Si and Al-Fe phases occur in the HAZ zone.

Figure 9. MIG welding analysis. Left side: SEM image and EDS in WZ. Right side: SEM image and EDS in HAZ.

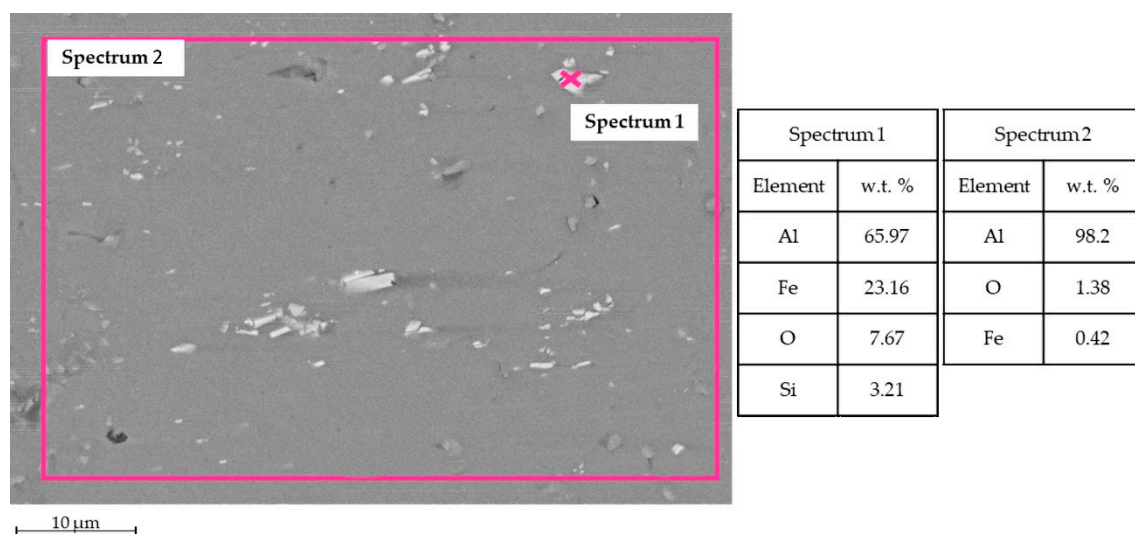
The base metal contains a certain amount of Si and Fe, as shown in Figure 10. It is well known that, if Fe exceeds the solid solubility limit of 0.05 wt %, it forms intermetallic phases Al-Fe [18]. Due to the H16 starting structure, these phases show an elongated shape.

Figure 10. Base metal (BM) AA1070 H16.

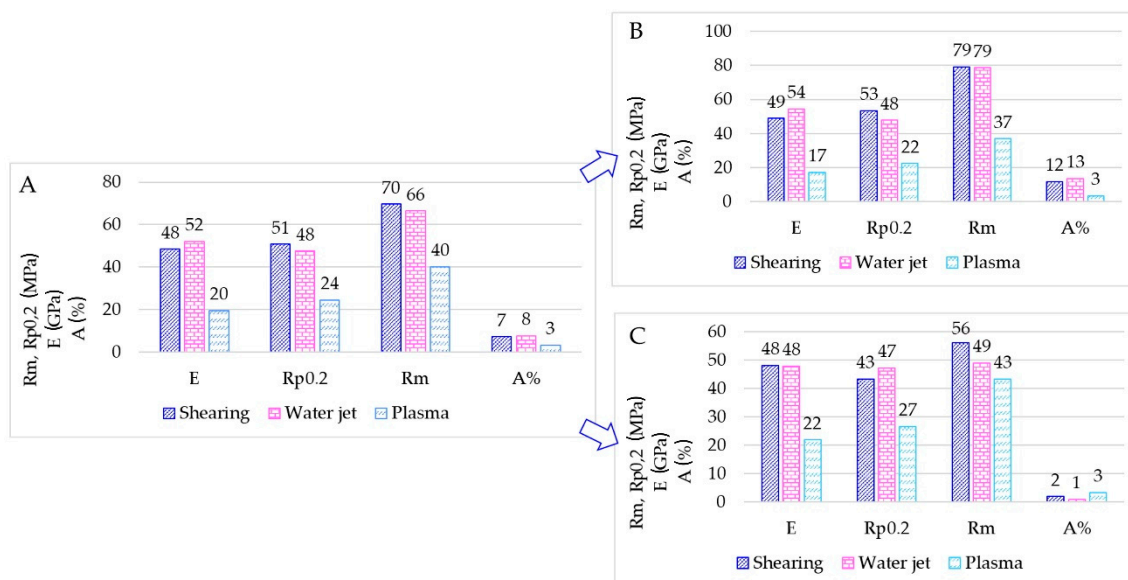
Results for TIG welding are summarized in Figure 11 through bar charts. The bar charts represent the average tensile properties measured (Figure 11A), the average tensile properties for the specimens as-welded (Figure 11B) and finally, the average tensile properties for the specimens having the milled weld (Figure 11C).

Figure 11. (A) Overall bar chart for TIG-welded sheets. (B) Bar charts for as-welded samples. (C) Bar charts for milled samples.

The average elongation at rupture A% in TIG-welded specimens is affected by the very low A% in the milled specimens. Mechanical properties observed (Rm, tensile strength; Rp0.2, yield strength) for sheared and water jet cutting appear similar.

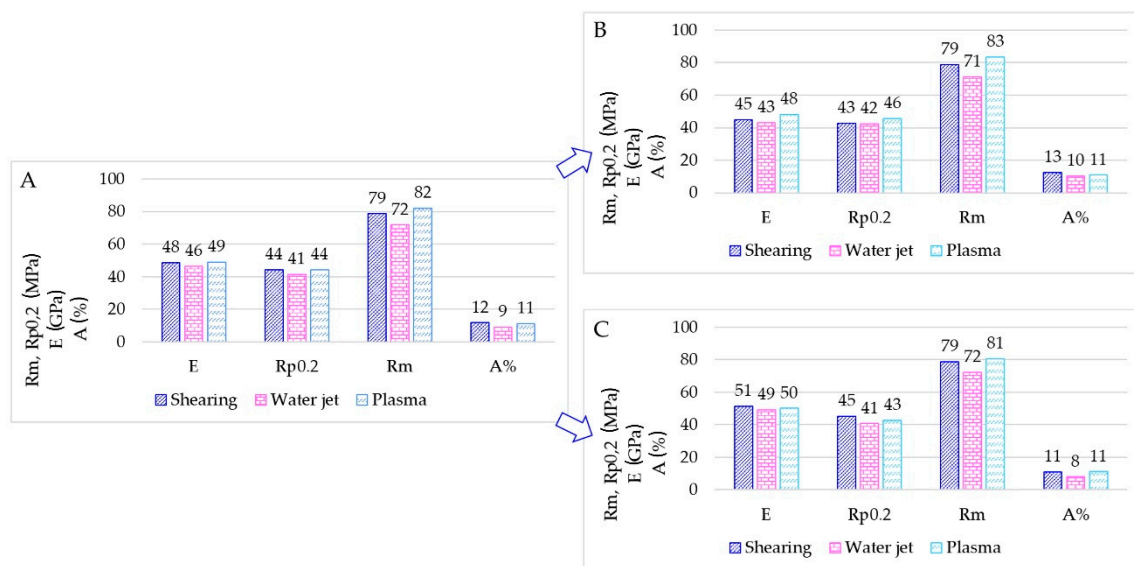
The average mechanical values of MIG-welded specimens are shown in Figure 12. Mechanical properties observed appear similar for each kind of sheet edge preparation, and the A% appear similar with or without the weld milling.

Figure 12. (A) Overall bar chart for MIG-welded sheets. (B) Bar charts for as-welded samples. (C) Bar charts for milled samples.

Moreover, porosities inside the weld cause a decrease in hardness near the BM values. On the contrary, in MIG welded specimens, specimens after water jet cutting (orange-bullet marker in Figure 14B) show low micro-hardness in WM. This behaviour is in line with the mechanical results shown in Figure 12 (the worst in MIG welding specimens).

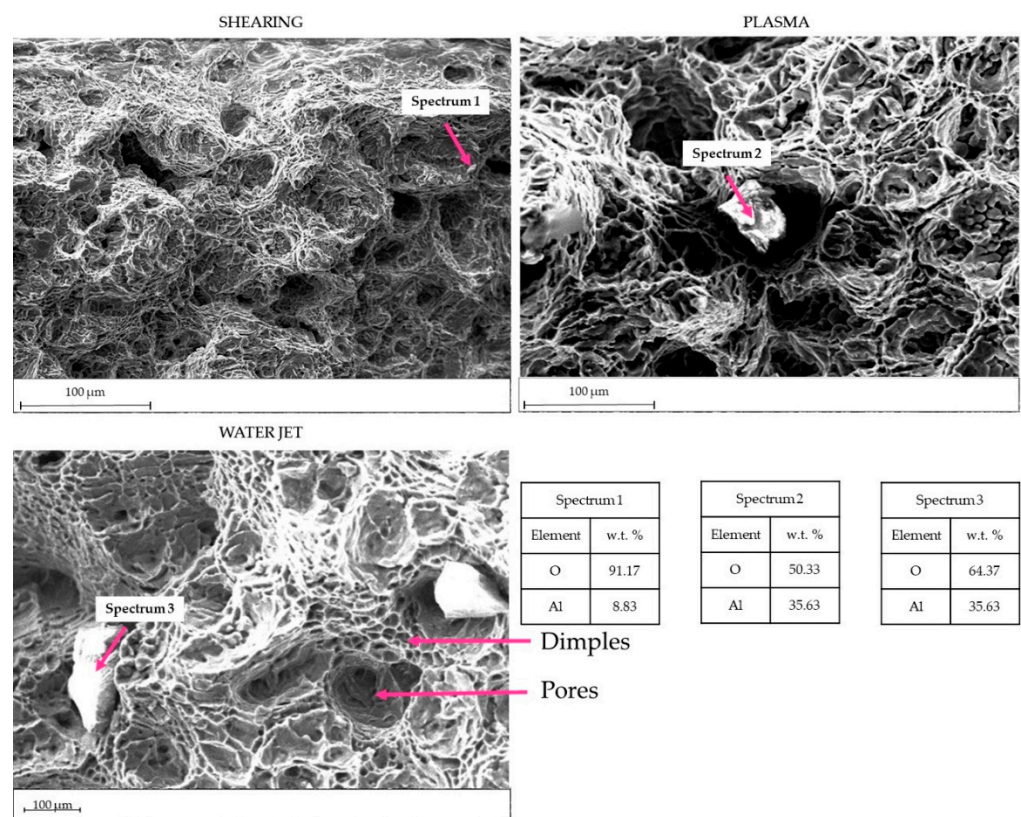
To assess these hypotheses, SEM observations were performed. The fracture surfaces were observed using SEM (Figure 13). Ductile fractures were noticed in all the specimens; all fractures were located in the welded part. Some welding appears non-penetrating along the entire thickness of the sheet. Furthermore, the weld seams appear rich in gas porosities [19] and in dendrites that negatively affect the mechanical strength. A high amount of oxide scale was observed, particularly in the water jet and plasma specimens (Figure 13—Spectrum 2 and Spectrum 3).

Figure 13. Surface fractures in three TIG-welded tensile specimens. Oxides were detected of variable sizes.

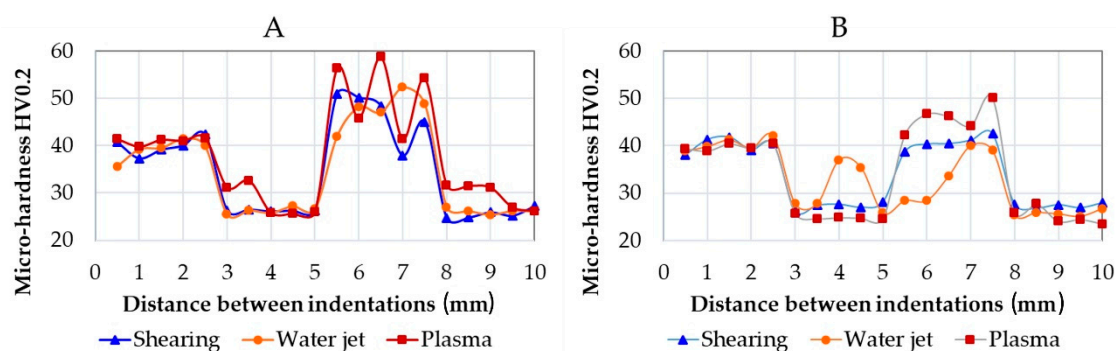
The WM has a dilution ratio that depends on the welding process. WM comprises AA1070 base metal and ER5356 filler metal for TIG welding and AA1070 and ER4043 for MIG welding. The micro-hardness in the welded samples was measured as drawn in Figure 2, and results are shown in Figure 14. The different dilution ratios may affect the average micro-hardness. Furthermore, in the WM, the micro-hardness is subjected to a certain variation caused by defects or hardening phases. In TIG welding, specimens' plasma-cuts show some inadequate penetration and porosities. This behaviour causes a variation in the micro-hardness measured (red-square marker in Figure 14A).

Figure 14. Graphical representation of the micro-hardness measured in TIG (A) and MIG (B) specimens.

Overall, higher micro-hardness was noticed in TIG welding with an average value of 48 HV0.2, while in MIG welding, the average value was 40 HV0.2. This result is, in turn, affected by the filler metal. In TIG welds, the micro-hardness in WM is higher than the micro-hardness in the BM; on the contrary, in MIG welds, the micro-hardness resulted similar in the BM and the WM. Micro-hardness values are average values depending on the intermetallic phases. Considering that the number of intermetallic phases is low in alloy AA1070, hardness in BM is almost the hardness of the α -Al phase: ca. 40 HV0.2. Furthermore, the micro-hardness in the α -Al depends on the alloying elements dissolved in the solid solution [20]. Intermetallic phases detected may affect the average values: α -AlFeSi and β -AlFeSi are respectively ca. 883 HV and 765 ([21]), Al-Mg ca. 48 HV [22], Al-Si ca. 80 HV [20].
