MIG and TIG Joining of AA1070 Aluminium Sheets with Different Surface Preparations

MIG and TIG Joining of AA1070 Aluminium Sheets with Different Surface Preparations / Fracchia, Elisa; Bidulská, Jana; Bidulský, Róbert; ACTIS GRANDE, Marco. - In: MATERIALS. - ISSN 1996-1944. - ELETTRONICO. - 15:412(2022). [10.3390/ma15020412]

**Abstract:** In this work, AA1070 aluminium alloy sheets are joined using TIG and MIG welding after three different edge preparations. Shearing, water jet and plasma-cut processes were used to cut sheets, subsequently welded using ER5356 and ER4043 filler metals for TIG and MIG, respectively. Mechanical properties of the obtained sheets were assessed through tensile tests obtaining a relation between sheet preparation and welding tightness. Micro-hardness measures were performed to evaluate the effects of both welding and cutting processes on the micro-hardness of the alloy, highlighting that TIG welding gives rise to inhomogeneous micro-hardness behaviour. After tensile tests, surface fractures were observed employing scanning electron microscopy to highlight the relation between tensile properties and edge preparations. Fractures show severe oxidation in t

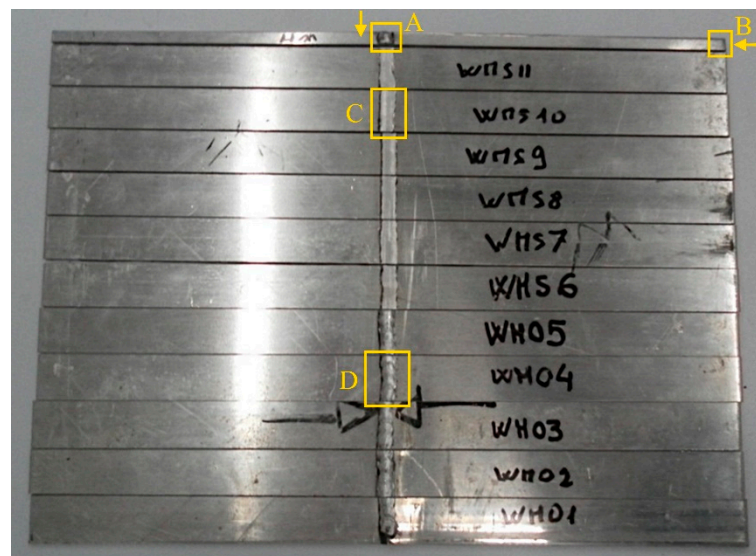
Cross-sectional micro-hardness measurements were performed on the welded samples using a Vickers micro-hardness tester, LEICA VMHT (Leica Microsystems, Heerbrugg, Switzerland), as shown in Figure 2. The parameters applied were 200 gf and 15 s. The number of specimens and tests are reported in Table 3, while samples' production in a single welded sheet is shown in Figure 3.

**Figure 3.** Sheets after waterjet cutting and MIG welding. The welded sheets were cut to obtain tensile test specimens and samples for microstructural observation and micro-hardness measures. A: Sample for weld observation and micro-hardness; the arrow indicates the side of observation. B: Sample for edge observation and micro-hardness; the arrow indicates the side of observation. C: Milled weld. D: Protruding weld.

Tensile tests were performed on samples shown in Figures 1 and 3.

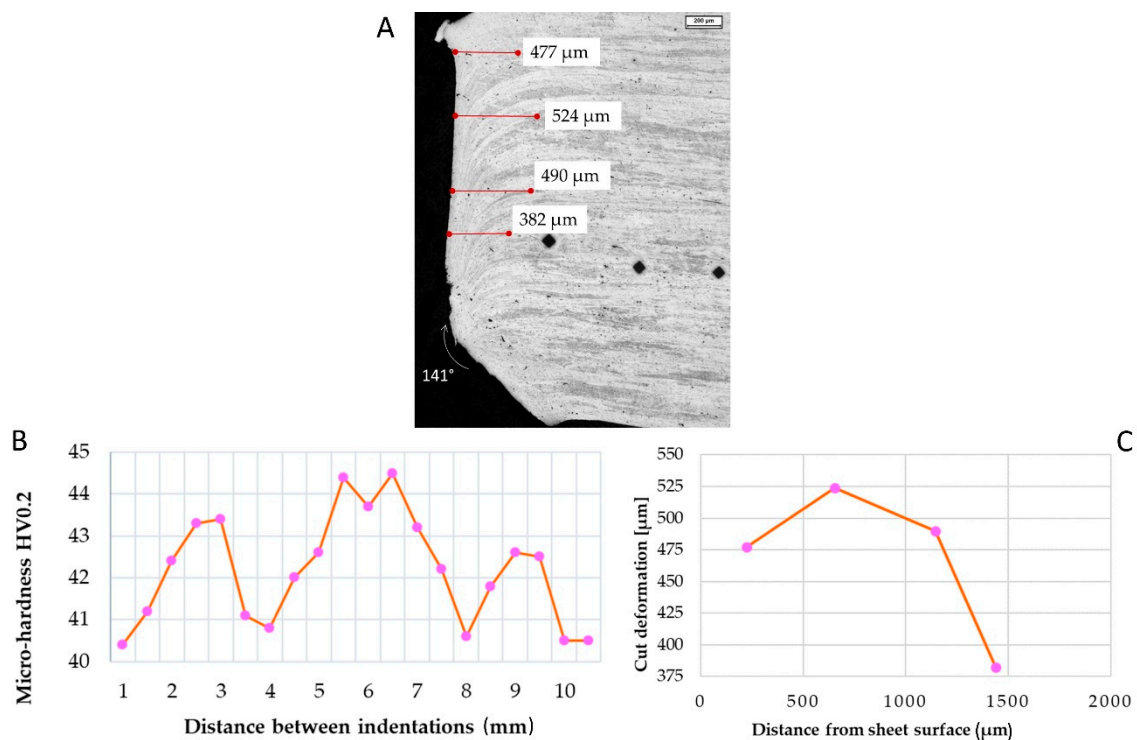
As for the water jet (Figure 6A), the initial distortion remained almost constant, with a measured value of 382  $\mu\text{m}$  in the middle of the sheet (Figure 6C). The bottom part of the sheet showed an intense deformation and material removal; an angle of  $141^\circ$  was measured. Only short variations in micro-hardness were documented (Figure 6B).

**Figure 6.** (A) Microscope image of the water jet cutting trace on AA1070 sheet. (B) Distortions in the first 1500  $\mu\text{m}$  were documented. (C) Micro-hardness measured along the first 10 mm starting from the cut edge. Marker: 200  $\mu\text{m}$ .

In [32], Wang et al. studied the kerf taper in aluminium alloy 6061, arguing that reducing the cutting speed causes the reduction of the kerf taper. Slow cutting speeds can produce a reverse taper, as seen in Figure 6, where the cut's kerf width is wider at the bottom than at the top. The jet stream removed more material at the bottom of the sheet than at the top. The reverse taper can also occur when cutting very soft materials [33]. On the other hand, literature highlights that multipass cutting [34] may increase surface finishing by obtaining flat surfaces.

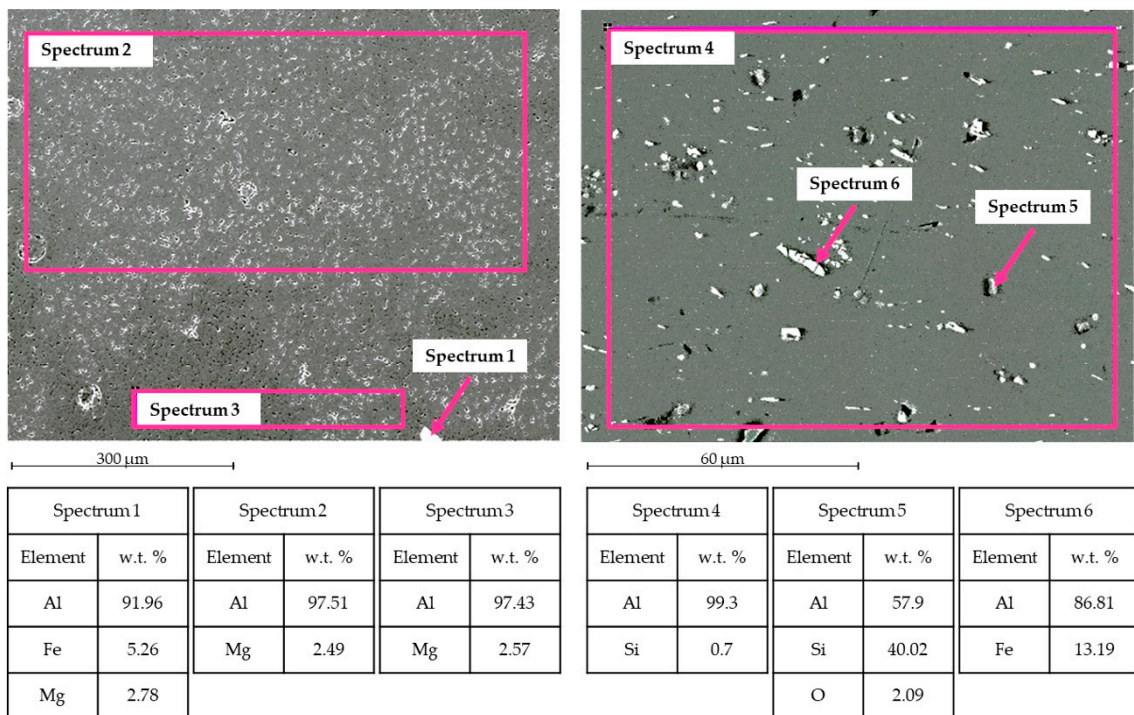
Figure 8 shows SEM-EDS analysis for TIG welding. In the WM, Al and Mg were observed, as expected, in the filler metal ER5356. Some intermetallic phases were observed, for instance, the phase Al-Fe-Mg [15] in Spectrum 1. In the HAZ zone, Al-Si and Al-Fe intermetallic phases were noticed [16].

**Figure 8.** TIG welding analysis. Left side: SEM image and EDS in WZ. Right side: SEM image and EDS in HAZ.

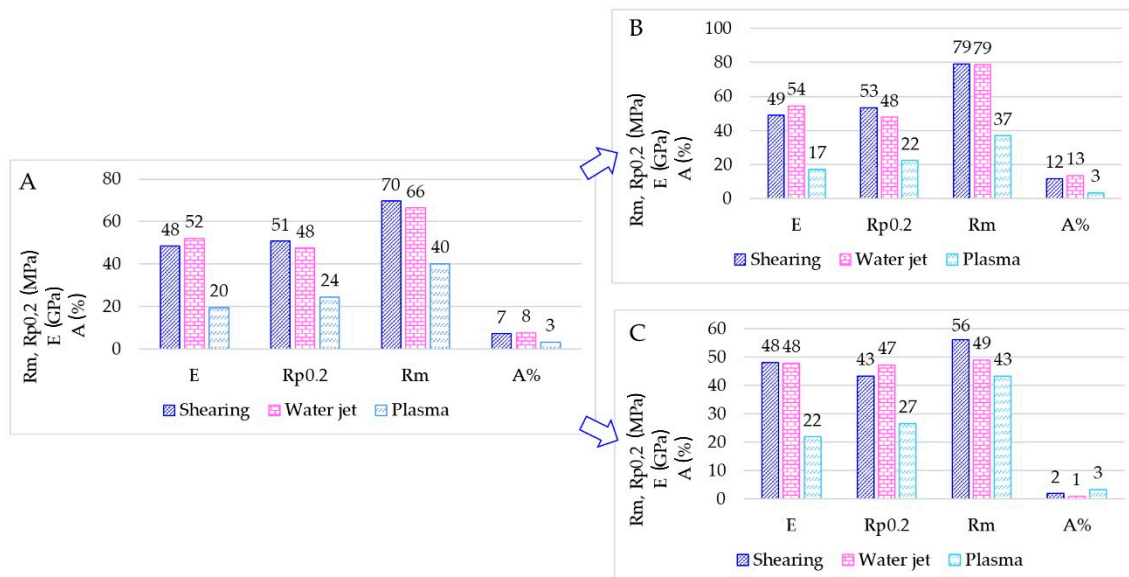
Results for TIG welding are summarized in Figure 11 through bar charts. The bar charts represent the average tensile properties measured (Figure 11A), the average tensile properties for the specimens as-welded (Figure 11B) and finally, the average tensile properties for the specimens having the milled weld (Figure 11C).

**Figure 11.** (A) Overall bar chart for TIG-welded sheets. (B) Bar charts for as-welded samples. (C) Bar charts for milled samples.

The average elongation at rupture A% in TIG-welded specimens is affected by the very low A% in the milled specimens. Mechanical properties observed (Rm, tensile strength; Rp0.2, yield strength) for sheared and water jet cutting appear similar.

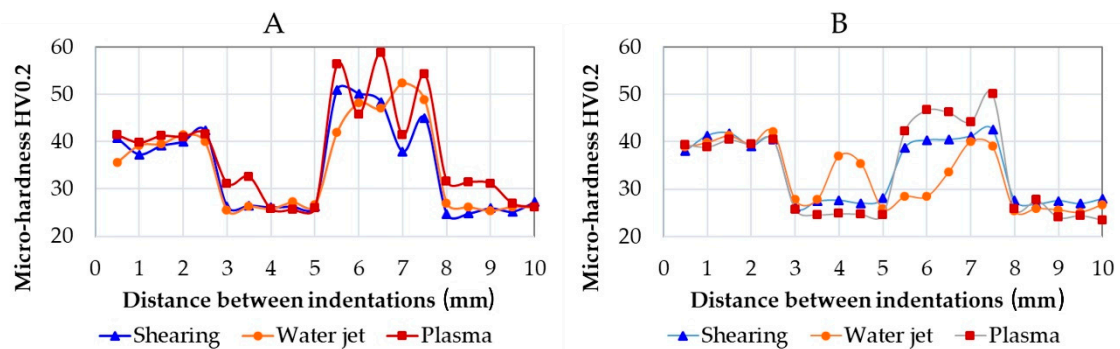
The WM has a dilution ratio that depends on the welding process. WM comprises AA1070 base metal and ER5356 filler metal for TIG welding and AA1070 and ER4043 for MIG welding. The micro-hardness in the welded samples was measured as drawn in Figure 2, and results are shown in Figure 14. The different dilution ratios may affect the average micro-hardness. Furthermore, in the WM, the micro-hardness is subjected to a certain variation caused by defects or hardening phases. In TIG welding, specimens' plasma-cuts show some inadequate penetration and porosities. This behaviour causes a variation in the micro-hardness measured (red-square marker in Figure 14A).

Moreover, porosities inside the weld cause a decrease in hardness near the BM values. On the contrary, in MIG welded specimens, specimens after water jet cutting (orange-bullet marker in Figure 14B) show low micro-hardness in WM. This behaviour is in line with the mechanical results shown in Figure 12 (the worst in MIG welding specimens).

**Figure 14.** Graphical representation of the micro-hardness measured in TIG (A) and MIG (B) specimens.

Overall, higher micro-hardness was noticed in TIG welding with an average value of 48 HV0.2, while in MIG welding, the average value was 40 HV0.2. This result is, in turn, affected by the filler metal. In TIG welds, the micro-hardness in WM is higher than the micro-hardness in the BM; on the contrary, in MIG welds, the micro-hardness resulted similar in the BM and the WM. Micro-hardness values are average values depending on the intermetallic phases. Considering that the number of intermetallic phases is low in alloy AA1070, hardness in BM is almost the hardness of the  $\alpha$ -Al phase: ca. 40 HV0.2. Furthermore, the micro-hardness in the  $\alpha$ -Al depends on the alloying elements dissolved in the solid solution [20]. Intermetallic phases detected may affect the average values:  $\alpha$ -AlFeSi and  $\beta$ -AlFeSi are respectively ca. 883 HV and 765 ([21]), Al-Mg ca. 48 HV [22], Al-Si ca. 80 HV [20].

The variation in micro-hardness inside the WM was caused by the high amount of gas porosities found in the weld pool, as observed in the surface fracture analysis in Figure 14. The reduction in the micro-hardness from the BM to the HAZ is attributable to the intermetallic Al-Fe coalescence and the grain coarsening.
