Experimental investigation on crack propagation paths in spur gears

F Curà¹, A Mura¹ and L Corsaro¹

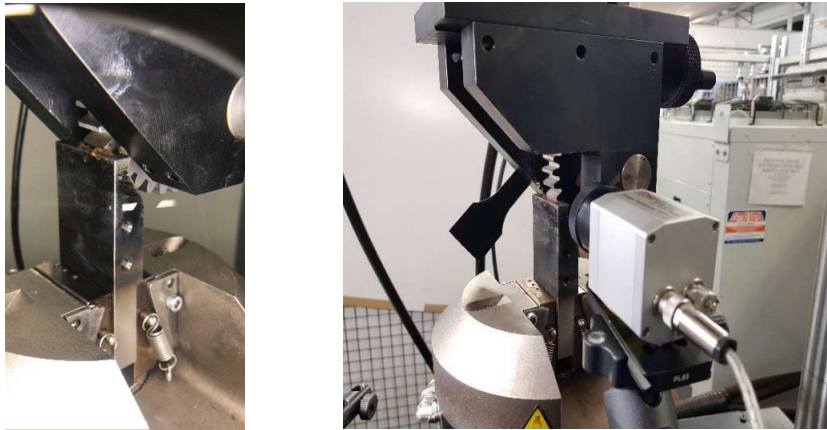
A special device connected to a standard fatigue machine was realized to perform bending tests for both standard and thin rim gears (see Figure 2, left side). A punch integrated into the device was able to apply the pulse loading to the gear tooth. In particular this punch was designed in order to load the tooth along its involute profile in both position and direction referred to the single contact point [8].

Figure 2. Test apparatus.

During bending tests, an IR thermocamera (*IR tech Timage Radimatic "XT"*) was utilized to monitor the surface thermal profile in the tooth root fillet zone (see Figure 2, right side). The thermal detector was located at a distance of 60 mm from the gear. A reference specimen (see Figure 2, right side) allowed to acquire the environmental temperature during each test. Gears and reference specimen were both covered by black spray paint to generate a surface with an emissivity close to 0,95. Two different thermal profiles were extracted from each thermogram near the root tooth fillet, respectively an *area* and a *point* of 2x2 pixel (located inside the area close to the crack initiation point). The relative temperature T (difference between the absolute temperature and the temperature of the reference specimen) was computed for Gears. Figure 3 illustrates an example of the area position near the tooth root fillet.

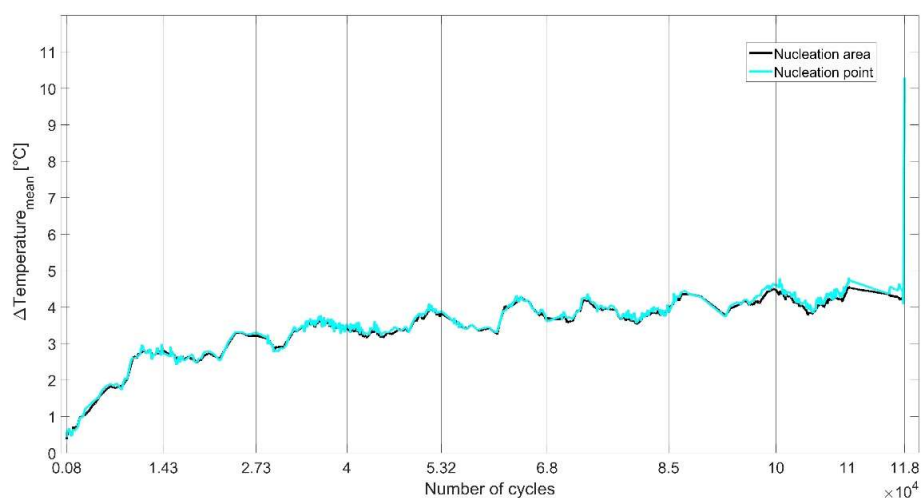
Figure 6 points out CR parameter values for Gears 2 and 3, characterised by different back up ratio (m_b) values and with the same web ratio (m_w), driving respectively to fail safe and catastrophic failures. Finally, Figures 7 and 8 show the thermal profiles monitored during the fatigue tests respectively for Gear 1 and Gear 2. In particular, in each Figure is reported the difference temperature ΔT (respect to the ambient temperature or reference specimen) as a function of the number of cycles, referred to both crack nucleation point and to an area around the nucleation point (nucleation area, mean value of temperature).

From the analysis of these Figures, it can be noted the increase of thermal profiles in the first phase of the test, then a stabilised condition of temperature and, finally, an abrupt variation corresponding to the failure. Nucleation point and area profiles show in both cases identical trends.

Figure 7. Gear 1 thermal profiles.

The comparison between Figures 7 and 8 shows that the fatigue life of Gear 2 is lower than that of Gear 1 in term of number of cycles (118000 cycles for Gear 1 and 104300 cycles for Gear 2), as expected. Moreover, the relative temperature ΔT level is higher for Gear 1 than for Gear 2. This unexpected result may be interpreted as a strong dissipation flow in the case of Gear 2 within the whole wheel body, due to the high displacements involved in fatigue tests.

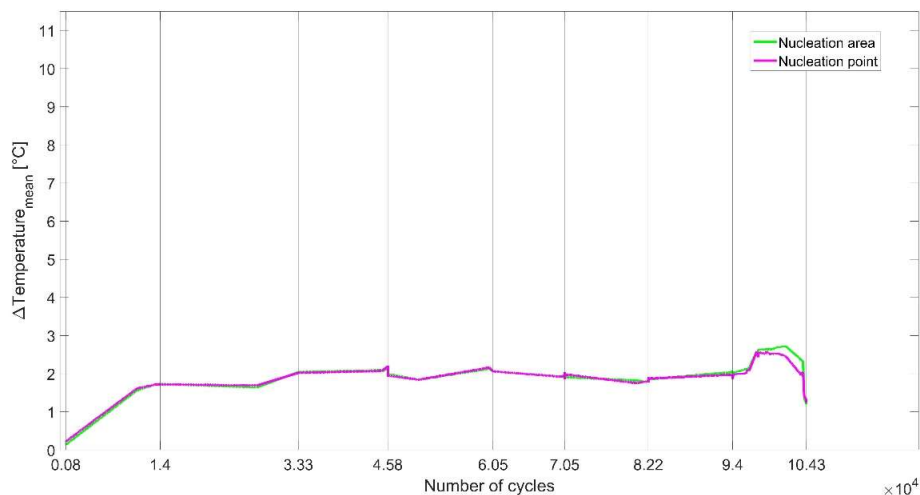
Figure 8. Gear 2 thermal profiles.
