# Experimental investigation on crack propagation paths in spur gears

F Curà<sup>1</sup>, A Mura<sup>1</sup> and L Corsaro<sup>1</sup>

<sup>1</sup> Dimeas Politecnico di Torino, corso Duca degli Abruzzi 24, 10129 Torino, Italy

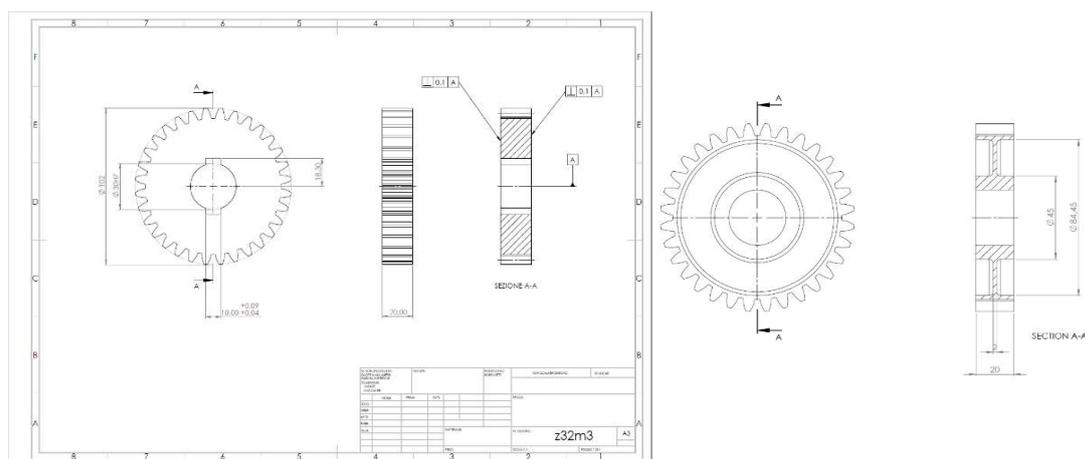
Geometrical parameters of each gear are resumed in Table 1. In particular are shown: pitch diameter ( $dp$ ), face width ( $b$ ), number of teeth ( $z$ ), modulus ( $m$ ), backup ratio (rim dimension respect to the tooth height) ( $mb$ ), web ratio (web thickness respect to the face width) ( $mw$ ) and gear blank factor ( $C_R$ ) [4]. As an example, technical drawings of Gear 1 and Gear 2 are shown in Figure 1.

**Figure 1.** Technical drawings of Gear 1 and Gear 2.

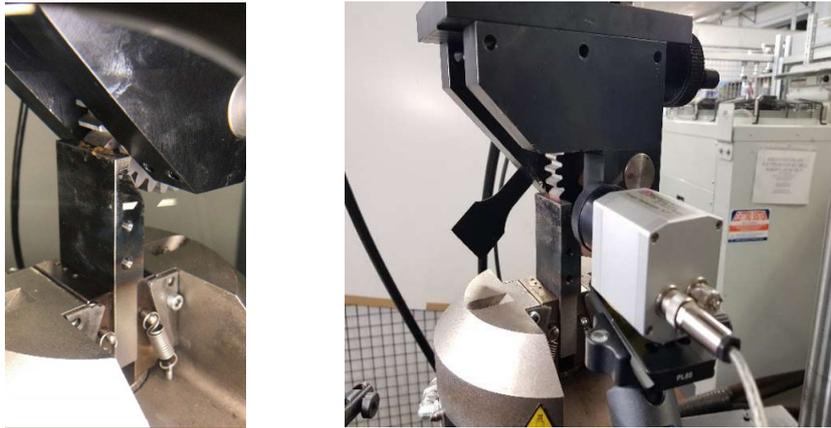
A special device connected to a standard fatigue machine was realized to perform bending tests for both standard and thin rim gears (see Figure 2, left side). A punch integrated into the device was able to apply the pulse loading to the gear tooth. In particular this punch was designed in order to load the tooth along its involute profile in both position and direction referred to the single contact point [8].

**Figure 2.** Test apparatus.

During bending tests, an IR thermocamera (*IR tech Timage Radimatic "XT"*) was utilized to monitor the surface thermal profile in the tooth root fillet zone (see Figure 2, right side). The thermal detector was located at a distance of 60 mm from the gear. A reference specimen (see Figure 2, right side) allowed to acquire the environmental temperature during each test. Gears and reference specimen were both covered by black spray paint to generate a surface with an emissivity close to 0,95. Two different thermal profiles were extracted from each thermogram near the root tooth fillet, respectively an *area* and a *point* of 2x2 pixel (located inside the area close to the crack initiation point). The relative temperature  $\Delta T$  (difference between the absolute temperature and the temperature of the reference specimen) was computed for Gears. Figure 3 illustrates an example of the area position near the tooth root fillet.

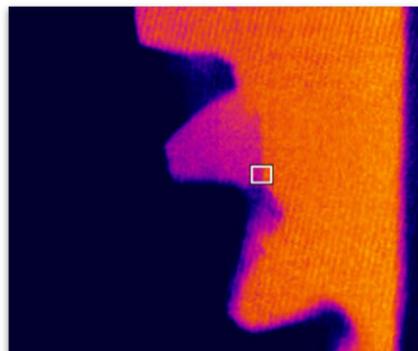
**Figure 3.** Position of the area.

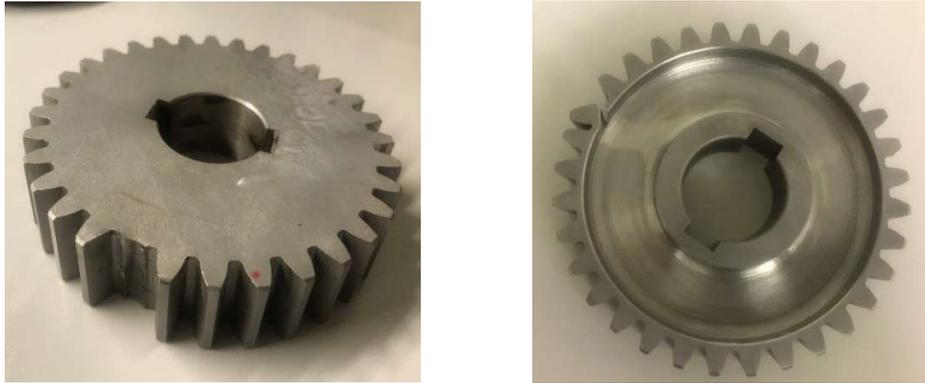
Figure 4 shows, as an example, Gear 1 and Gear 2 and their failure typologies. As it can be observed, Gear 1 crack path (on the left) corresponds to a classical fail safe condition, while in Gear 2 (on the right) a crack path directed through the rim can be pointed out.

**Figure 4.** Gear 1 (left) and Gear 2 (right) crack paths.

Figure 5 shows an example of thermal images recorded during fatigue tests. More in detail, the left image is related to Gear 1 and, as in Figure 4, a crack propagating through the tooth can be appreciated. The right image shows the crack propagating through the rim, as predicted for Gear 2 already in the design phase.

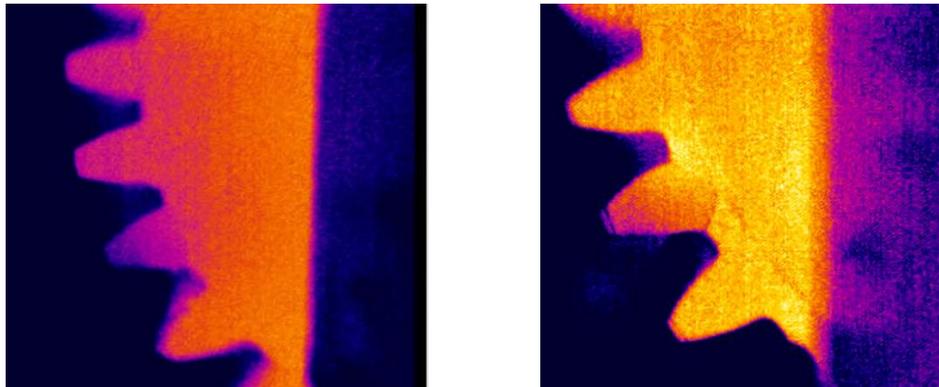
**Figure 5.** Thermal images of Gear 1 (left) and Gear 2 (right).

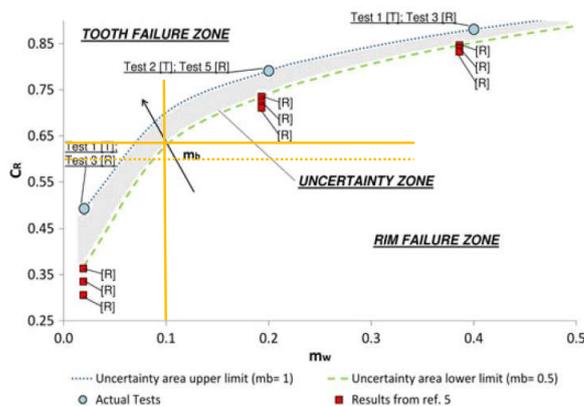
Figure 6. CR factor [2].

Figure 6 points out CR parameter values for Gears 2 and 3, characterised by different back up ratio ( $m_b$ ) values and with the same web ratio ( $m_w$ ), driving respectively to fail safe and catastrophic failures. Finally, Figures 7 and 8 show the thermal profiles monitored during the fatigue tests respectively for Gear 1 and Gear 2. In particular, in each Figure is reported the difference temperature  $\Delta T$  (respect to the ambient temperature or reference specimen) as a function of the number of cycles, referred to both crack nucleation point and to an area around the nucleation point (nucleation area, mean value of temperature).

As a matter of fact, geometrical parameters of Gear 2, in particular its backup and web ratio values, were chosen to verify the corresponding catastrophic failure already emphasised by numerical simulations, and now demonstrated by fatigue tests. Rim and web geometries may be related to the well known CR parameter [4] (see Table 1), as a function of both backup ratio and web ratio values. As already indicated in [2], the position of this parameter respectively in the tooth failure zone, in the uncertainty zone or in the rim failure zone of its graph (see Figure 6 [2]) allows us to draw some hypothesis about the possibility of safety or unsafety fracture basing only on the gear geometry.

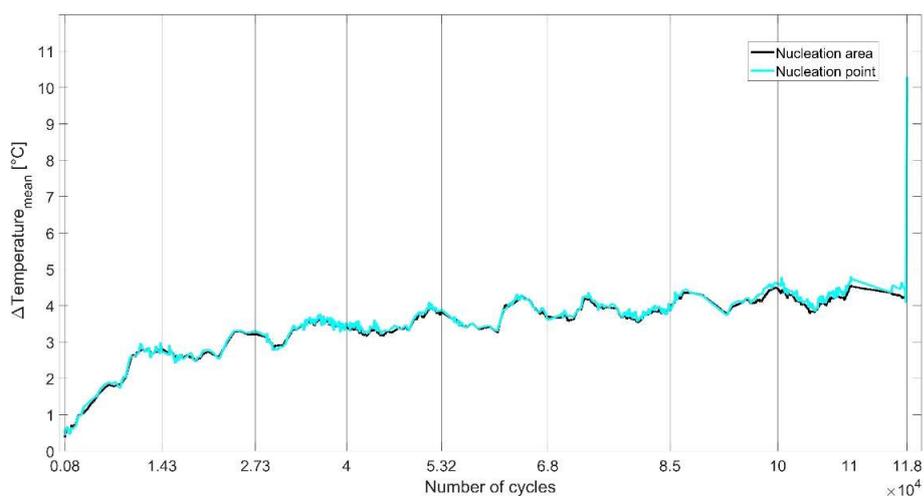
From the analysis of these Figures, it can be noted the increase of thermal profiles in the first phase of the test, then a stabilised condition of temperature and, finally, an abrupt variation corresponding to the failure. Nucleation point and area profiles show in both cases identical trends.

Figure 7. Gear 1 thermal profiles.

The comparison between Figures 7 and 8 shows that the fatigue life of Gear 2 is lower than that of Gear 1 in term of number of cycles (118000 cycles for Gear 1 and 104300 cycles for Gear 2), as expected. Moreover, the relative temperature  $\Delta T$  level is higher for Gear 1 than for Gear 2. This unexpected result may be interpreted as a strong dissipation flow in the case of Gear 2 within the whole wheel body, due to the high displacements involved in fatigue tests.

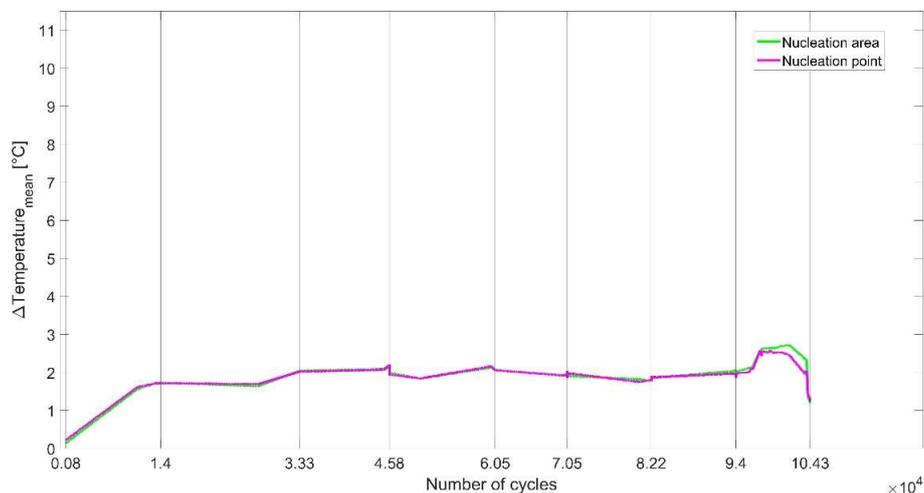
**Figure 8.** Gear 2 thermal profiles.
