# Experimental investigation on crack propagation paths in spur gears

F Curà<sup>1</sup>, A Mura<sup>1</sup> and L Corsaro<sup>1</sup>

<sup>1</sup> Dimeas Politecnico di Torino, corso Duca degli Abruzzi 24, 10129 Torino, Italy

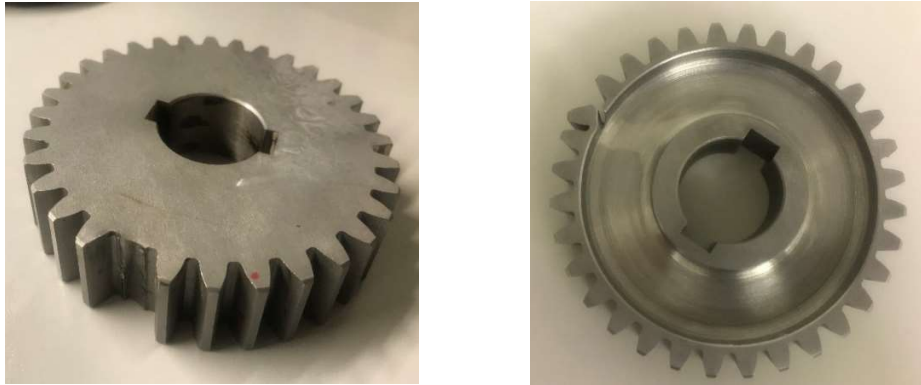
**Figure 4.** Gear 1 (left) and Gear 2 (right) crack paths.

Figure 4 shows, as an example, Gear 1 and Gear 2 and their failure typologies. As it can be observed, Gear 1 crack path (on the left) corresponds to a classical fail safe condition, while in Gear 2 (on the right) a crack path directed through the rim can be pointed out.

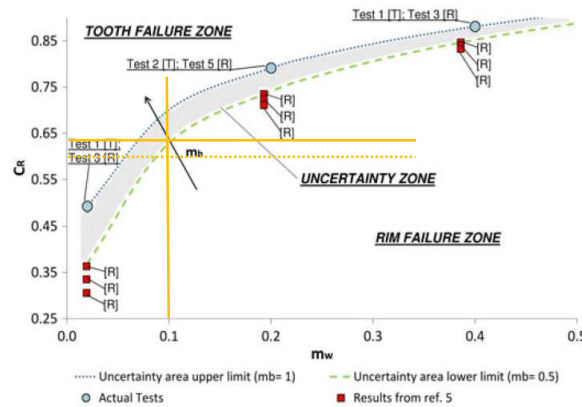
Figure 6. CR factor [2].

Figure 6 points out CR parameter values for Gears 2 and 3, characterised by different back up ratio ( $m_b$ ) values and with the same web ratio ( $m_w$ ), driving respectively to fail safe and catastrophic failures. Finally, Figures 7 and 8 show the thermal profiles monitored during the fatigue tests respectively for Gear 1 and Gear 2. In particular, in each Figure is reported the difference temperature  $\Delta T$  (respect to the ambient temperature or reference specimen) as a function of the number of cycles, referred to both crack nucleation point and to an area around the nucleation point (nucleation area, mean value of temperature).
