Static behaviour of in scale masonry vaults under imposed settlement of the supports

F. Roselli, M. Alforno & F. Venuti

Politecnico di Torino, Department of Architecture and Design, Torino, Italy

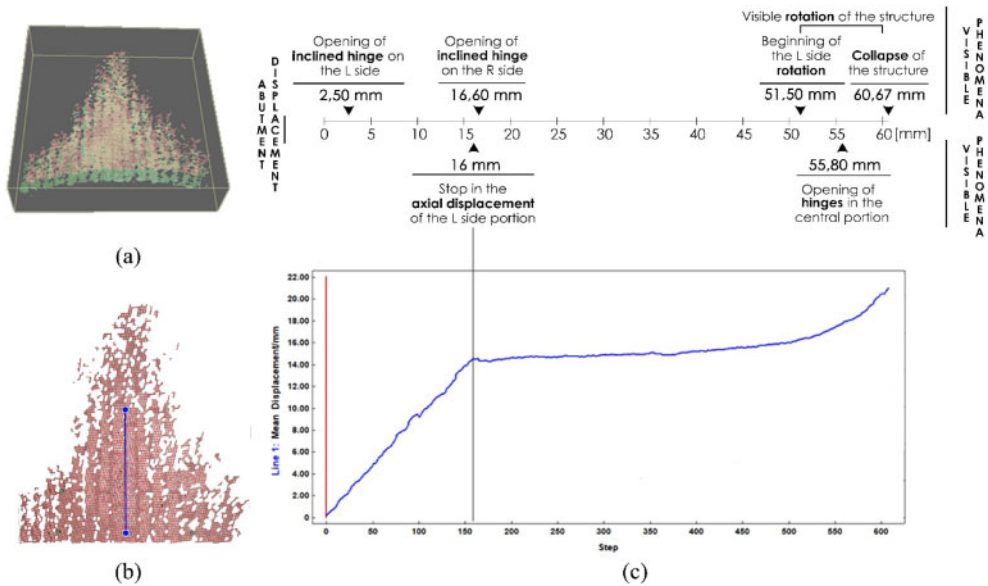
Figure 8. DIC cameras' field of view at step 0 (red) and 244 (green) of the imposed displacement (a), position of the linear strain-gauge (b), time history of mean displacement of the linear strain-gauge on the R1 vault (c).

A deeper insight into the phenomena observed and recorded on each vault during the tests is provided in Figure 8 for the R_1 vault, as an example. In particular, Figure 8 compares the macroscopic visible phenomena reconstructed by direct observation, video acquisition and three-dimensional data managing of the range-based and image-based acquisition techniques at different stages of imposed displacement (Figure 8c top) to the mean displacement of a control linear strain-gauge (Figure 8b, corresponding with the key voussoirs of the vault) versus imposed displacement recorded through DIC (Figure 8c bottom). This comparison shows how the mean displacement linearly increases until the step (about 16 mm) corresponding to the reduction in the axial displacement (γ) of the central portion of the vault and to the development of the inclined longitudinal crack that separates the right haunch portion. Then, the mean displacement remains almost constant and start increasing again in correspondence of the step (about 51 mm) when the structure starts rotating until collapse.
