Static behaviour of in scale masonry vaults under imposed settlement of the supports

F. Roselli, M. Alforno & F. Venuti

ABSTRACT: The European architectural heritage is heavily characterized by the use of unreinforced masonry spatial structures, like vaults, which represent vulnerable elements in historical buildings. In recent years, the use of in-scale models to investigate the structural behaviour of vaults has largely increased in scientific research. In-scale models allow to overcome the difficulty of performing destructive tests on real structures and allow to investigate the complex three-dimensional failure mechanisms derived by different kinds of load, including the settlement of the supports. In this study, an experimental campaign is carried out on 1:5 in-scale models of barrel vaults with different brick laying techniques, to investigate their structural behaviour under settlement of the supports. Two brick patterns are tested: radial and vertical, with bed joints respectively orthogonal and parallel to the head arch plane. Models are built with cement blocks and low cohesion mortar, to simulate the typical historic masonry behaviour. Two tests for each brick arrangem

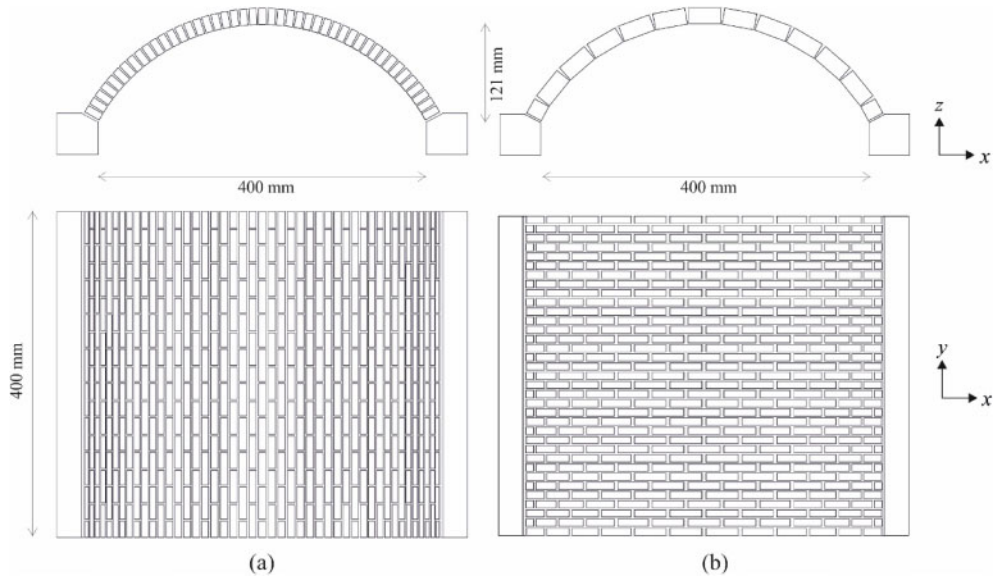
Figure 1. Geometry of the barrel vault in the radial (a) and vertical (b) configuration.

The adopted case study is a 1:5 model of a barrel vault with a square base: the net span of the vault is approximately 40 cm, the rise is about 12 cm, and the length of the vault is 40 cm (Figure 2). The barrel vault is made of blocks of dimensions $9 \times 20 \times 40$ mm, which mimic in scale 1:5 the dimensions of classic masonry bricks.

- a radial pattern (R), composed of multiple rows of rowlock oriented bricks, placed orthogonal to the main vertical plane of the vault (Figures 1a and 2a);
- a vertical pattern (V), where the bricks are laid in rows parallel to the main vertical plane of the structure (Figures 1b and 2b).

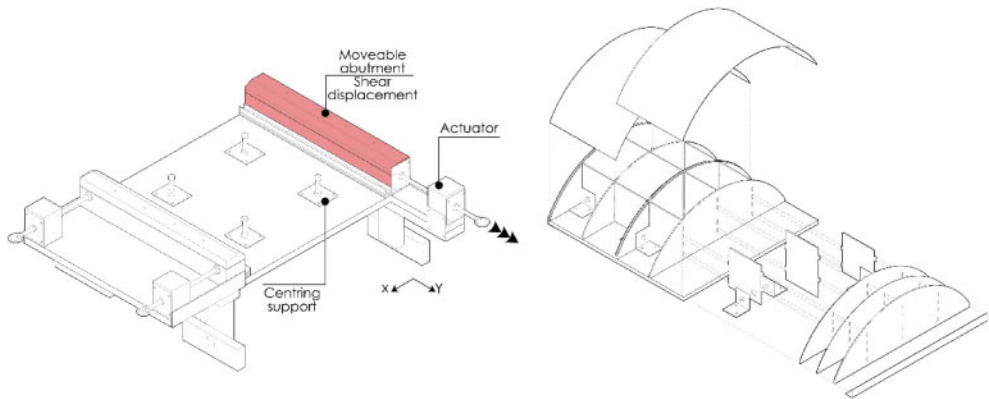
Figure 2. Experimental set up of the barrel vault: testing device and detail of the centring.

The experimental set up of the barrel vault was designed to allow both opening and shear tests to be performed (Figure 2). Specifically, one of the abutments is fixed in the x direction and allowed to move in y direction (simple shear mechanism), while the other abutment is fixed in the y direction and can be moved in x direction (opening mechanism). Four pins support the centring, and the slab where they are fixed can be lowered to allow the centring removal after completion of the vault.

Imposed settlements are measured by a digital calliper installed in correspondence of the moving abutment.

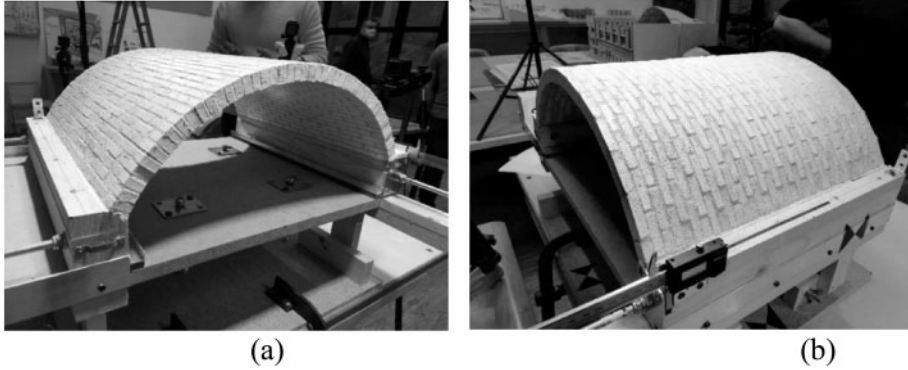
Figure 3. The built model in the radial (a) and vertical (b) configuration.

All the built models (Figure 3) are composed of 450 bricks with a similar global mortar quantity. A total of 4 models, two for each arrangement, are tested under shear displacement.

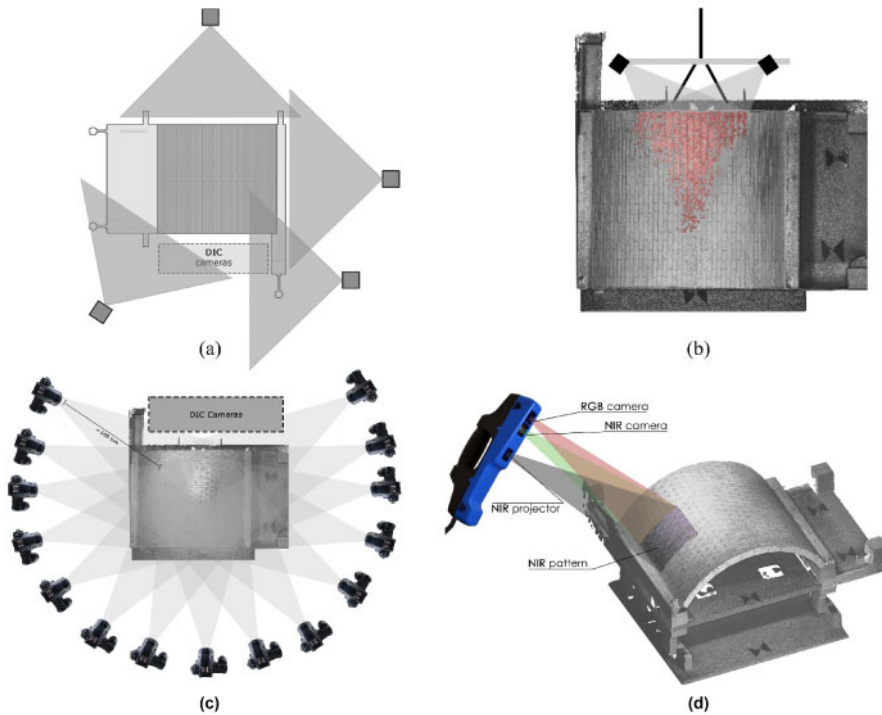
Figure 4. Summary of the adopted acquisition methodologies: (a) GoPro Hero 5 session cameras, (b) DIC cameras, (c) close-range photogrammetry, (d) range-based structured light scanning.

During the tests, the direct observation of the phenomena occurred to the structures is accompanied by the acquisition of relevant data. These acquisitions are performed with contactless solutions to avoid alterations of the test proceeding. A constant video acquisition is performed by four synchronized GoPro Hero 5 session cameras distributed around the vault models (Figure 4a) with the aims of relating the cracking phenomena with the imposed displacement, monitored with

a digital calliper, and capturing the collapse mechanism of the structures. Due to the destructive nature of the tests, three-dimensional data of the models are acquired in several steps of the imposed displacement in order to manage the spatial data of the structures after their failure. Image-based close-range photogrammetry (Figure 4c) and range-based structured light scanning (Figure 4d) solutions are used with these aims, because of their common use in literature in the data acquisition for moveable heritage (Patrucco et al. 2019). At the end of the process, the result obtained is a series of three-dimensional dense point-clouds with an estimated error of about 1 mm. Furthermore, Digital Image Correlation (DIC) is performed, on a little portion of the models (corresponding with the key voussoirs of the vaults) (Figure 4b), for monitoring the three-dimensional deformations of the structures. The data are acquired, as couples of stereoscopic images, by steps of 0.1 mm of imposed displacement. The result obtained is a series of quadrangular meshes with a submillimeter estimated error.

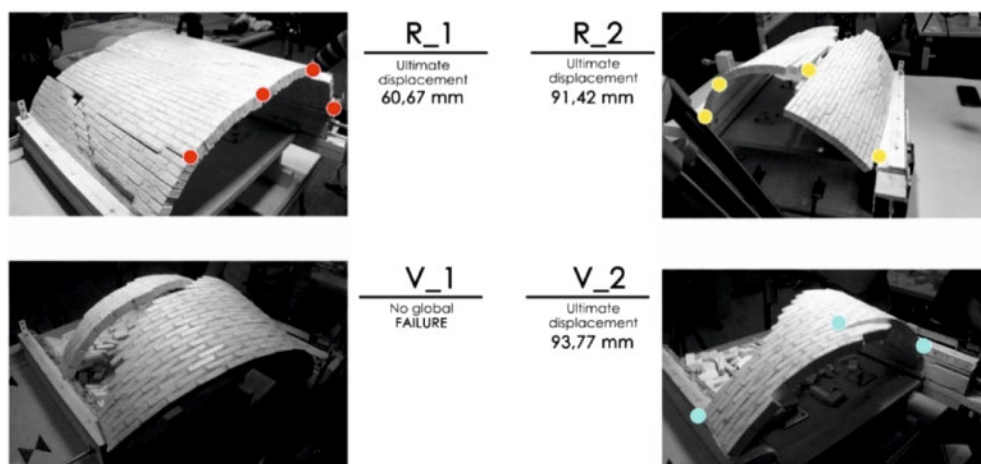
Figure 5. Collapse mechanisms of the tested models.

The high-speed and high-resolution cameras provide images of the collapse mechanisms of the tested models. In Figure 5 a selection of images of the failure, from the most representative perspective, is reported. Differently from arches, vaults involve complex three-dimensional failure mechanisms. The latter are quite different for vaults with different brick pattern, but also between vaults with the same brick arrangement.

The R models show a four-hinge mechanism, even though they reach the collapse at quite different ultimate displacements (60.67 mm in R_1 and 91.42 mm in R_2). The hinges run across the whole depth of the model following the longitudinal joints, with two of them placed at the abutment interface and one in the proximity of the key bricks. On the contrary, the V models show a different behaviour, characterized by the local collapse of some arches and by the rigid rotation of the separated portions of the vault. The rigid rotation of the vault on the abutment is particularly evident in the V_1 model, which reaches the end of displacement range (fixed at 150 mm) without a global failure. The V_2 model collapses at 93.77 mm of imposed displacement with a three-hinge mechanism, developed among the arches still in compression, with the slipping of the structure from one of the abutments.

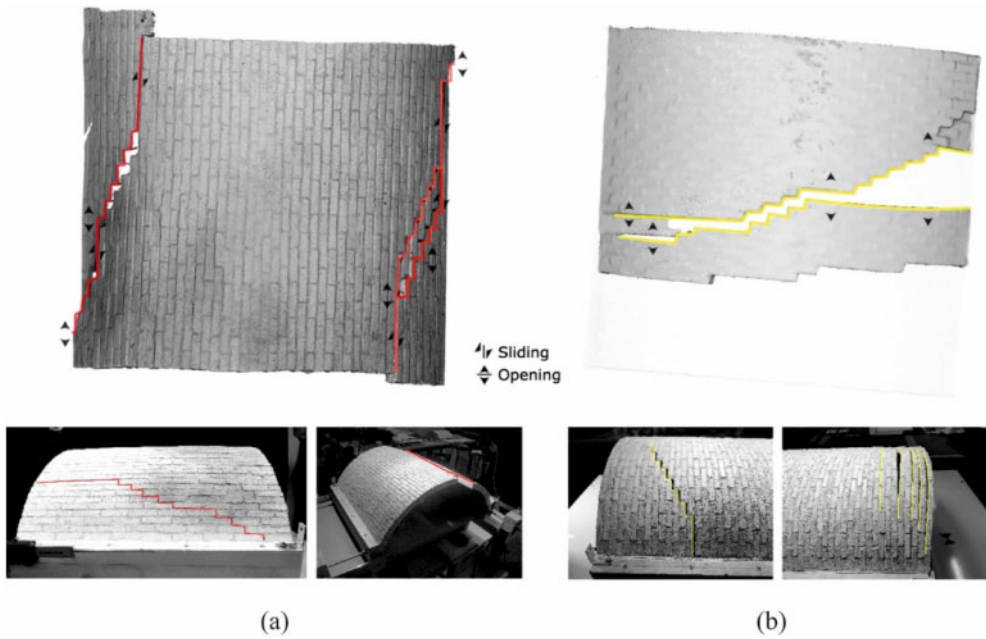
Figure 6. Crack pattern of R (a) and V (b) vaults.

The critical analyses of the crack patterns experienced in the models reveal substantial differences between the two bricks patterns (Figure 6). In the R models most of the cracks are represented by fractures occurring along the longitudinal joints. These major cracks appear to be quite straight

along a single longitudinal joint or inclined involving multiple rows of bricks (Figure 6a). On the other hand, in the V models the major cracks occur in the radial joints, leading to the formation of separate portions of the structure (Figure 6b) that lead to local collapses. Also in V models, the major cracks can assume either straight or inclined directions, reasonably depending on construction issues.

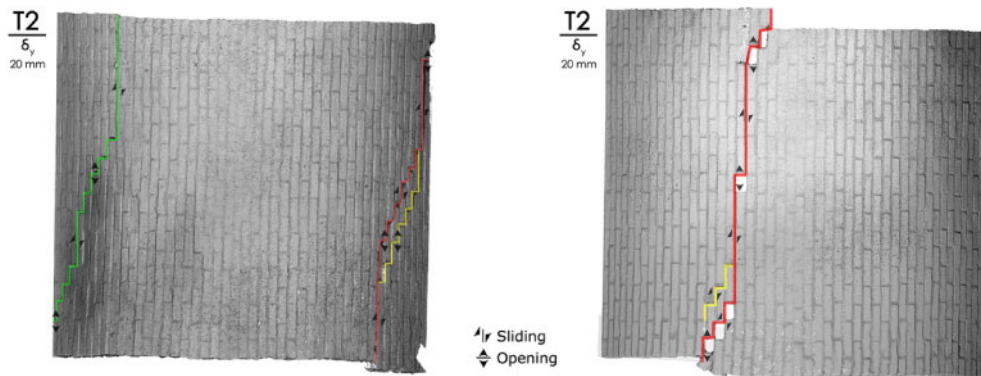
Figure 7. Crack pattern of R_1 (a) and R_2 (b) vaults for imposed displacement of 20 mm.

Besides the described main differences in the crack pattern between vaults arranged with different brick patterns, some minor differences occur between vaults arranged with the same pattern, as clearly visible in Figure 7 for the R_1 and R_2 vaults. Specifically, the major crack position varies due to construction issue, i.e., to the impossibility to perfectly replicate the model construction. In the R_1 vault the two major cracks lead to the separation of the central portion, that starts rotating upon the sliding haunches; in the R_2 model, the major crack along the top of the vaults extrados

leads to a major sliding between the two portions, which cause small local failures near the heads and the rigid rotation of the two haunches upon the abutment, while the contact surface between them is reducing. This difference in the collapse mechanism induces quite different displacement capacity, being the ultimate displacement of the R_2 vault 50% higher than the one of the R_1 vault.

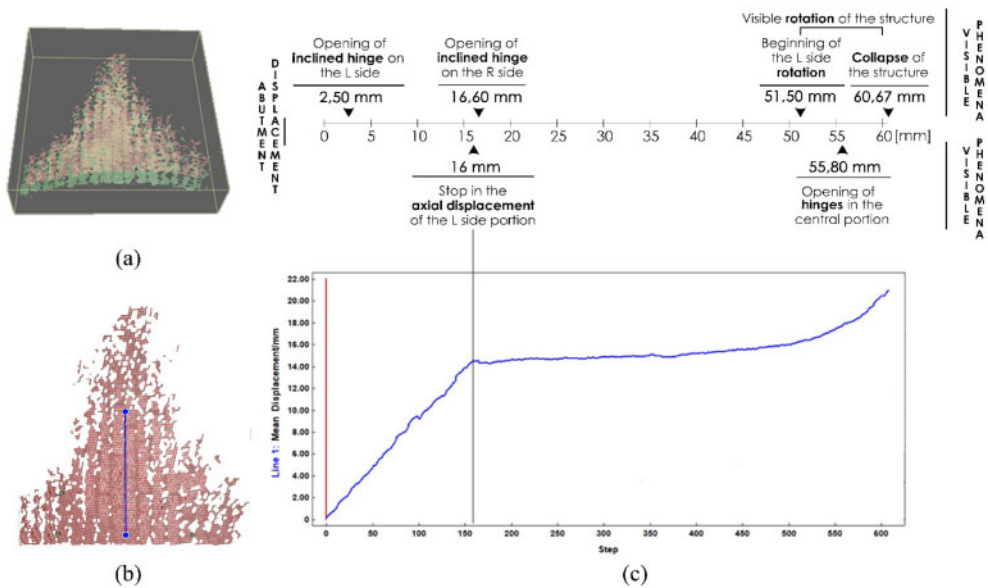
Figure 8. DIC cameras' field of view at step 0 (red) and 244 (green) of the imposed displacement (a), position of the linear strain-gauge (b), time history of mean displacement of the linear strain-gauge on the R1 vault (c).

A deeper insight into the phenomena observed and recorded on each vault during the tests is provided in Figure 8 for the R_1 vault, as an example. In particular, Figure 8 compares the macroscopic visible phenomena reconstructed by direct observation, video acquisition and three-dimensional data managing of the range-based and image-based acquisition techniques at different stages of imposed displacement (Figure 8c top) to the mean displacement of a control linear strain-gauge (Figure 8b, corresponding with the key voussoirs of the vault) versus imposed displacement recorded through DIC (Figure 8c bottom). This comparison shows how the mean displacement linearly increases until the step (about 16 mm) corresponding to the reduction in the axial displacement (y) of the central portion of the vault and to the development of the inclined longitudinal crack that separates the right haunch portion. Then, the mean displacement remains almost constant and start increasing again in correspondence of the step (about 51 mm) when the structure starts rotating until collapse.
