Static behaviour of in scale masonry vaults under imposed settlement of the supports

F. Roselli, M. Alforno & F. Venuti

Politecnico di Torino, Department of Architecture and Design, Torino, Italy

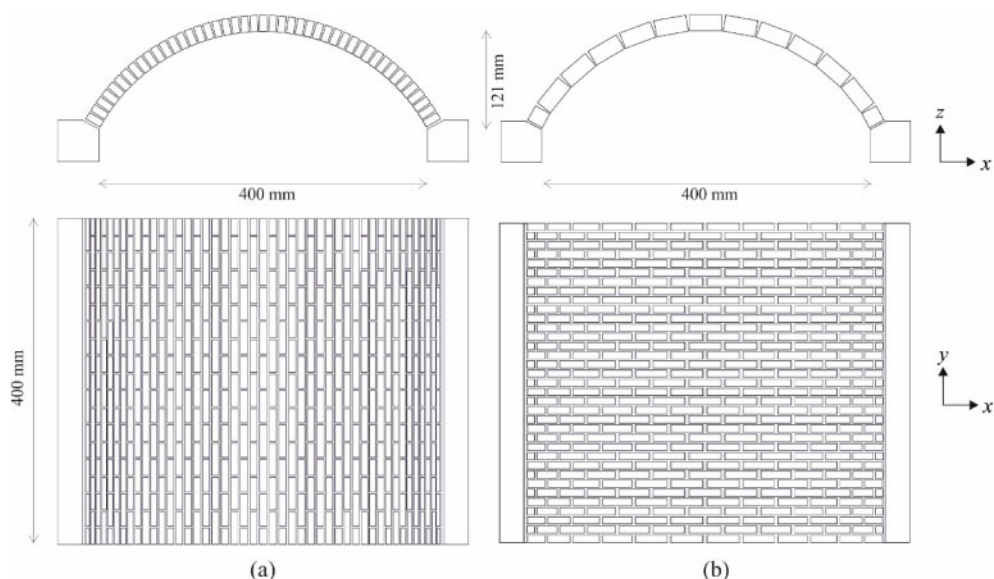
Figure 1. Geometry of the barrel vault in the radial (a) and vertical (b) configuration.

The adopted case study is a 1:5 model of a barrel vault with a square base: the net span of the vault is approximately 40 cm, the rise is about 12 cm, and the length of the vault is 40 cm (Figure 2). The barrel vault is made of blocks of dimensions $9 \times 20 \times 40$ mm, which mimic in scale 1:5 the dimensions of classic masonry bricks.

- a radial pattern (R), composed of multiple rows of rowlock oriented bricks, placed orthogonal to the main vertical plane of the vault (Figures 1a and 2a);
- a vertical pattern (V), where the bricks are laid in rows parallel to the main vertical plane of the structure (Figures 1b and 2b).

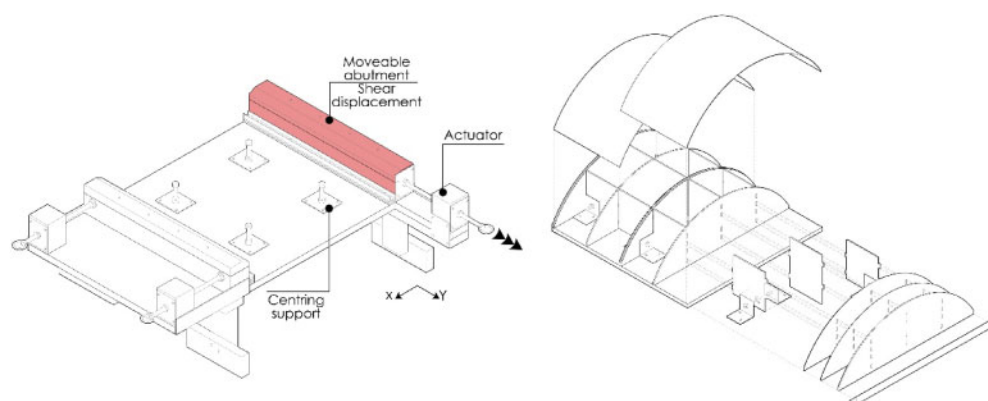
Figure 2. Experimental set up of the barrel vault: testing device and detail of the centring.

The experimental set up of the barrel vault was designed to allow both opening and shear tests to be performed (Figure 2). Specifically, one of the abutments is fixed in the x direction and allowed to move in y direction (simple shear mechanism), while the other abutment is fixed in the y direction and can be moved in x direction (opening mechanism). Four pins support the centring, and the slab where they are fixed can be lowered to allow the centring removal after completion of the vault.

The setup is completed by a further device, used only during the construction of the vault with vertical pattern. It consists of a boundary vertical panel, fixed at one of the vault boundaries, against which successive brick courses make contrast by means of clamps. This solution avoids out-of-plane rotation of the new courses and provides stability during construction thanks to the pre-compression exerted by the clamps.

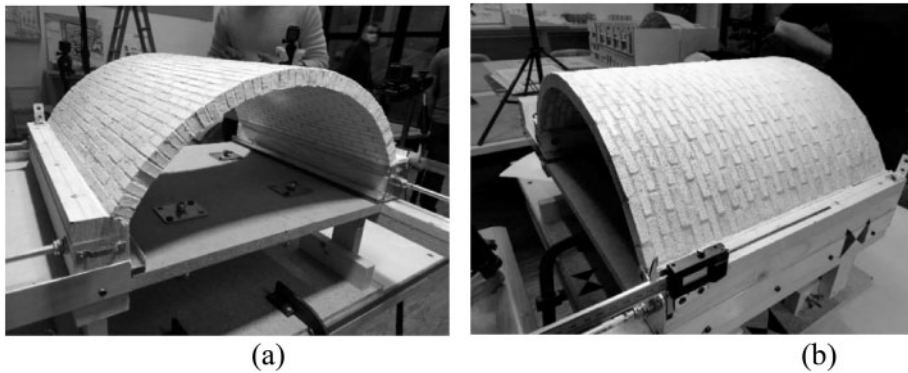
Figure 3. The built model in the radial (a) and vertical (b) configuration.

All the built models (Figure 3) are composed of 450 bricks with a similar global mortar quantity. A total of 4 models, two for each arrangement, are tested under shear displacement.

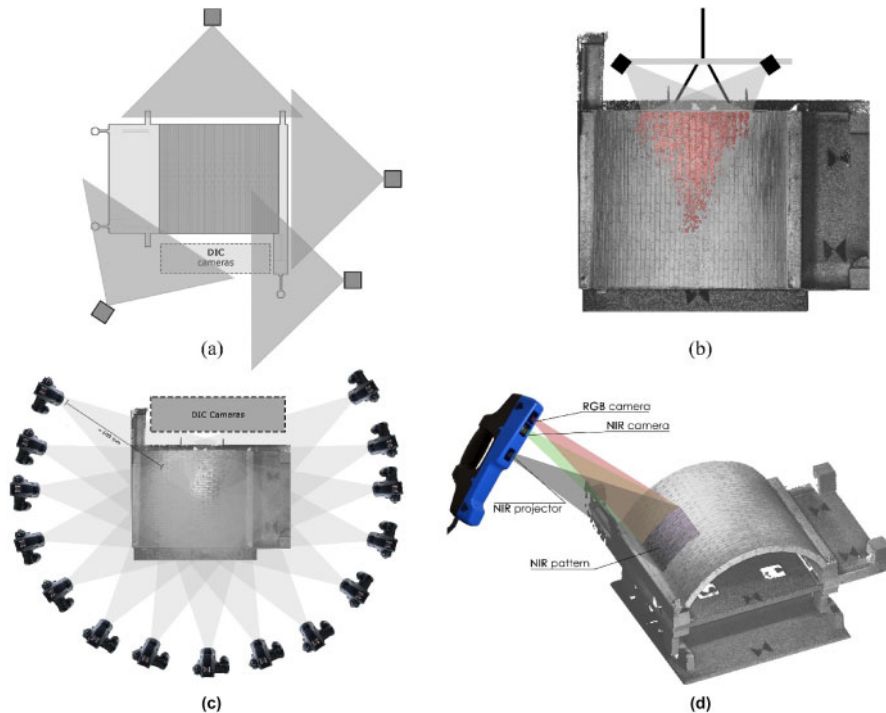
Figure 4. Summary of the adopted acquisition methodologies: (a) GoPro Hero 5 session cameras, (b) DIC cameras, (c) close-range photogrammetry, (d) range-based structured light scanning.

During the tests, the direct observation of the phenomena occurred to the structures is accompanied by the acquisition of relevant data. These acquisitions are performed with contactless solutions to avoid alterations of the test proceeding. A constant video acquisition is performed by four synchronized GoPro Hero 5 session cameras distributed around the vault models (Figure 4a) with the aims of relating the cracking phenomena with the imposed displacement, monitored with

a digital calliper, and capturing the collapse mechanism of the structures. Due to the destructive nature of the tests, three-dimensional data of the models are acquired in several steps of the imposed displacement in order to manage the spatial data of the structures after their failure. Image-based close-range photogrammetry (Figure 4c) and range-based structured light scanning (Figure 4d) solutions are used with these aims, because of their common use in literature in the data acquisition for moveable heritage (Patrucco et al. 2019). At the end of the process, the result obtained is a series of three-dimensional dense point-clouds with an estimated error of about 1 mm. Furthermore, Digital Image Correlation (DIC) is performed, on a little portion of the models (corresponding with the key voussoirs of the vaults) (Figure 4b), for monitoring the three-dimensional deformations of the structures. The data are acquired, as couples of stereoscopic images, by steps of 0.1 mm of imposed displacement. The result obtained is a series of quadrangular meshes with a submillimeter estimated error.

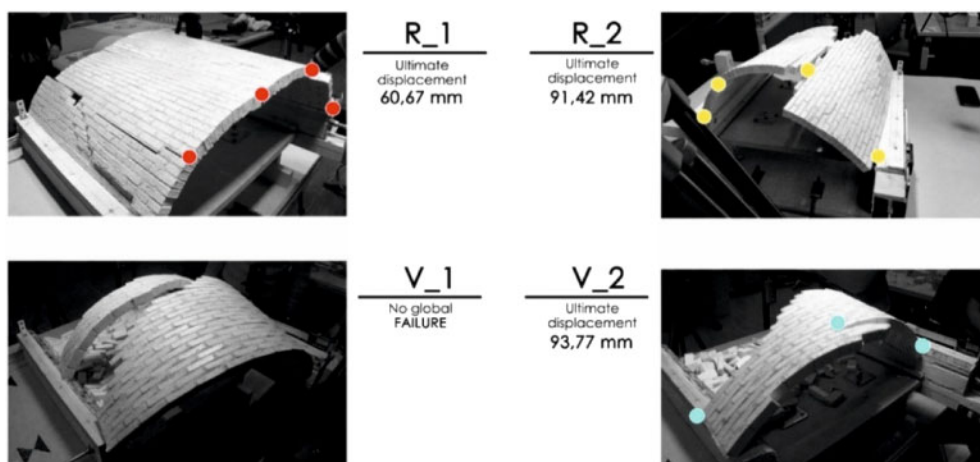
Figure 5. Collapse mechanisms of the tested models.

The high-speed and high-resolution cameras provide images of the collapse mechanisms of the tested models. In Figure 5 a selection of images of the failure, from the most representative perspective, is reported. Differently from arches, vaults involve complex three-dimensional failure mechanisms. The latter are quite different for vaults with different brick pattern, but also between vaults with the same brick arrangement.

The R models show a four-hinge mechanism, even though they reach the collapse at quite different ultimate displacements (60.67 mm in R_1 and 91.42 mm in R_2). The hinges run across the whole depth of the model following the longitudinal joints, with two of them placed at the abutment interface and one in the proximity of the key bricks. On the contrary, the V models show a different behaviour, characterized by the local collapse of some arches and by the rigid rotation of the separated portions of the vault. The rigid rotation of the vault on the abutment is particularly evident in the V_1 model, which reaches the end of displacement range (fixed at 150 mm) without a global failure. The V_2 model collapses at 93.77 mm of imposed displacement with a three-hinge mechanism, developed among the arches still in compression, with the slipping of the structure from one of the abutments.

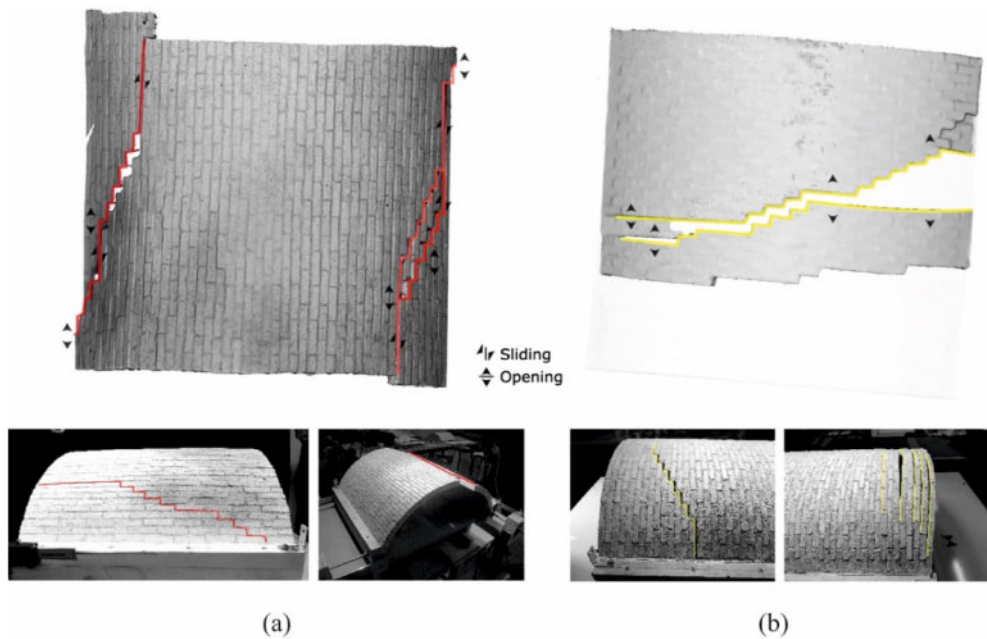
Figure 6. Crack pattern of R (a) and V (b) vaults.

The critical analyses of the crack patterns experienced in the models reveal substantial differences between the two bricks patterns (Figure 6). In the R models most of the cracks are represented by fractures occurring along the longitudinal joints. These major cracks appear to be quite straight

along a single longitudinal joint or inclined involving multiple rows of bricks (Figure 6a). On the other hand, in the V models the major cracks occur in the radial joints, leading to the formation of separate portions of the structure (Figure 6b) that lead to local collapses. Also in V models, the major cracks can assume either straight or inclined directions, reasonably depending on construction issues.

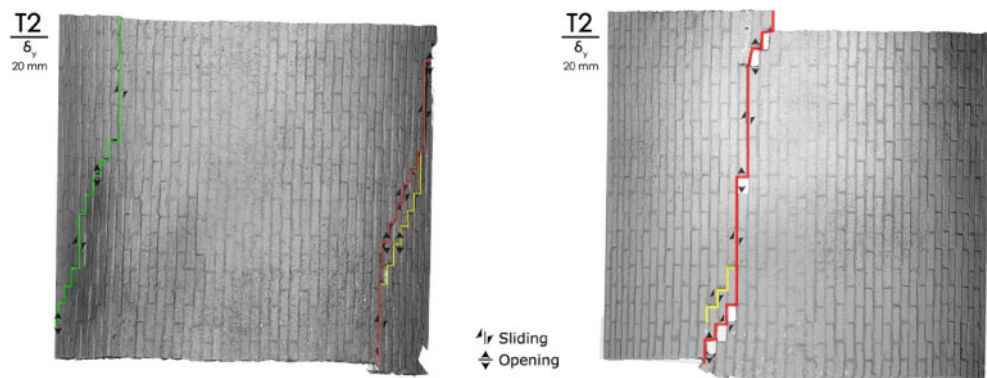
Figure 7. Crack pattern of R_1 (a) and R_2 (b) vaults for imposed displacement of 20 mm.

Besides the described main differences in the crack pattern between vaults arranged with different brick patterns, some minor differences occur between vaults arranged with the same pattern, as clearly visible in Figure 7 for the R_1 and R_2 vaults. Specifically, the major crack position varies due to construction issue, i.e., to the impossibility to perfectly replicate the model construction. In the R_1 vault the two major cracks lead to the separation of the central portion, that starts rotating upon the sliding haunches; in the R_2 model, the major crack along the top of the vaults extrados

leads to a major sliding between the two portions, which cause small local failures near the heads and the rigid rotation of the two haunches upon the abutment, while the contact surface between them is reducing. This difference in the collapse mechanism induces quite different displacement capacity, being the ultimate displacement of the R_2 vault 50% higher than the one of the R_1 vault.

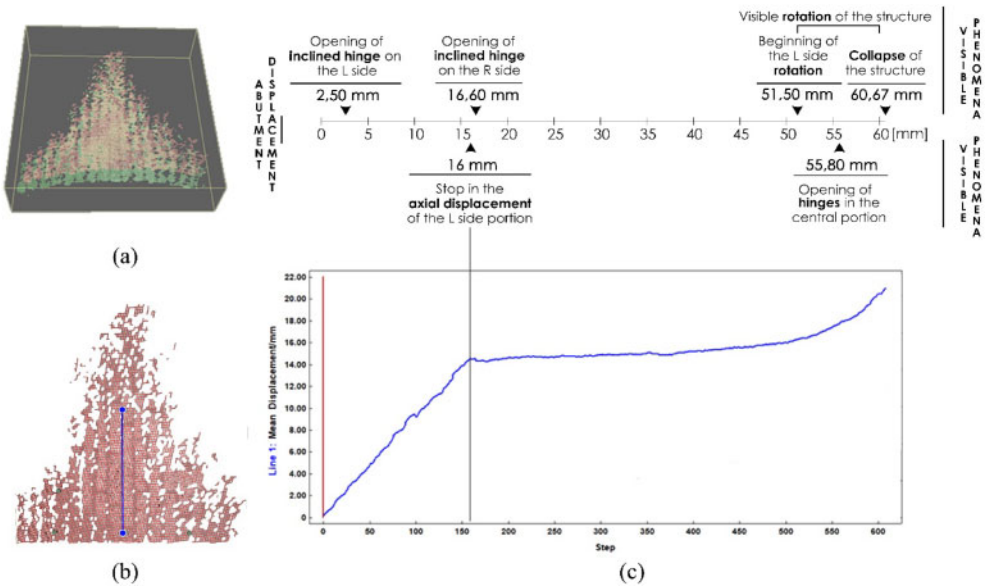
Figure 8. DIC cameras' field of view at step 0 (red) and 244 (green) of the imposed displacement (a), position of the linear strain-gauge (b), time history of mean displacement of the linear strain-gauge on the R1 vault (c).

A deeper insight into the phenomena observed and recorded on each vault during the tests is provided in Figure 8 for the R_1 vault, as an example. In particular, Figure 8 compares the macroscopic visible phenomena reconstructed by direct observation, video acquisition and three-dimensional data managing of the range-based and image-based acquisition techniques at different stages of imposed displacement (Figure 8c top) to the mean displacement of a control linear strain-gauge (Figure 8b, corresponding with the key voussoirs of the vault) versus imposed displacement recorded through DIC (Figure 8c bottom). This comparison shows how the mean displacement linearly increases until the step (about 16 mm) corresponding to the reduction in the axial displacement (y) of the central portion of the vault and to the development of the inclined longitudinal crack that separates the right haunch portion. Then, the mean displacement remains almost constant and start increasing again in correspondence of the step (about 51 mm) when the structure starts rotating until collapse.
