Recovering the heritage and building traditions of the village of Tacora, Chile / Bocci, Martina; Yuste, Beatriz. - In: JOURNAL OF TRADITIONAL BUILDING, ARCHITECTURE AND URBANISM. - ISSN 2660-5821. - STAMPA. - 1:1(2020), pp. 235-240. [10.51303/jtbau.vi1.343]

Recovering the heritage and building traditions of the village of Tacora, Chile

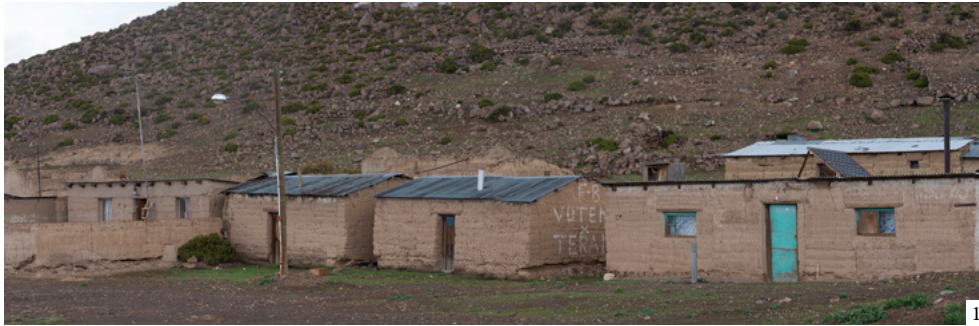
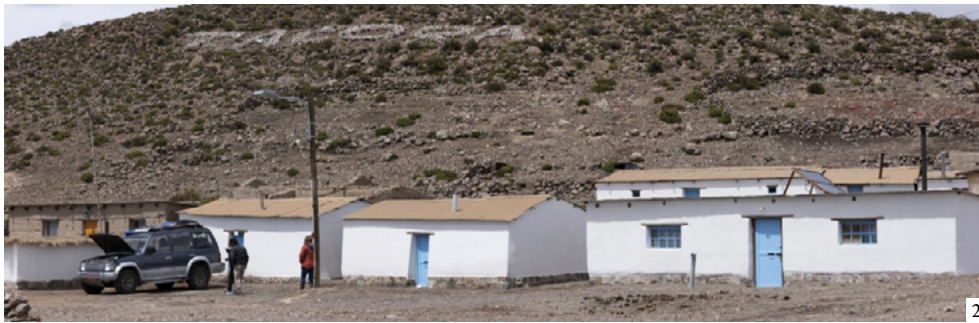
1 and 2: The houses of the village before and after their restoration

The interventions employed local techniques and solutions, without altering the architectural character of the place. Missing or eroded stone basements were restored; collapsed or detached portions of walls were rebuilt; cracks and fissures were repaired with earthen mortar injections, filled with adobe bricks or with volcanic stones and earthen mortars. In some gables, masonry was replaced by lightweight *quincha*: a local traditional structure made of wood and reeds which is filled with a mixture of earth and straw.

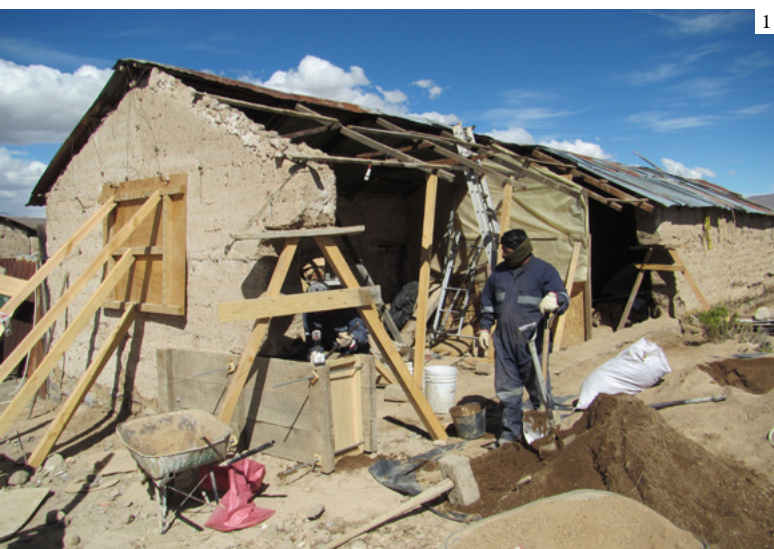
1

1: Process of reconstruction of a rammed-earth wall
2: Wooden reinforcement of a rammed-earth wall

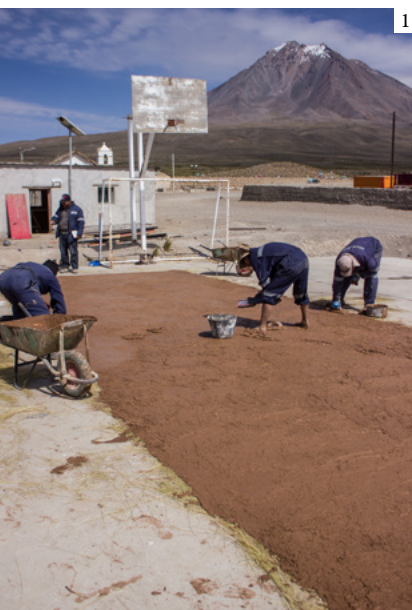
1: Making of a *caruna*

In the weaving workshop and the shop an oral tradition, which was still remembered by one of the workers, was recovered: *caruna* was laid on cowhide laces, braided to the rafters. *Caruna* is an insulation mat obtained by first placing some straw randomly on a flat surface, then pouring earth and *baba de tuna*, and finally treading on the mix. Once it is almost dry, it is cut and rolled (Bocci 2019).

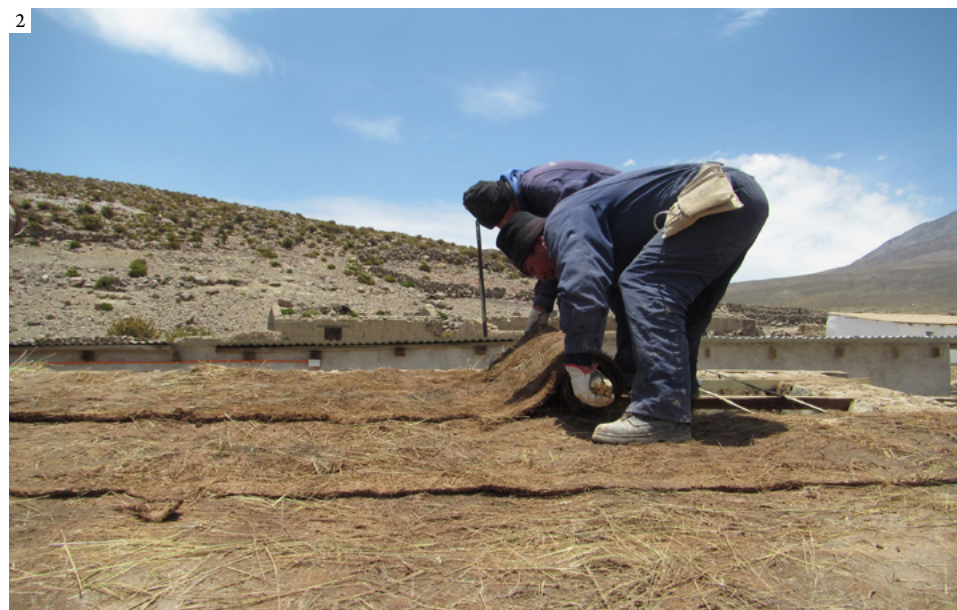
2: A *caruna* being placed on a roof
