Recovering the heritage and building traditions of the village of Tacora, Chile

Recovering the heritage and building traditions of the village of Tacora, Chile / Bocci, Martina; Yuste, Beatriz. - In: JOURNAL OF TRADITIONAL BUILDING, ARCHITECTURE AND URBANISM. - ISSN 2660-5821. - STAMPA. - 1:1(2020), pp. 235-240. [10.51303/jtbau.vi1.343]

Martina Bocci, Beatriz Yuste

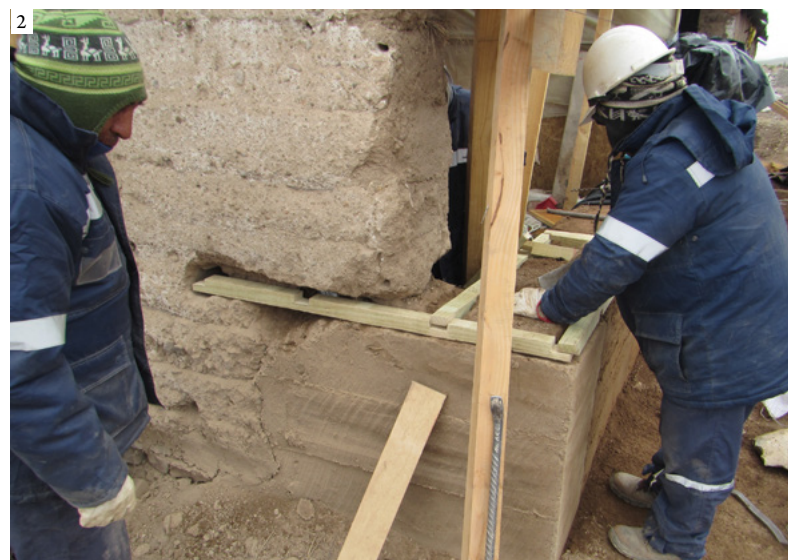
2

2: Wooden reinforcement of a rammed-earth wall

In order to improve the seismic resistance of the restored buildings, low-tech solutions based on studies by Julio Vargas Neumann – a professor at the Pontificia Universidad Católica del Perú – were used, such as biaxial nets, wooden reinforcements and geomats.

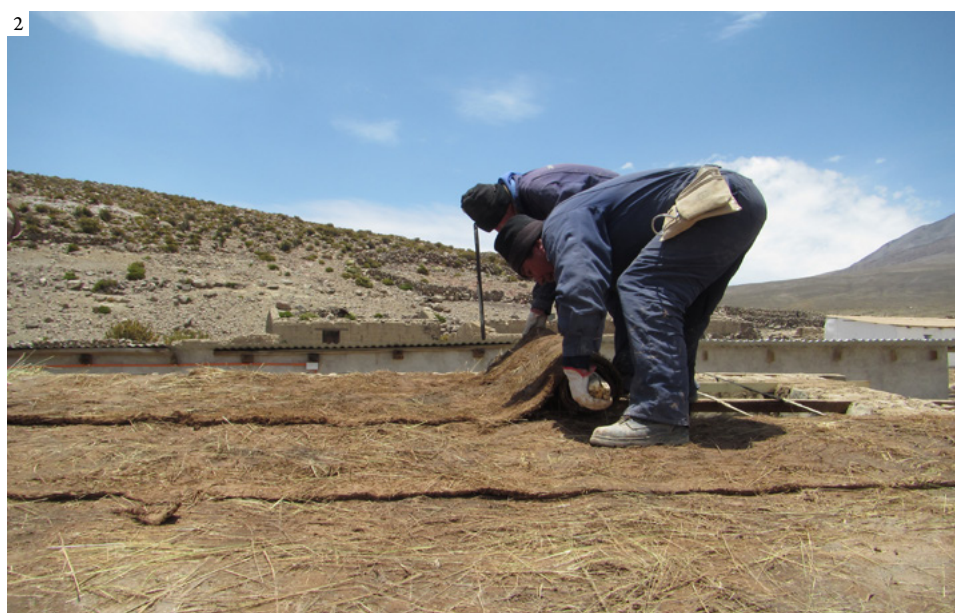
2: A *caruna* being placed on a roof

In the weaving workshop and the shop an oral tradition, which was still remembered by one of the workers, was recovered: *caruna* was laid on cowhide laces, braided to the rafters. *Caruna* is an insulation mat obtained by first placing some straw randomly on a flat surface, then pouring earth and *baba de tuna*, and finally treading on the mix. Once it is almost dry, it is cut and rolled (Bocci 2019).
