Recovering the heritage and building traditions of the village of Tacora, Chile

Tacora is a village in the Chilean highlands with an extraordinary natural and cultural landscape. During the last years, its population has migrated massively to the city of Arica. In 2018, the community and the Fundación Altiplano organized a training program for the restoration of the façades of its buildings. The program employed and qualified community members in traditional building trades related to construction with earth, stone and wood. This training program opens up a horizon of new opportunities for sustainable development related to the extraordinary cultural heritage of Tacora.

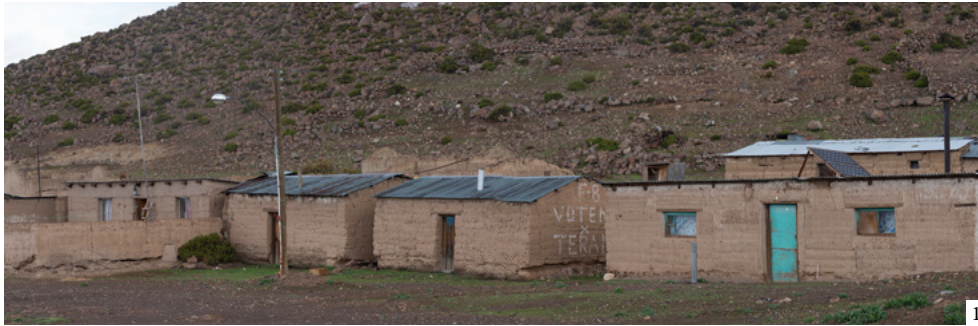
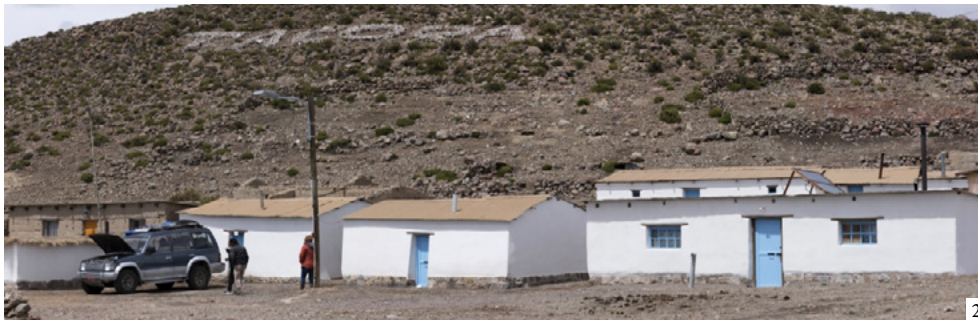
1 and 2: The houses of the village before and after their restoration

The interventions employed local techniques and solutions, without altering the architectural character of the place. Missing or eroded stone basements were restored; collapsed or detached portions of walls were rebuilt; cracks and fissures were repaired with earthen mortar injections, filled with adobe bricks or with volcanic stones and earthen mortars. In some gables, masonry was replaced by lightweight *quincha*: a local traditional structure made of wood and reeds which is filled with a mixture of earth and straw.

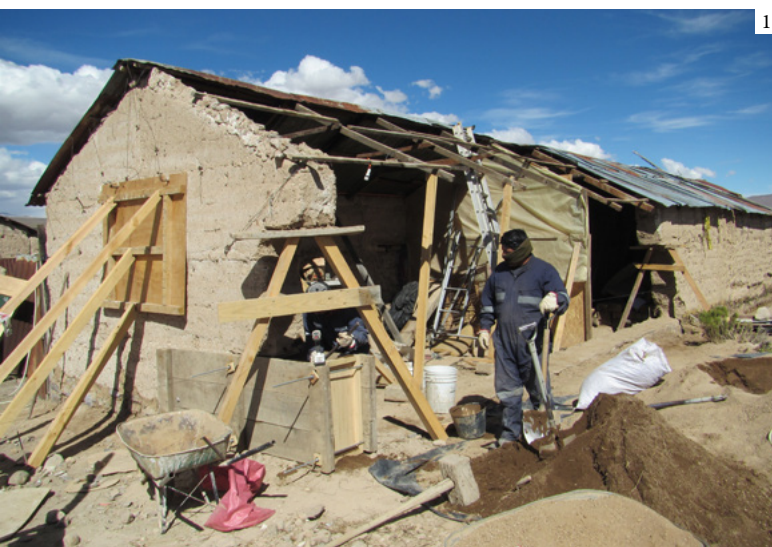
1

1: Process of reconstruction of a rammed-earth wall

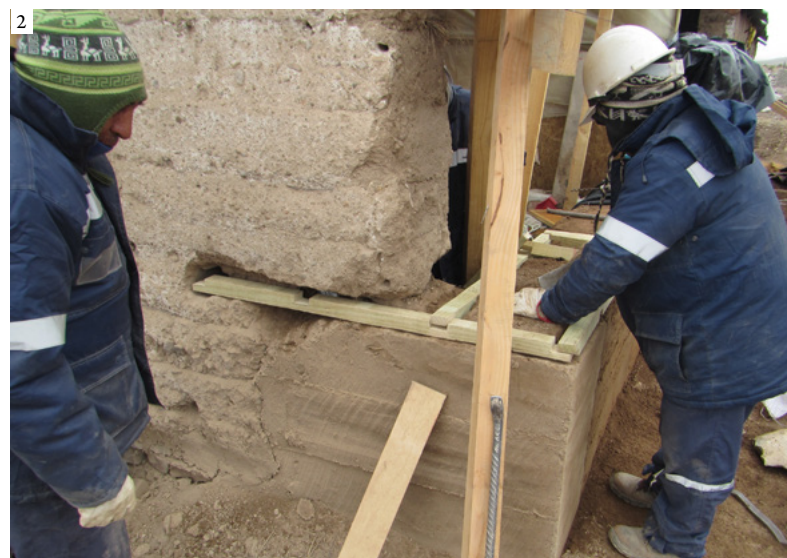
2

2: Wooden reinforcement of a rammed-earth wall

In order to improve the seismic resistance of the restored buildings, low-tech solutions based on studies by Julio Vargas Neumann – a professor at the Pontificia Universidad Católica del Perú – were used, such as biaxial nets, wooden reinforcements and geomats.

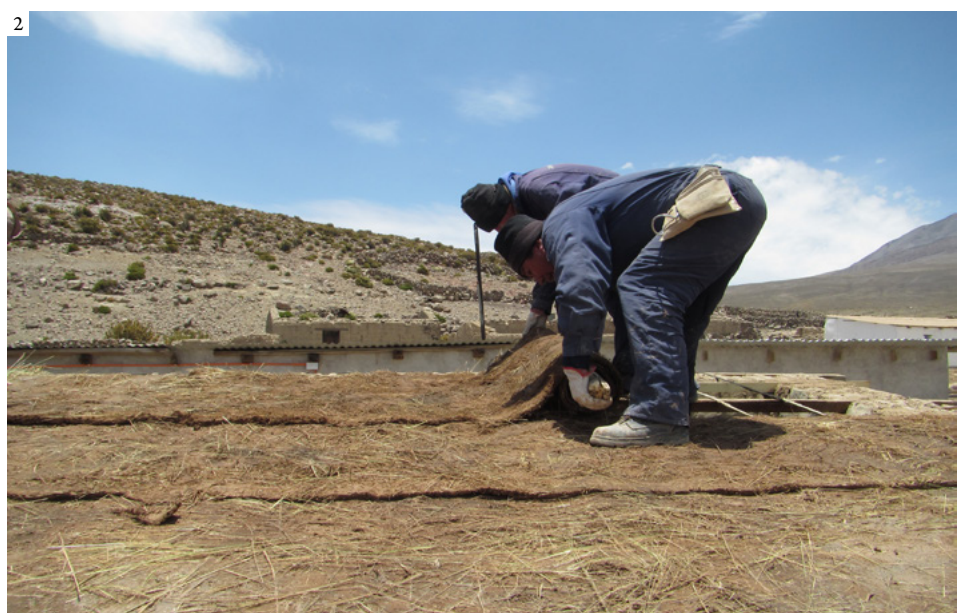
2: Cutting of the cowhide to make the laces used in the roofing

In the weaving workshop and the shop an oral tradition, which was still remembered by one of the workers, was recovered: *caruna* was laid on cowhide laces, braided to the rafters. *Caruna* is an insulation mat obtained by first placing some straw randomly on a flat surface, then pouring earth and *baba de tuna*, and finally treading on the mix. Once it is almost dry, it is cut and rolled (Bocci 2019).
