Improvement of foundation soil behavior for Gründerzeit buildings in Austria using polyurethane resin injections

Improvement of foundation soil behavior for Gründerzeit buildings in Austria using polyurethane resin injections / Dominijanni, Andrea; Gabassi, Matteo; Kopf, Fritz F.; Minardi, Alberto; Paschetto, Alberto. - STAMPA. - (2022), pp. 964-976. (Intervento presentato al convegno 3rd International ISSMGE TC301 Symposium tenutosi a Naples (Italy) nel 22-24 June 2022) [10.1201/9781003308867-75].

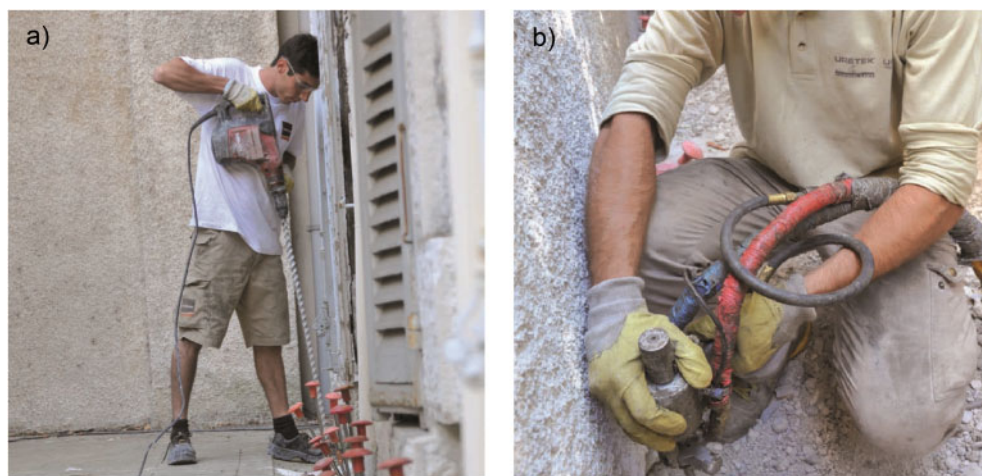
Figure 1. Example of operations: a) Drilling of the borehole; b) Equipment for the injection of the expanding polyurethane resin.

volume increase under unconfined conditions (null mechanical stress) of about thirty times (Buzzi et al. 2008; Dei Svaldi et al. 2005). When the resins are injected underground, the expansion process occurs in confined conditions leading to a compaction of the soil surrounding the injection point until a mechanical equilibrium is achieved between the resin and the soil (Dominijanni & Manassero 2014). The injection can be performed at different depths using either several injection tubes with single-point injection at the bottom end of the tube or a single tube with several lateral injection points (multi-point). In both cases, the injections are performed with small tubes (external diameter of about 10–15 mm) and equipment, reducing the treatment impact on the existing structure as much as possible. Figure 1 shows an example of the drilling operations carried out with a portable drill, and the equipment adopted to perform the injection of the resin in the installed tube from the ground surface.

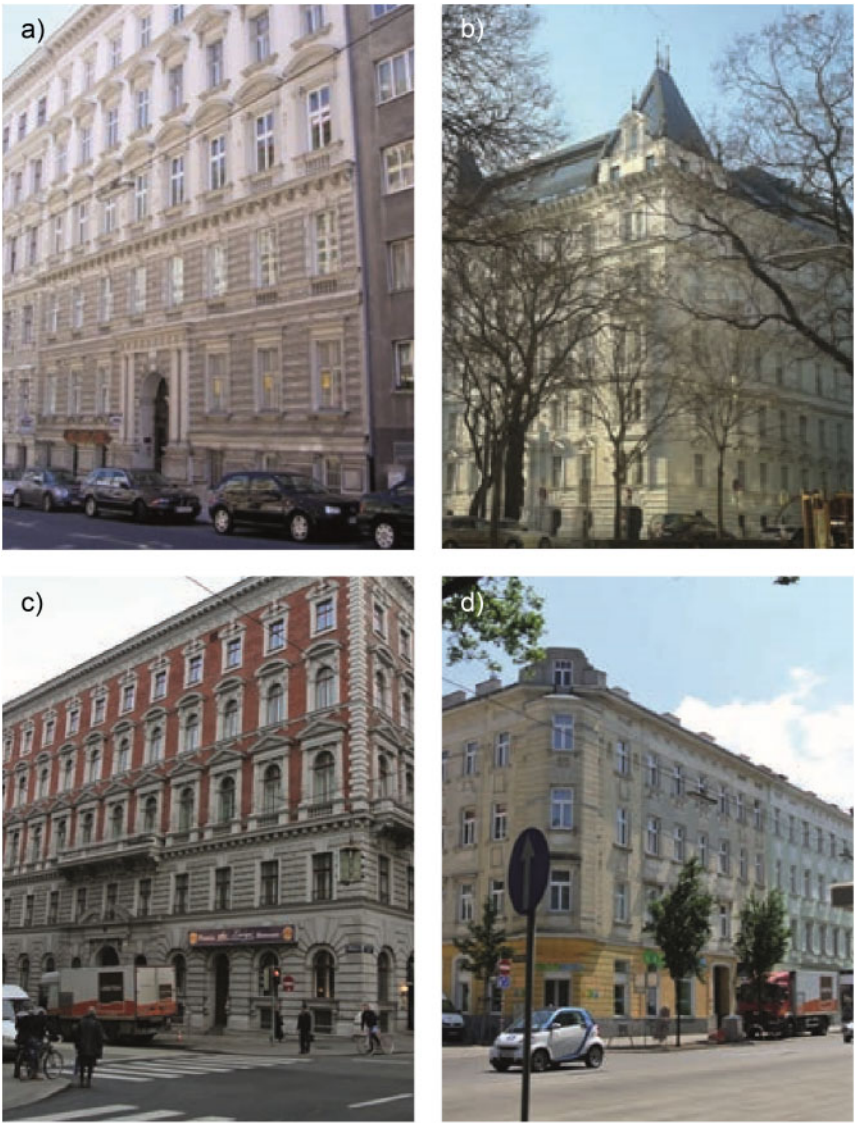
An example of four historical buildings in Vienna, constructed during the Gründerzeit period, which have been subjected to soil foundation treatment with polyurethane resins for the construction of attics and/or renovation works, is illustrated in Figure 3. In all of the four cases, the buildings have shallow foundations at a depth in the interval 0.6–2.0 m below the ground surface. In this framework, the injections have been performed underneath the foundation beams. For the building in the image a) (Figure 3), about 260 m linear of strip foundations at a depth interval of 1.3–1.5 m were treated in 20 days of work. For the building in the image b), about 350 m linear of strip foundations at a depth

of 2.0 m were treated in 25 days of work. These two works were performed for the construction of an additional attic floor. For the buildings in the images c) and d) (Figure 3), about 200 m linear and 50 m linear of strip foundations were treated in 18 and 5 days, respectively; in these two last cases, the treatment aimed at the improvement of the foundation soil for settlements mitigation occurred during and after renovation works of the structures. In all the illustrated examples, the foundation soil was mainly composed of a silty sand/gravel. This feature has made the treatment of polyurethane resins extremely attractive. The performed works allowed the stabilization and improvement of the foundation soil, which is usually assessed through settlements monitoring system.

Figure 3. Overview of Gründerzeit buildings in the city of Vienna that undergone foundation soil treatment with expanding polyurethane resins.
