After the earthquake. Design processes for intervention on vernacular heritage in Central Italy

Gianluca Loffredo¹, Federica Recla², Nicolò Suraci³, Cristiano Tosco⁴

Topic: T4.1. Conservation and restoration projects of vernacular architecture

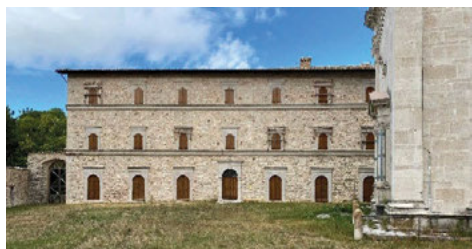
Fig.1. View of “Palazzo delle Guate” (Source: Cristiano Tosco, 2021)

All the buildings are nowadays characterized by natural cleft stone facades, even though some plaster traces are visible. Thanks to the absence of plaster, it is possible to read different textures in the natural stone, which suggest transformations and additions in the construction history.

The quality of the masonry is adequate since the walls are not built with sack masonry, nevertheless, the mortar has a poor quality.⁶ These characteristics, combined with other factors (volumes, heights, seismic intensity, etc.), have led to several cracks and some localized collapses.

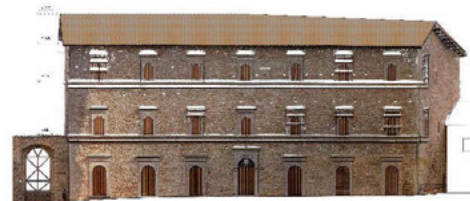
Fig. 2. The southern elevation of “Palazzo delle Guate” (Source: Archiving, 2020)

After this assessment, the technicians involved in the process and the owner of the building – that is, the Camerino’s diocesan chancery (*Curia*) – work together to set the goals for the structural and architectural design. The main objectives of this work are seismic security and accessibility, modern hygienic standards, and fire prevention. Overall, the Shrine is an important local monument: this means that memory and image of the complex become important elements during the design phase (Fig. 2).

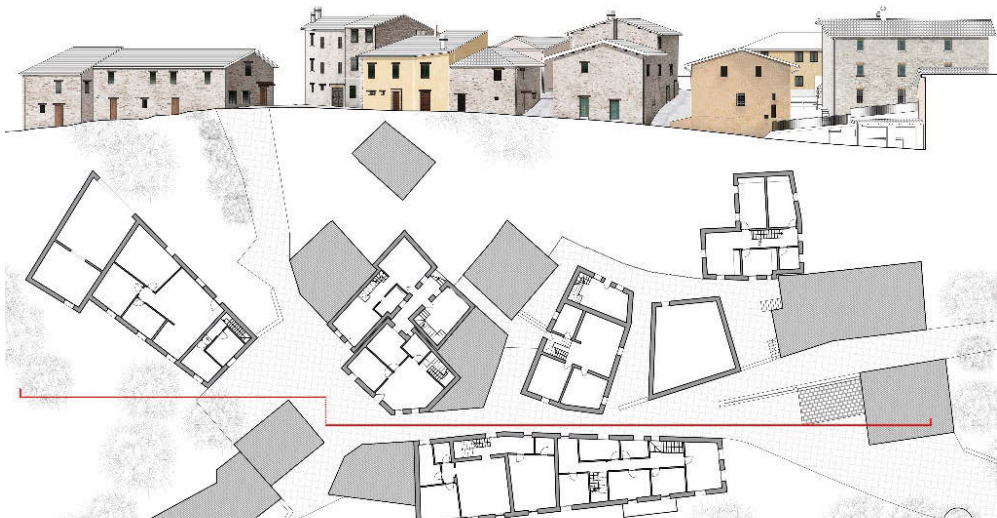
Fig. 5. Plan and elevation at the project prefiguration (Source: Archliving, 2021, with editing by Cristiano Tosco, 2022)

The above-mentioned frameworks depict a complex situation, the investigation of which has required a constant campaign of inspections to outline the characteristics of the building with the least possible approximation and to select the most significant aspects. Damage conditions required a project that must be oriented to complete demolition and reconstruction opening the widely debated topic of reconstruction "as it was, where it was" (Fig. 5). Technical principles of the ongoing project of reconstruction try to consider Gabbiano as a unique vernacular system, where guidelines are oriented to the repetition in volumes of buildings, to the location, size, and proportion maintenance of the openings, to the restoration or similar reconstruction of shading systems in wood and the removal of evident superfetations.
