After the earthquake. Design processes for intervention on vernacular heritage in Central Italy

Topic: T4.1. Conservation and restoration projects of vernacular architecture

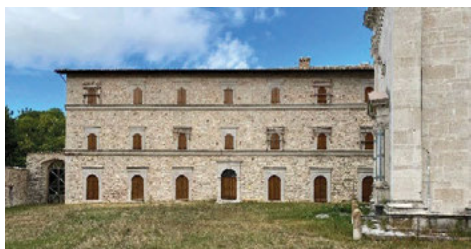
Fig.1. View of “Palazzo delle Guaite” (Source: Cristiano Tosco, 2021)

Besides the central plan church, characterized by square honed stones (ashlar masonry), the complex consists of four main buildings: *Palazzo delle Guaite* (Guardhouse) (Fig. 1), *Casa dei Pellegrini* (Pilgrims' house), *Casa dell'Armata* (Army house) and *Fontanile* (Fountain building).

All the buildings are nowadays characterized by natural cleft stone facades, even though some plaster traces are visible. Thanks to the absence of plaster, it is possible to read different textures in the natural stone, which suggest transformations and additions in the construction history.

The quality of the masonry is adequate since the walls are not built with sack masonry, nevertheless, the mortar has a poor quality.⁶ These characteristics, combined with other factors (volumes, heights, seismic intensity, etc.), have led to several cracks and some localized collapses.

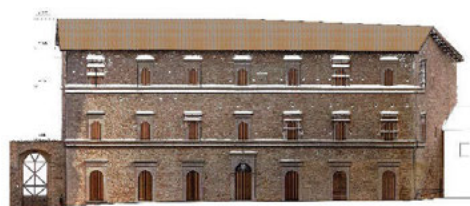
Fig. 2. The southern elevation of “Palazzo delle Guaite” (Source: Archiving, 2020)

After this assessment, the technicians involved in the process and the owner of the building – that is, the Camerino's diocesan chancery (*Curia*) – work together to set the goals for the structural and architectural design. The main objectives of this work are seismic security and accessibility, modern hygienic standards, and fire prevention. Overall, the Shrine is an important local monument: this means that memory and image of the complex become important elements during the design phase (Fig. 2).

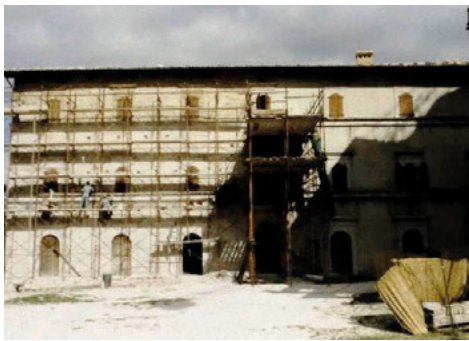
Fig. 3. Photography from 1988 testifying the presence of plaster on the Shrine façades (Source: Archivio Impresa Alessandrini, 2019)

One of the main topics is the potential reintroduction of the plaster on the natural stone façade of *Palazzo delle Guate*. Historic research, historical pictures (Fig. 3), and an accurate survey of the masonry stone suggest that the exterior aspect of that building was historically characterized by the presence of plaster. The reintroduction of plaster, in addition to FRCM (Fabric Reinforced Cementitious Matrix), would nowadays be a proper method to increase the mechanical resistance of the masonry and, concurrently, restore the historical appearance of the building.

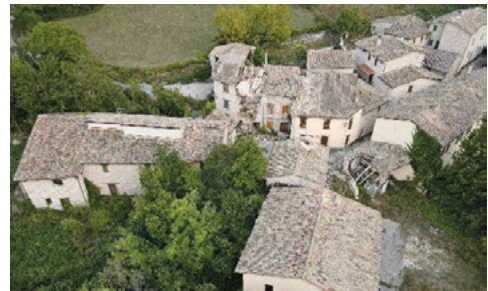
Fig. 4. Drone photography of Gabbiano and its landscape (Source: Archiving, 2021)

Gabbiano is a small and rural settlement in the hamlet of Pieve Torina (Macerata district). Standing over a hill, the village is composed of eight buildings (with different private properties) and one church on a principal sinuous path axis (Fig. 4).
