3D Data Fusion for Historical Analyses of Heritage Buildings Using Thermal Images: The Palacio de Colomina as a Case Study

3D Data Fusion for Historical Analyses of Heritage Buildings Using Thermal Images: The Palacio de Colomina as a Case Study / Patrucco, G., Gómez, A., Adineh, A., Rahrig, M., Lerma, J.L.. - In: REMOTE SENSING. - ISSN 2072-4292. - ELETTRONICO. - 14:22(2022), pp. 1-23. [10.3390/rs14225699]

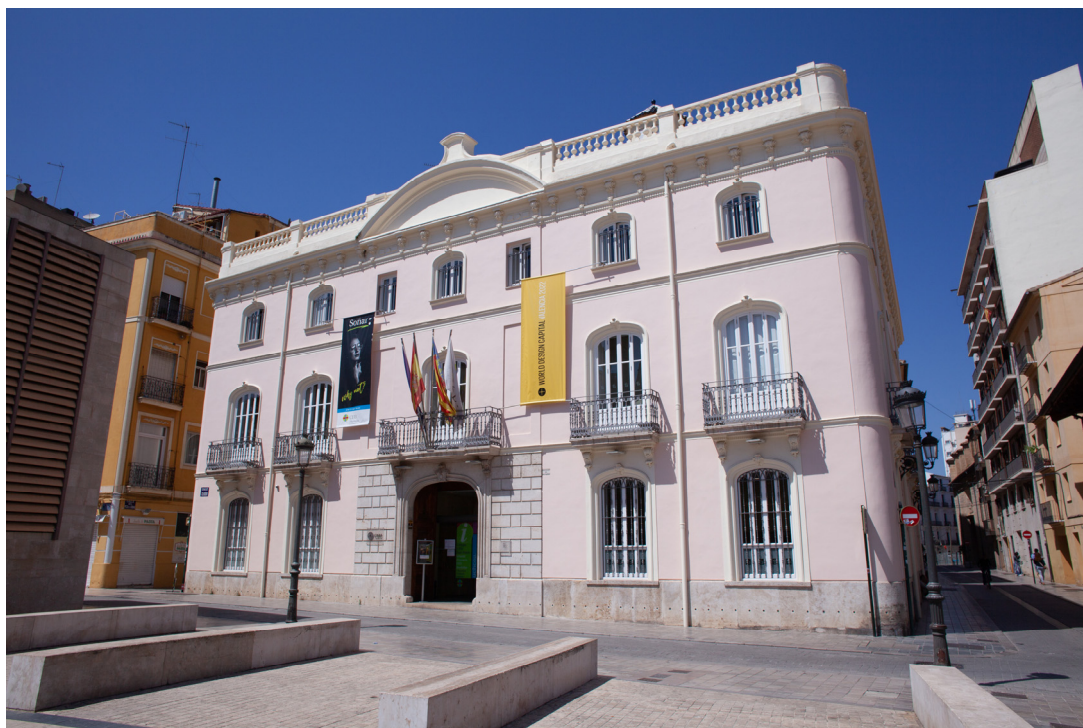
**Figure 1.** Colomina Palace (southern façade).

The *Weight of Flour* Street alludes to a presently non-existing endowment. There are neither engravings, photographs of this building, nor publications that describe its appearance, even in the Historical Archive of Valencia, which guards medieval documents. However, it appears on several old maps of the city centre, the 18th-century plan by Tomás Vicente Tosca in 1704, and the *Valentia Edetanorum vulgo del Cid* by J. Fortea in 1738 [27]. In this sense, very few Valencians, seeing the name of the street, imagine that the *Weight of Flour* building existed, but no one knows what it looked like, and that, under the present eclectic decoration of the Colomina Palace (Figure 1), its original medieval façade remains.

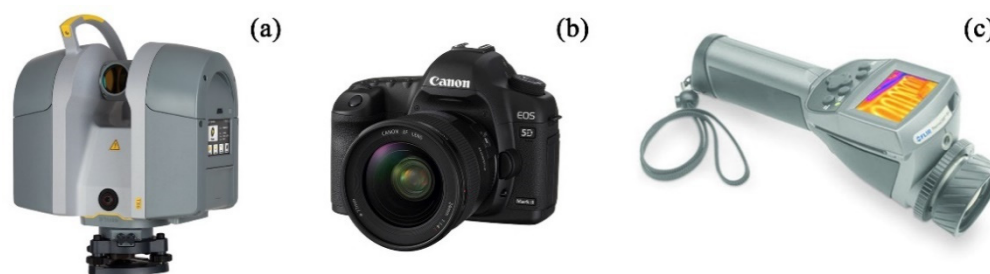
**Figure 3.** (a) Trimble TX6 laser scanner; (b) Canon EOS 5D Mark II; (c) FLIR ThermaCAM™ B4.

- 8 LiDAR scans, using a Trimble TX6 laser scanner (Figure 3a) in order to provide high-resolution point clouds to accurately describe the external geometries of the Palacio;
- 455 colour digital images, using a DSLR camera (model: Canon EOS 5D Mark II) (Figure 3b) to document the visible range of the electromagnetic spectrum;
- 308 TIR images, using a terrestrial thermal camera (model: FLIR ThermaCAM™ B4) (Figure 3c) to detect anomalies or phenomena that are not visible to the human eye, but noticeable in long wave infrared (LWIR—8–14.000 nm).

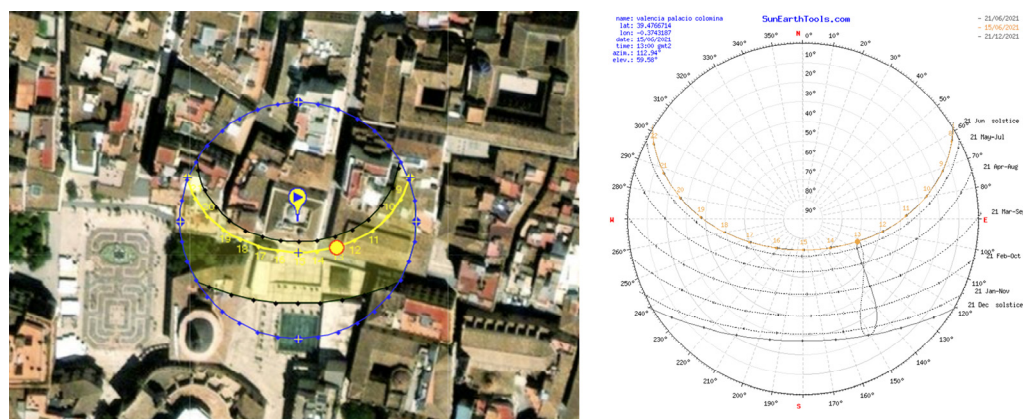
**Figure 4.** Solar path scheme from one of the days on which the TIR images were collected.

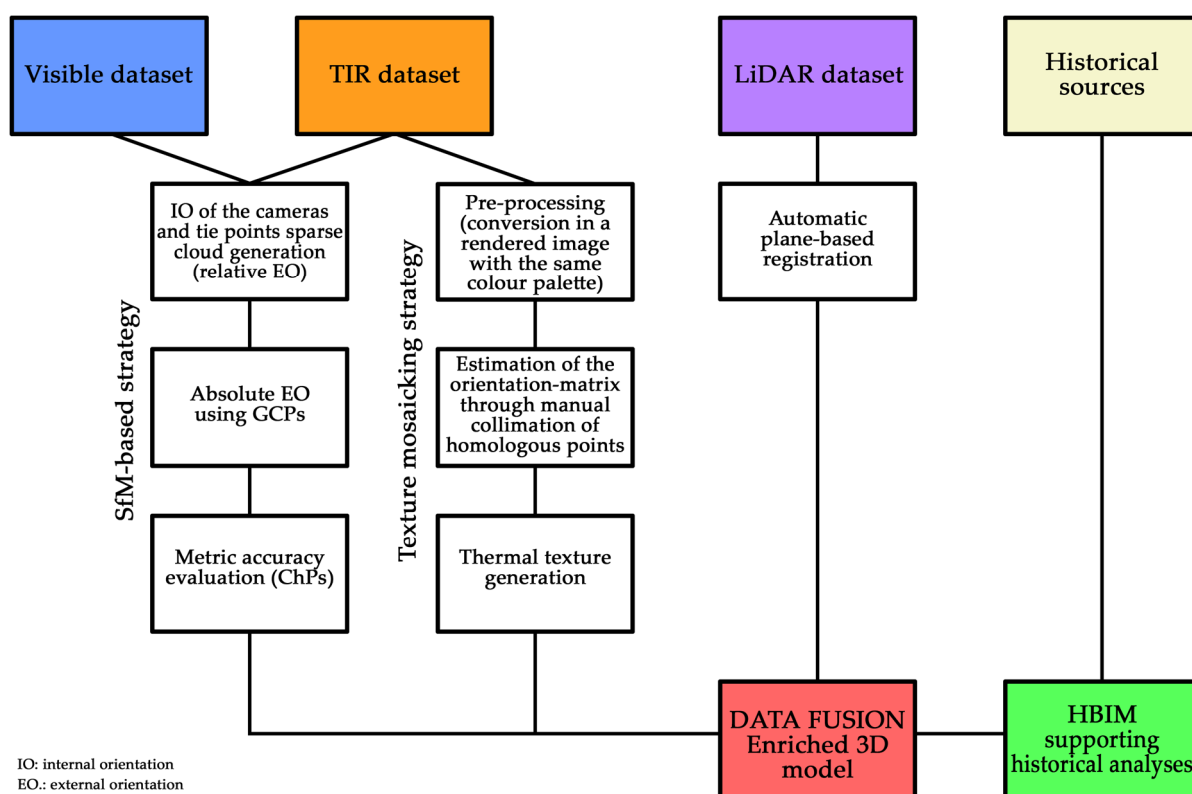
**Figure 6.** Flowchart of the followed workflows.

- The LiDAR scans were registered using an automatic plane-based registration;
- The colour digital images were processed following a photogrammetric SfM-based procedure;
- The TIR images were processed following two different pipelines: when possible (i.e., when the thermograms were acquired following photogrammetric criteria), a standard photogrammetric SfM-based workflow was followed, similar to colour processing; the second workflow consisted of projecting the thermal images on the 3D mesh derived from LiDAR—characterised by a very high spatial resolution—to generate a thermal texture;
- These procedures will be further described in the following sections. The workflows carried out in this study can be observed in Figure 6.

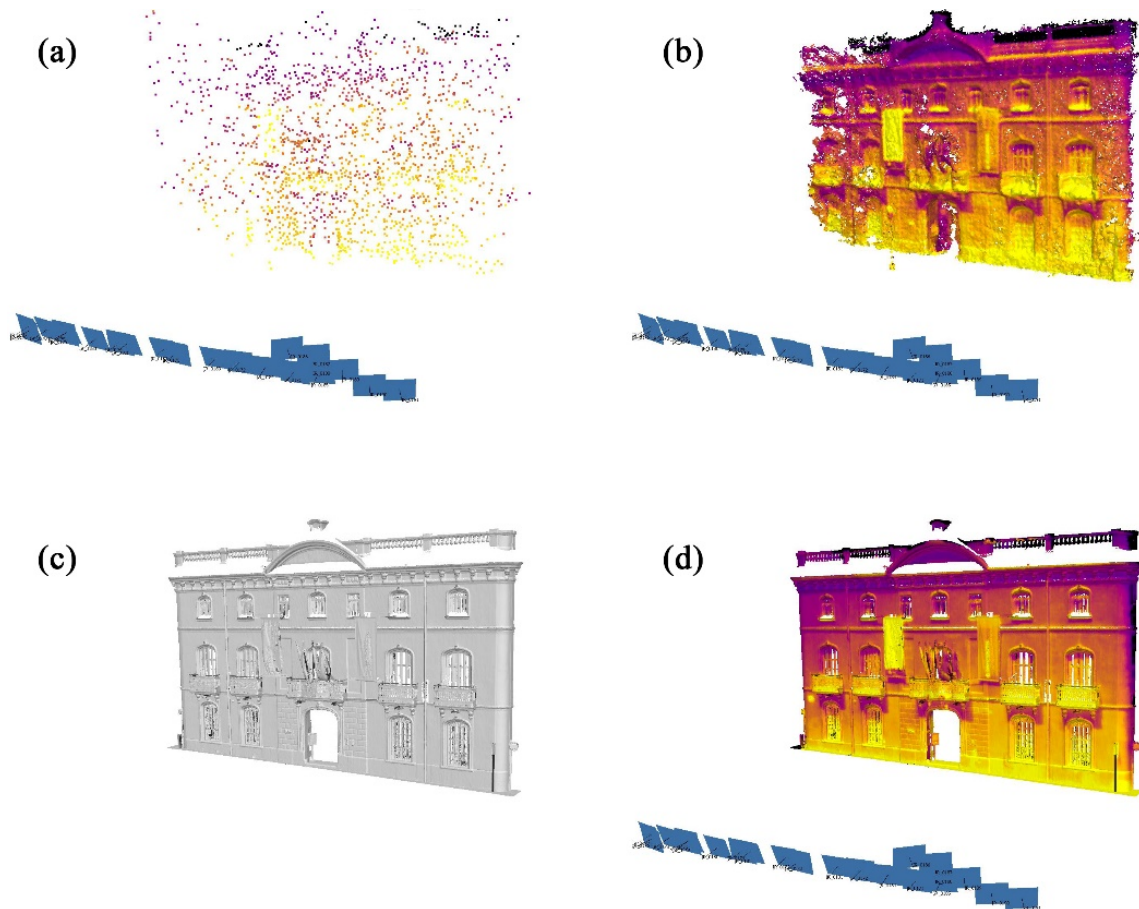
**Figure 8.** (a) Oriented thermal images and sparse cloud of tie points; (b) dense point cloud derived from thermal images, characterised by low resolution and topological errors; (c) high-resolution point cloud derived from LiDAR; (d) integration between the LiDAR point cloud (high-resolution geometry) and thermal data (information connected to the radiometry).

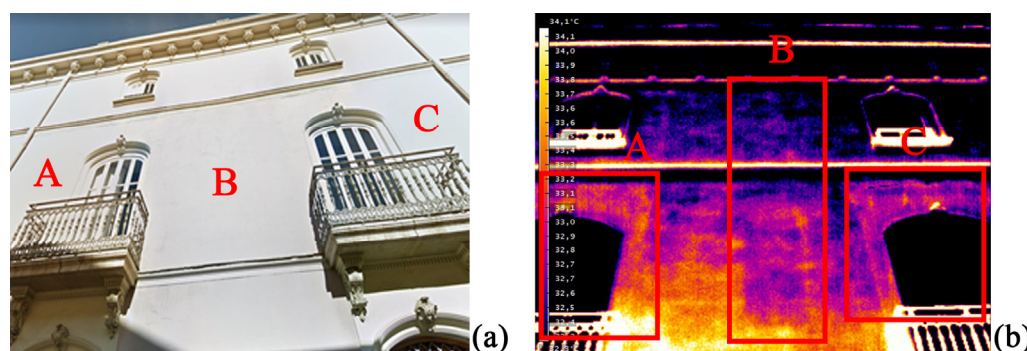
**Figure 14.** (a) Colour image of a section of the eastern façade of the Palacio; (b) thermal image of the same area. It is possible to observe some anomalies not visible in the colour image but clearly detectable in the thermal image (highlighted in red as A, B and C).

- Traces that are consistent with the presence of architectural elements obliterated by subsequent building interventions (Figure 14);
- Possible clues of drastic modifications regarding the volume of the building.

In the first case, by way of example, we report some discrepancies detected in the central part of the eastern façade. Hereby, radiometric contrasts coherent with the presence of (a) façade decorations, niches, or obliterated windows, and (b) remains of the decorated frames of the central windows, appear more massive and thicker, compared with the current ones (Figure 14, areas A and C).

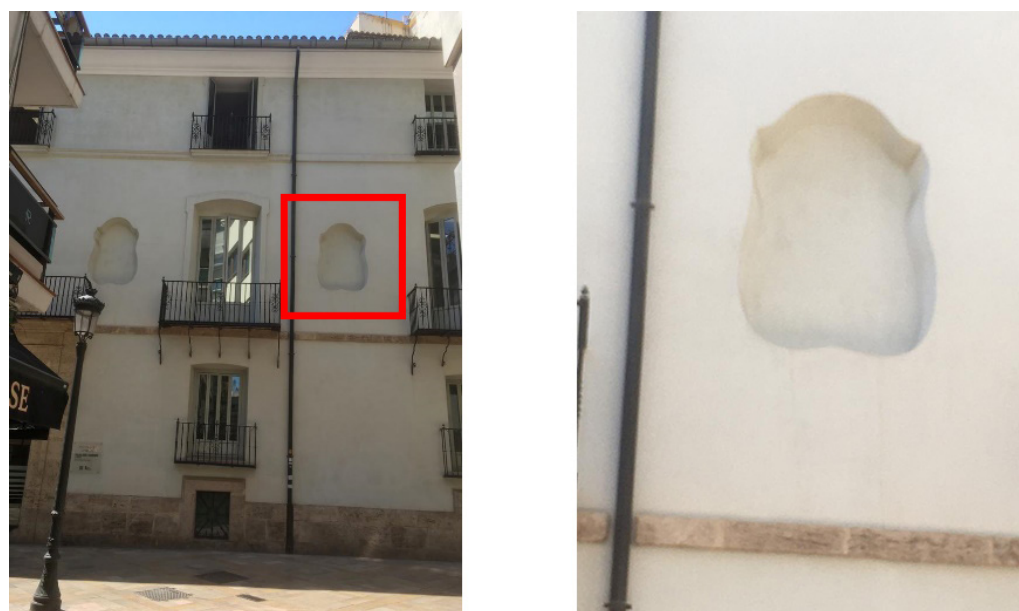
**Figure 18.** Decorative niches on the façade of the Boil de Arenós Palace, Street of Libreros, Valencia.
