3D Data Fusion for Historical Analyses of Heritage Buildings Using Thermal Images: The Palacio de Colomina as a Case Study

Article 3D Data Fusion for Historical Analyses of Heritage Buildings Using Thermal Images: The Palacio de Colomina as a Case Study

Giacomo Patrucco ^{1,*}, Antonio Gómez ², Ali Adineh ^{3,4}, Max Rahrig ⁴ and José Luis Lerma ⁴

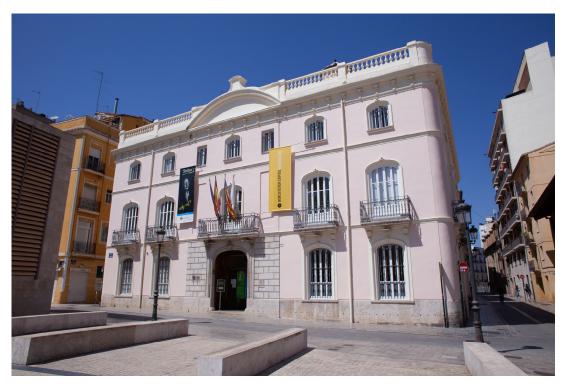
Figure 1. Colomina Palace (southern façade).

The Weight of Flour Street alludes to a presently non-existing endowment. There are neither engravings, photographs of this building, nor publications that describe its appearance, even in the Historical Archive of Valencia, which guards medieval documents. However, it appears on several old maps of the city centre, the 18th-century plan by Tomás Vicente Tosca in 1704, and the Valentia Edetanorum vulgo del Cid by J. Fortea in 1738 [27]. In this sense, very few Valencians, seeing the name of the street, imagine that the Weight of Flour building existed, but no one knows what it looked like, and that, under the present eclectic decoration of the Colomina Palace (Figure 1), its original medieval façade remains.

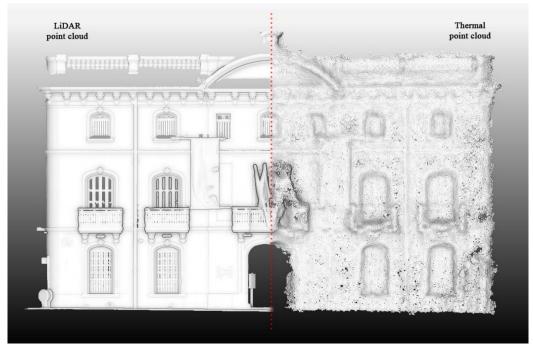
Figure 12. On the left, LiDAR point cloud of the southern façade. On the right, photogrammetric dense point cloud derived from TIR images.

As it is possible to observe in Figures 12 and 13, the denser and more detailed point cloud was the LiDAR point cloud, even after the decimation process (as expected, the point cloud was denser in those areas closer to the laser scanner stations during the acquisition, specifically the centre of the façade and the lateral areas, near the corners). The level of detail was appreciable also in the visible colour photogrammetric point cloud, although it was possible to find many areas characterised by high levels of noise due to the presence of surfaces (explicitly corresponding to the plastered walls) that represented a challenge for the photogrammetric approach (vid. Section 2.3.2).

Concerning the photogrammetric data derived from the SfM-based processing of the TIR images, from a preliminary visual inspection, it appears evident that the thermal point cloud was characterised by a lower level of detail and a high level of noise, coherently with the limited spatial resolution of the TIR images. This aspect becomes even more evident by comparison with the LiDAR point cloud, which can be observed in Figure 12. Moreover, as it is possible to follow in Figure 13c, the thermal point cloud was significantly less dense than the others.

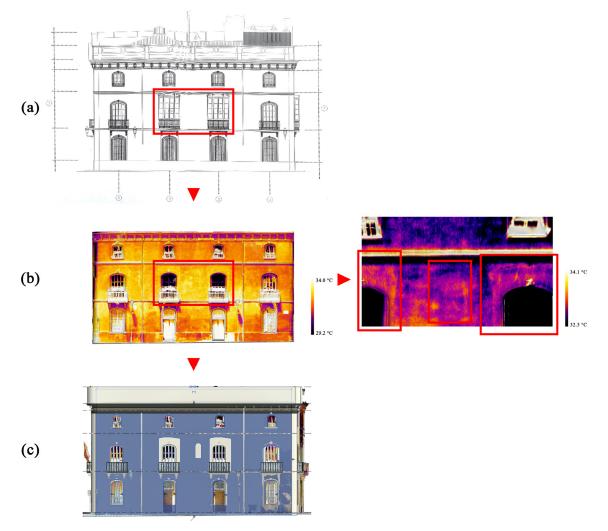
Figure 17. Eastern façade. Superimposition of different data in the HBIM environment: (**a**) condition mapping from 1995; (**b**) TIR orthoimagery showing the thermal anomalies (different temperature scales); (**c**) virtual reconstruction of the "A" and "C" anomalies according to the historical plan and further reconstruction of the central "B" anomaly.

In order to stress the effectiveness of the possibility of matching historical documents in a BIM environment, an example is proposed regarding the thermal anomalies detected on the east façade. While overlaying the thermal information and the historical plans, a direct comparison was much easier, and the location of the thermal discrepancies "A" and "C" could be analysed in connection with the condition mapping of 1995 (Figure 17).

The cause of the thermal anomaly "B" remains unclear. The discrepancy shape is coherent with a horizontal line ending in an arch. Within the HBIM, it is possible to model virtual reconstructions. In this way, the thermal anomaly was reconstructed together with the changes in the central windows (Figure 17c). Based on this virtual reconstruction, the anomaly can be better discussed. There are two possible interpretations: in the first, the anomaly could be interpreted as a niche in the façade, which is common in similar examples in Valencia (Figure 18). However,, as observed in the virtual reconstruction, the niche would not fit symmetrically into the façade, shifting out of the central axis. Therefore, a connection to the visible façade representing the construction of 1863 with perfect symmetries is unlikely. This leads to the second interpretation. The anomaly may have been caused by an occluded window of an earlier construction of the building. This would be an indication that structures of previous buildings are still preserved underneath the shape of the 1863 façades.

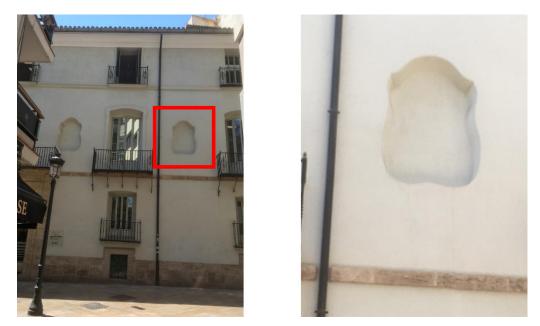
Figure 18. Decorative niches on the façade of the Boil de Arenós Palace, Street of Libreros, Valencia.
