Behavior of Half-Joints: Design and Simulation of  
Laboratory Tests

Behavior of Half-Joints: Design and Simulation of  
Laboratory Tests / Asso, Rebecca; Domaneschi, Marco; Marano, Giuseppe C.; Palmisano, Fabrizio; Palombella,  
Giuseppe. - In: INFRASTRUCTURES. - ISSN 2412-3811. - 7:12(2022). [10.3390/infrastructures7120160]

# Behavior of Half-Joints: Design and Simulation of Laboratory Tests

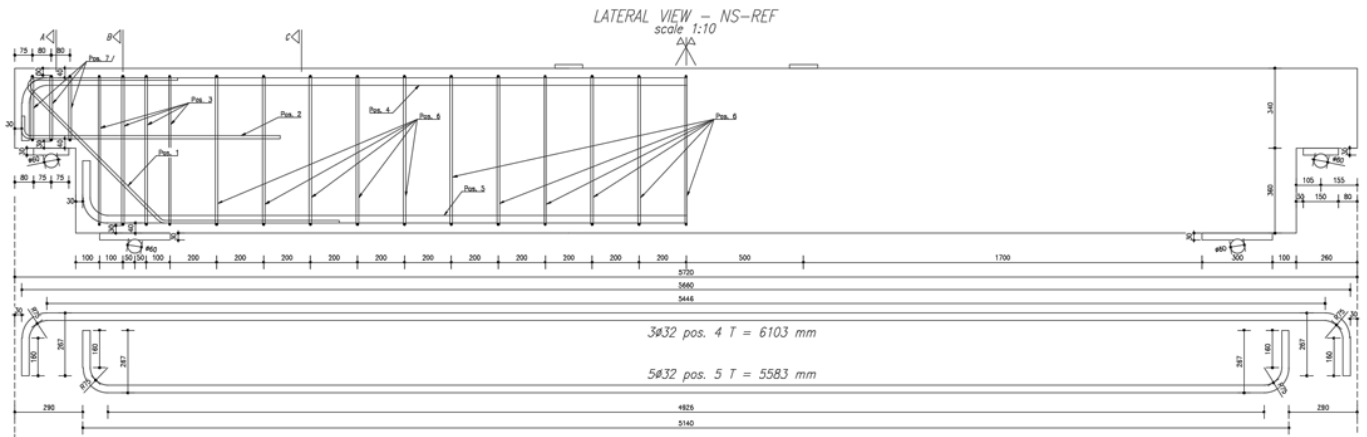
Figure 5. Lateral view and rebars in pos. 4 and pos. 5.

- NS-ND: is based on NS-REF with the removal of the diagonal rebars.
- NS-RS: is based on NS-REF with the reduction of the stirrups nearby the nib.
- Figure 5 summarizes the reinforcement arrangement in the longitudinal section. Figures 6–8 depict the remaining sections and rebar positions.

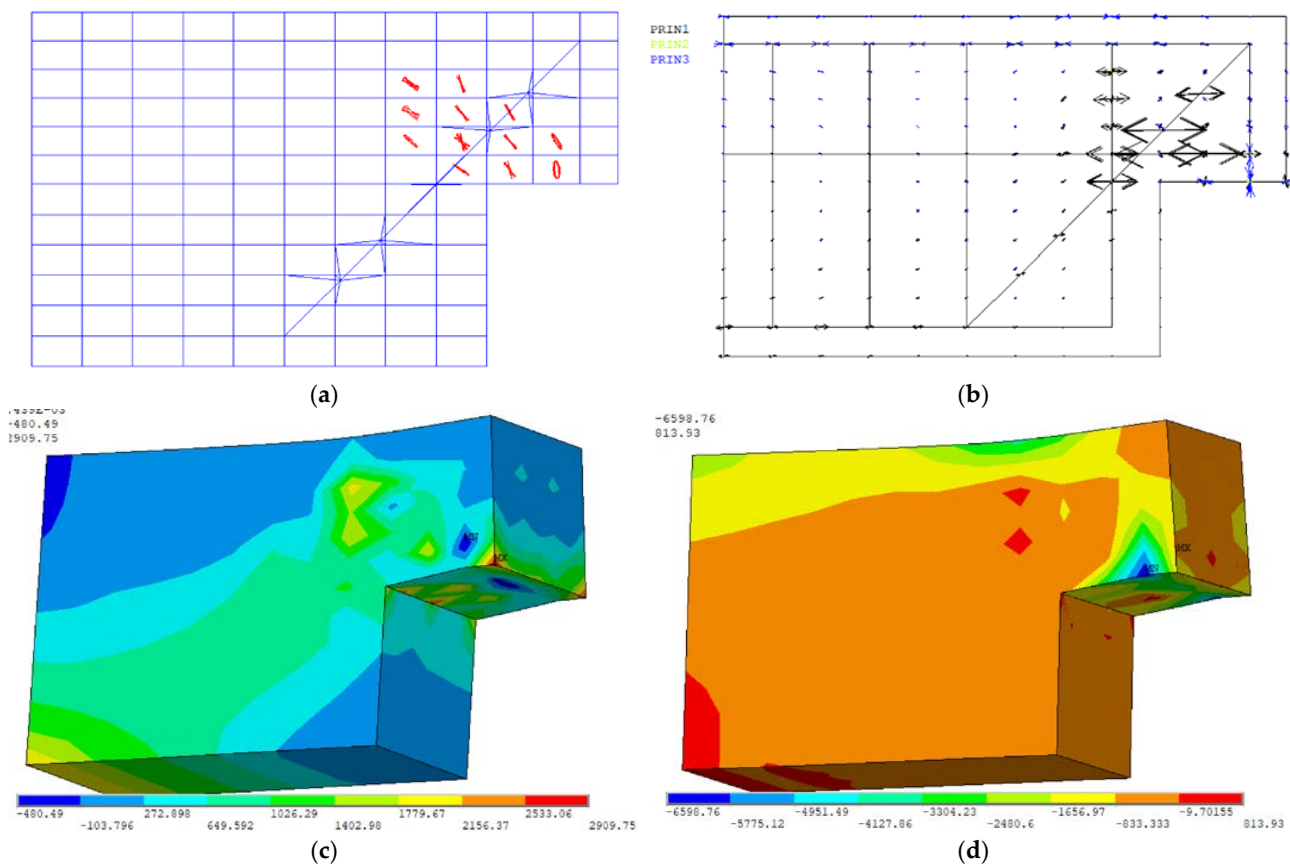
**Figure 19.** Half-joint in NS-RS configuration. (a) Cracking surfaces at collapse (97% final load); (b) vector plot of principal stresses just before collapse; (c) 1st principal stress just before collapse [kN/m<sup>2</sup>]; (d) 3rd principal stress just before collapse [kN/m<sup>2</sup>].

- Focusing on NS-RS configuration (Figure 18), the performed numerical analysis highlights a similar behavior with respect to the other cases. The evolution of the internal stresses is similar to up to 87% of the final load. Subsequently, NS-REF, NS-NU, and NS-ND cases show the beam collapse, while the NS-RS case is able to rearrange the stress path and absorb almost the whole of the final load (97%).
