Stress Corrosion Cracking of Additively Manufactured Alloy 625

Keywords: laser powder bed fusion; Alloy 625; stress corrosion cracking; hydrogen embrittlement

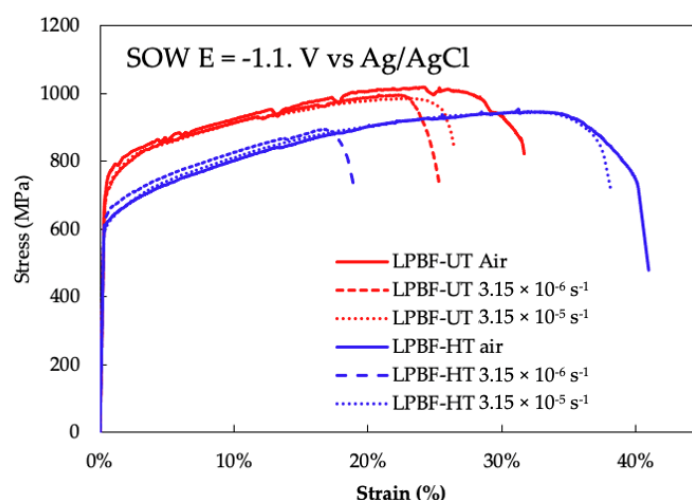
Figure 2. SSRT results of LPBF-UT (red line) and LPBF-HT (blue line) at $3.15 \times 10^{-6} \text{ s}^{-1}$ in air, at $3.15 \times 10^{-6} \text{ s}^{-1}$ in SOW under cathodic protection, and at $3.15 \times 10^{-5} \text{ s}^{-1}$ after hydrogen pre-charging.

The SSRT curves are shown in Figure 2. The UT-LPBF specimen (red curves in Figure 2) tested in air at $3.15 \times 10^{-6} \text{ s}^{-1}$ showed a very pronounced plastic region achieving 1018 MPa of ultimate stress and 32% of strain to failure. The tests in SOW were carried out at the same cathodic polarisation, -1.1 V vs. SCE, and had the same duration (about 16 h), but with two different strain rates: the first at $3.15 \times 10^{-6} \text{ s}^{-1}$ and the second at $3.15 \times 10^{-5} \text{ s}^{-1}$; in this last case the specimen was pre-charged with hydrogen before starting the tensile test. The cathodic polarised specimen tested at the lower strain rate presented a reduction of the total strain with respect to the specimen tested in air, achieving a value equal to 25%, the specimen pre-charged with hydrogen showed less reduction of ductility (26%). The heat treatment (blue curves in Figure 2) decreased the yield and maximum stress of all specimens, and increased the ductility, which in air was 61% of total strain. The differences between the reduction of ductility with respect to air are more evident in these specimens (LPBF-HT): the specimens cathodically polarised in SOW and strained at $3.15 \times 10^{-5} \text{ s}^{-1}$ presented a total elongation of 22%, whereas the pre-charged specimen showed a total strain of 50%. The reduction of area values are in agreement with the total elongation values, as summarized in Table 3.

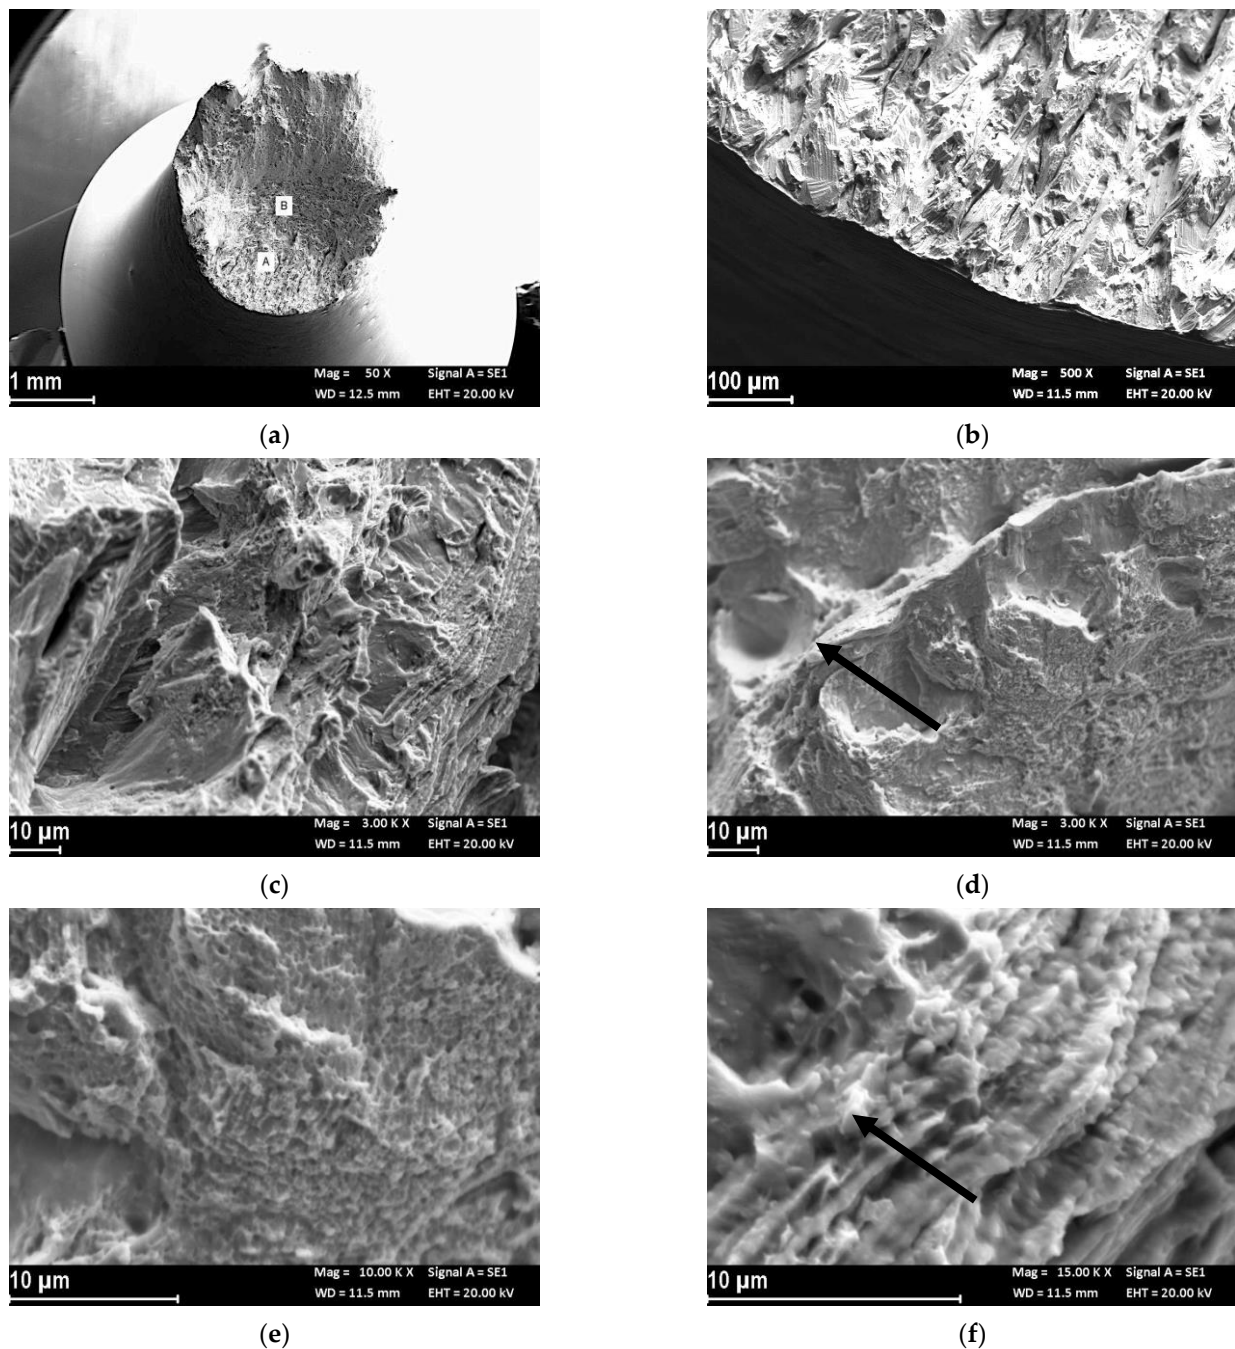
Figure 4. Secondary electron images of the fracture surface of UT-LPBF specimen after the SSRT test at strain rate $3.15 \times 10^{-6} \text{ s}^{-1}$ in SOW and cathodic polarization at -1.1 V vs. Ag/AgCl : (a) macro image; (b) close-up of the trigger zone (zone A in (a)) with brittle morphology; (c) close-up of (b) in which is evident a quasi-cleavage growth, (d) close-up of (b) in which is evident the separation of the melt pool (arrow) and presence of dimples in the upper melt pool; (e) close-up of the center of the specimen (zone B in (a)), presence of dimples and brittle zone; (f) close-up at higher magnification of (e) in which are evident the presence of intermetallic precipitates.

Figure 4a reports the macro image of the UT-LPBF specimen after the test in SOW and cathodic polarization of −1.1 V vs. Ag/AgCl. The specimen still showed plastic deformation, as can be seen from the reduction of area percentage shown in Table 3, but the fracture surface had a flat trigger area (zone A of Figure 4a), which extended to the center of the specimen (zone B of Figure 4a) and the final break was due to sliding by shearing. The trigger zone had a quasi-cleavage aspect (Figure 4b), which is typical of hydrogen embrittlement phenomena. The higher magnification details (Figure 4c) show the alternation of flat areas and small dimples. Microfractures were evident at the separations of the fusion wells, which changed the fracture propagation (Figure 4d). The fracture surface at the center of the specimen (zone B of Figure 4a) was mixed, with brittle area interspersed with small dimples (Figure 4e). The high-magnification image shows the presence of small intermetallic precipitates on the flat facets (Figure 4f).

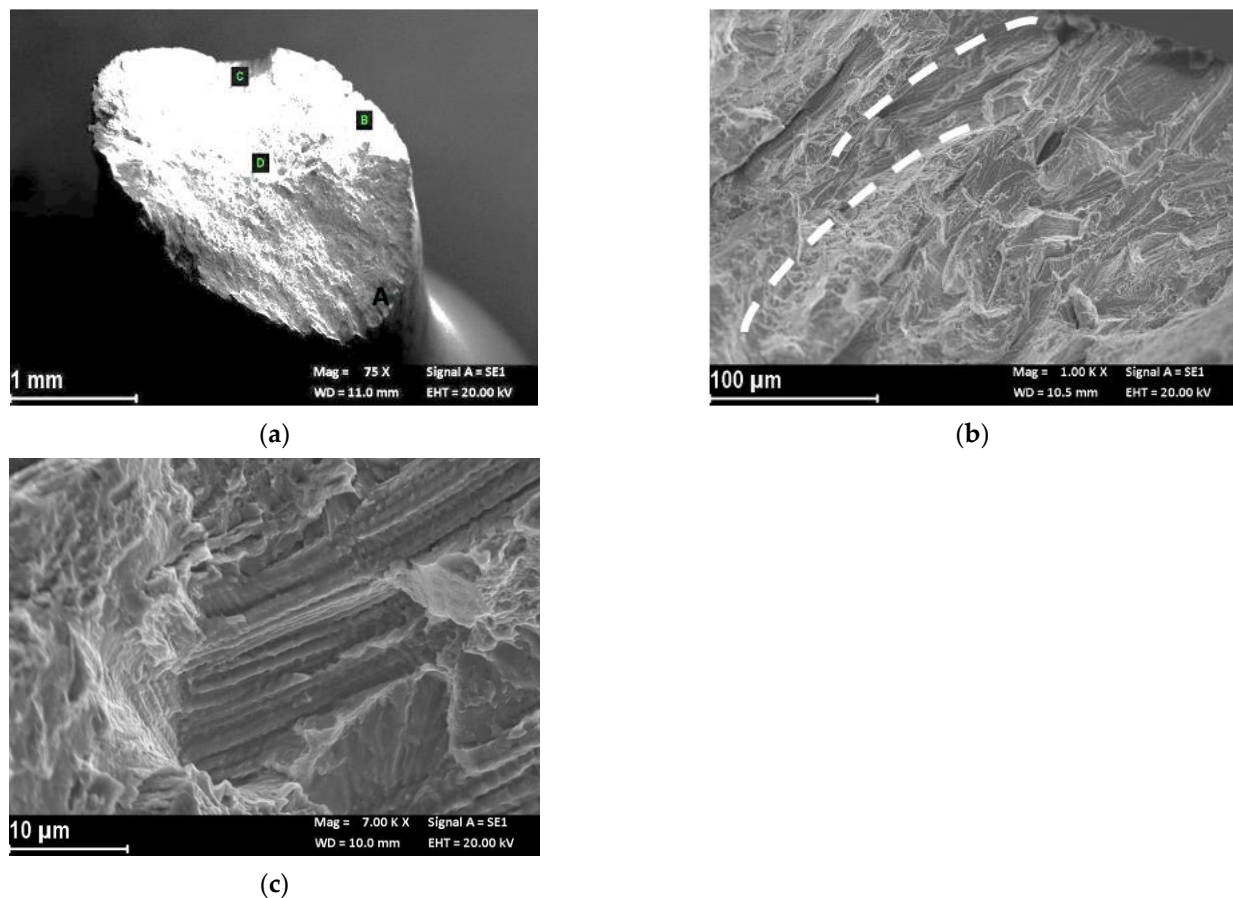
Figure 5. Fractographic analysis of the UT-LPBF specimen after the SSRT test at strain rate $3.15 \times 10^{-5} \text{ s}^{-1}$ in SOW and cathodic polarization at -1.1 V vs. Ag/AgCl after 16 h of hydrogen pre-charging: (a) macro image; (b) close-up of zone A, and (c) a similar morphology is observed in zone C; close-up of zone B; zone D in (a) is fully ductile.

Figure 5a shows the macro image of the fracture surface of the UT-LPBF specimen pre-charged with hydrogen for 16 h and then strained at $3.15 \times 10^{-5} \text{ s}^{-1}$. The fracture surface had some small trigger areas with a morphology typical of hydrogen embrittlement (zone A, B and C of Figure 5a; the close-up of zone A is shown in Figure 5b, the close-up of zone B is shown in Figure 5c), while the central area had a mixed fracture consisting of numerous dimples, small brittle facets and rare areas of quasi-cleavage. The final breakage of the specimen occurred by sharing. The value of the normalized reduction of area was very similar to that obtained in the previous case. At high magnification for areas A (Figure 5b), B (Figure 5c) and C of the specimen, a morphology similar to that observed in Figure 4 could be noted, with many brittle facets arranged perpendicularly to the direction of propagation of the fracture (along the dendritic growth) that occasionally jumped on a different plane, and a separation of the border of the melting pool (dotted line in Figure 5b).

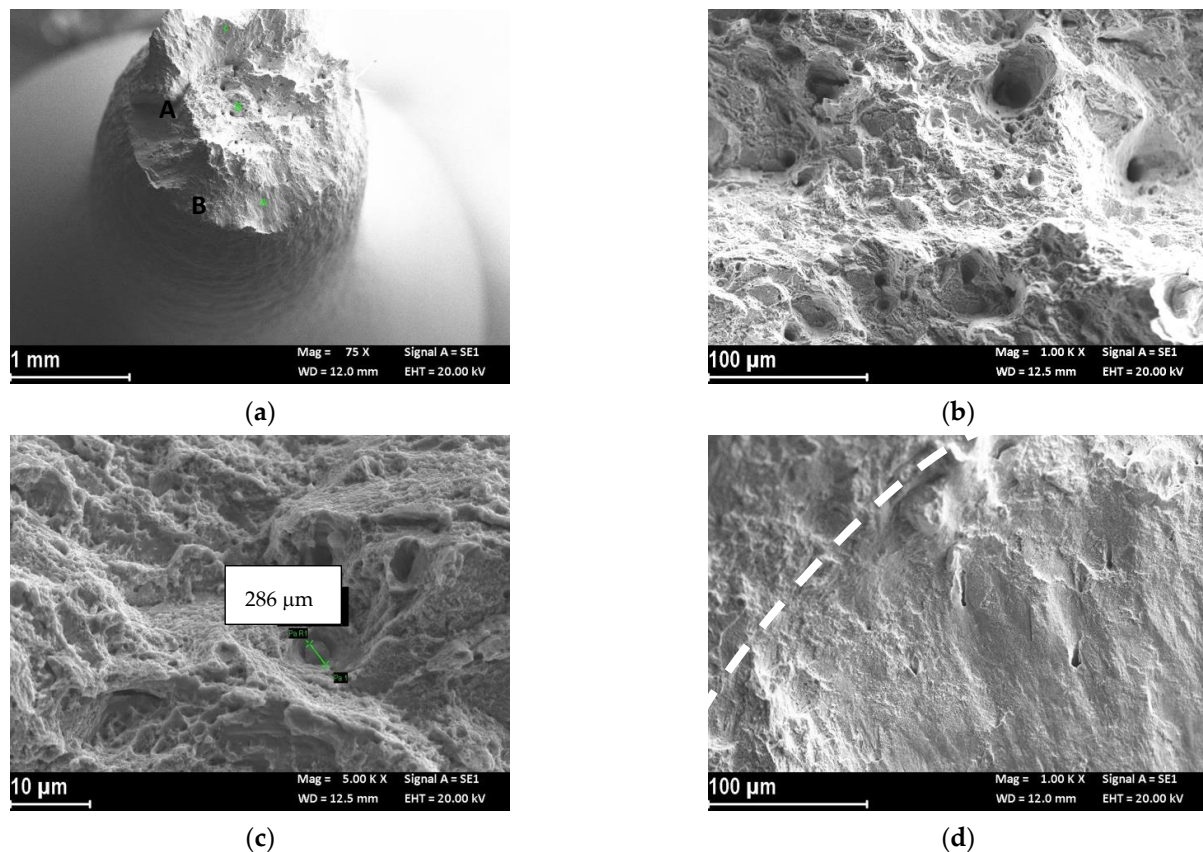
Figure 6. Fractographic analysis of the HT-LPBF specimen after the SSRT test in air: (a) macro image; (b) close up of the center of the specimen (zone A in (a)) with presence of dimples; (c) close-up of a large precipitate in (b); (d) close-up of the border of the specimen (zone B in (a)) in which is evident the change of fracture growth in the corresponding edge of the melt pool.

Figure 6a shows the fracture surface of the heat-treated specimens tested in air. The fracture surface had a typical cup and cone shape with a morphology in the center characterized by dimples of very variable dimensions (Figure 6b). Larger dimples were sometimes associated with large-sized precipitates (Figure 6c). The final fracture, also in this case, occurred by sliding by sharing (Figure 6d), with separations between the melt pools (dotted line in Figure 6d).

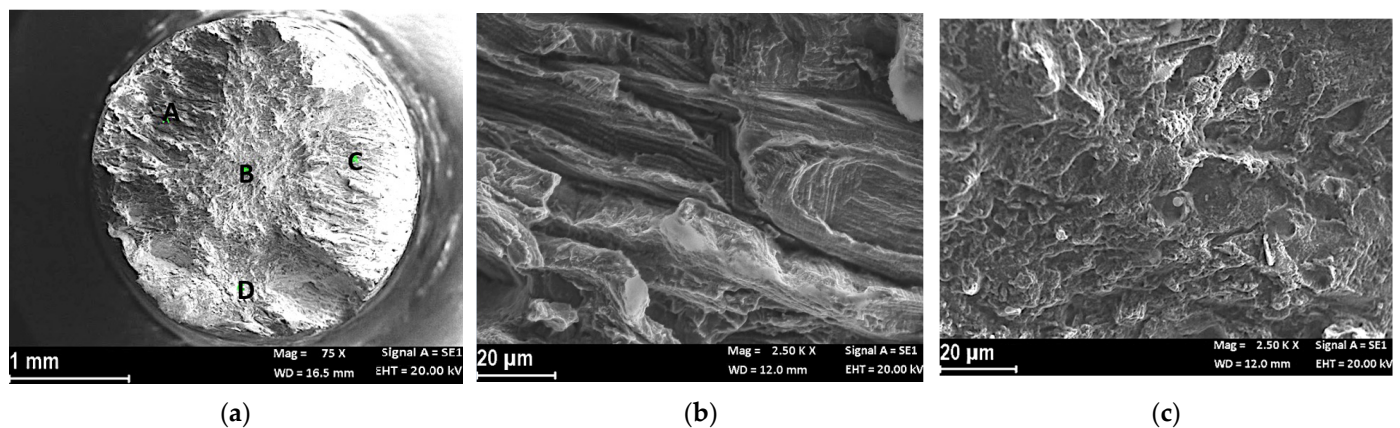
Figure 7. Fractographic analysis of the HT-LPBF specimen after the SSRT test at strain rate $3.15 \times 10^{-6} \text{ s}^{-1}$ in SOW and cathodic polarization at -1.1 V vs. Ag/AgCl : (a) macro image; (b) close-up of the trigger of the fracture (zone A of (a))—zone C has the same morphology of zone A; (c) close-up of the center of the specimen (zone B of (a))—a similar morphology is present in zone D of (a)).

The fracture surface of the heat-treated specimen at the end of the SSRT test with strain rate $3.15 \times 10^{-6} \text{ s}^{-1}$ cathodically polarized at -1.1 V vs. Ag/AgCl in SOW was totally flat (Figure 7a); there were two large trigger zones by hydrogen embrittlement (denoted with A in the Figure 7a) with a morphology similar to the UT specimens (Figure 7b), with flat facets arranged in a radial direction, separated by longitudinal microfractures and flat areas of cleavage. Even the center of the specimen appeared with a quasi-cleavage morphology (areas B and C—close-up in Figure 7c), with a sporadic presence of small dimples.

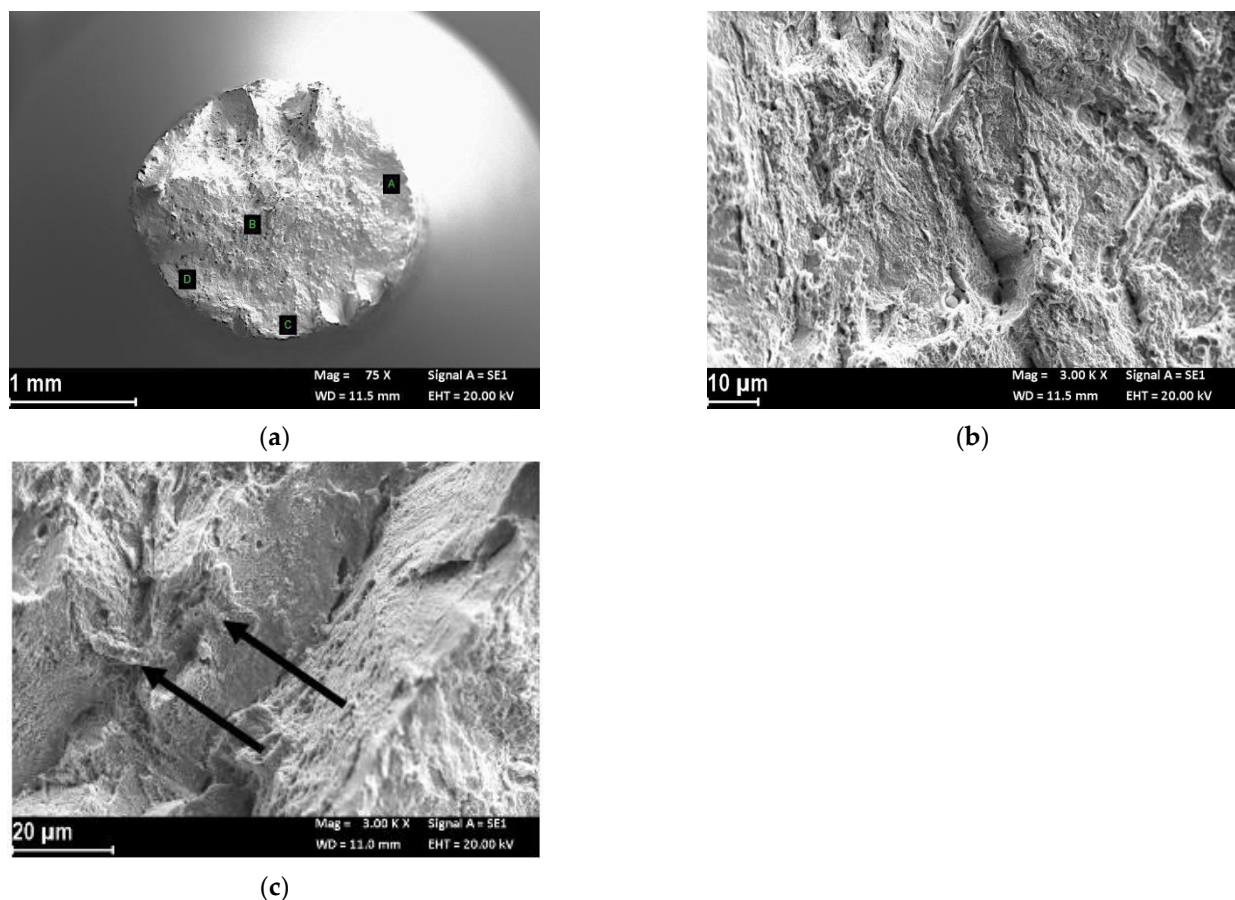
Figure 8. Fractographic analysis of the HT-LPBF specimen after the SSRT test at strain rate $3.15 \times 10^{-5} \text{ s}^{-1}$ in SOW and cathodic polarization at -1.1 V vs. Ag/AgCl after 16 h of hydrogen pre-charging: (a) macro image; (b) close up of the trigger of the fracture (zone A in (a)); (c) close-up of the center of the specimen (zone B in (a)), the arrows indicate second phases.

Finally, Figure 8a shows the fracture surface of the specimen preloaded with hydrogen for 16 h and then subjected to an SSRT test at a strain rate of $3.15 \times 10^{-5} \text{ s}^{-1}$. Contrary to the previous case, the fracture surface showed necking, with small triggers of HE on the lateral surface (zones C and D of Figure 8a) with a mixed morphology with dimples and small areas of quasi-cleavage (Figure 8b). Conversely, the center of the specimen displayed mainly small dimples, but with separations along the longitudinal axis of quasi-cleavage (Figure 8c).
