Seismic analysis of medical equipment in Ospedale Mauriziano (Torino): a resilience-based approach

XIX ANIDIS Conference, Seismic Engineering in Italy

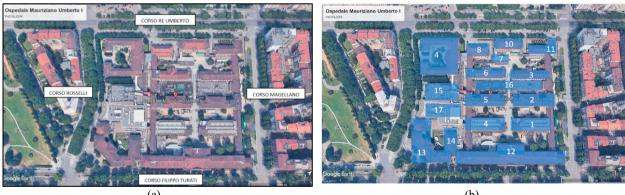
Fig. 1. Ospedale Mauriziano "Umberto I", Torino, Italy: (a) aerial view of the hospital complex; (b) denomination of the buildings (pavilions) that form the hospital complex, the Emergency Department is in Pavilion 17.

The Emergency Department of the hospital is housed in the building named Pavilion 17 (Figure 1(b)), built in 1996 and subsequently extended in 2010. The supporting structure of the building is a 4 storeys reinforced concrete frame, the floor system is given by reinforced concrete uniform slabs with orthotropic behaviour. Regularity in plan and in elevation and an in-plane diaphragm behaviour of the floor slabs are assumed in the seismic analyses.
