Review on the Experimental Characterization of Fracture in Active Material for Lithium-Ion Batteries

Review on the Experimental Characterization of Fracture in Active Material for Lithium-Ion Batteries / Pistorio, Francesca; Clerici, Davide; Mocera, Francesco; Soma, Aurelio. - In: ENERGIES. - ISSN 1996-1073. - 15:23(2022), p. 9168. [10.3390/en15239168]

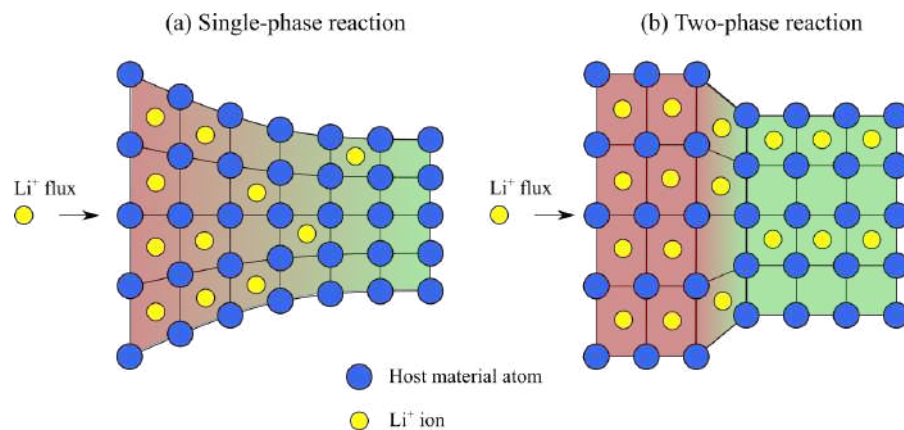
Figure 1. Mechanical stress resulting from inhomogeneous concentration due to (a) single phase-reaction and (b) phase transition.

Then, the inhomogeneous lithium concentration within the particle causes differential deformation of the lattice structure, leading to diffusion-induced stress (DIS) [8–13,21]. Furthermore, some materials show a two-phase behavior, i.e., two phases with a different lithium content coexist in the same particle, causing a significant strain mismatch at the interface between them, and thus stress, as illustrated in Figure 1b.

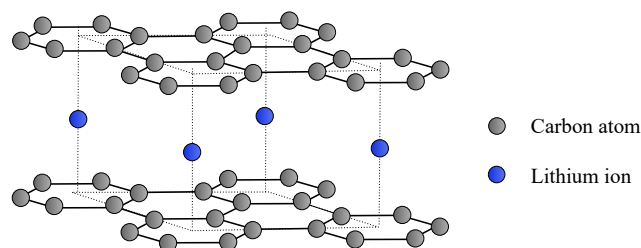
Figure 2. Crystalline structure of lithiated graphite. Lithium ions are depicted in blue and intercalate between the graphene planes. Carbon atoms are depicted in gray.

The structure of graphite is characterized by a stacking sequence of graphene layers, where carbon atoms are arranged in a hexagonal pattern. Lithium intercalates in the graphite structure occupying the interstitial defects between the graphene planes, as shown in Figure 2.

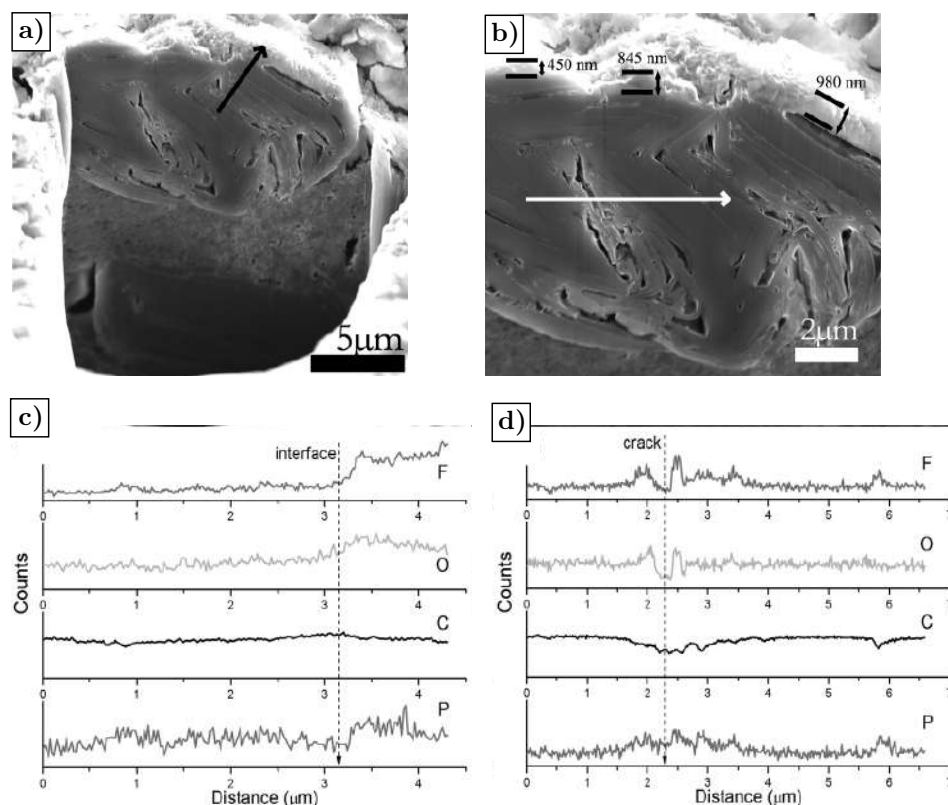
Figure 4. (a,b) Secondary electron FIB images of the cross-section of a graphite particle. (c,d) The elemental line scan analysis along the black and white lines in panels (a,b), respectively. Adapted with permission by American Chemical Society from [46], Copyright 2005.

Zhang et al. [46] used element scan analysis (ELSA) to identify the location and composition of the SEI layer. According to Figure 4, ELSA shows peaks in F, O and P elements when SEI is encountered, as it is composed of fluorides (LiF), Li-alkyl carbonates ($\text{CH}_3\text{OCO}_2\text{Li}$, $(\text{CH}_3\text{OCO}_2\text{Li})_2$) from EC/DMC decomposition and electrolytes (LiPF_6). Then, they observed the SEI layer both on the particle surface and at the core, confirming the presence of surface and internal cracks.

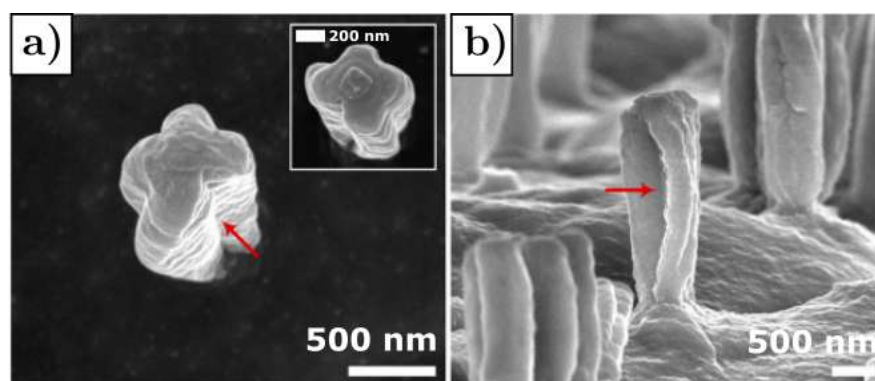
Figure 5. SEM images showing cracks in silicon nanowire, pointed out by the red arrow. (a) Top view and (b) Side view. Reprinted with permission from [54], Copyright 2012.

Concerning nanowires, they are characterized by a continuous 1D electronic pathway that facilitates efficient charge transport, as compared to nanoparticles [48]. Furthermore, they can grow directly from the current collector, making binder and conductive agents unnecessary but limiting the lithium flux and current rate as a consequence. Several studies observed an anisotropic expansion during the alloying process, which is greater in the [110] direction, making the cross-section elliptical [52,53]. As a result, intense tensile hoop stress arises along the shorter axis of the ellipse, causing severe crack propagation [54], as confirmed by the SEM images in Figure 5.

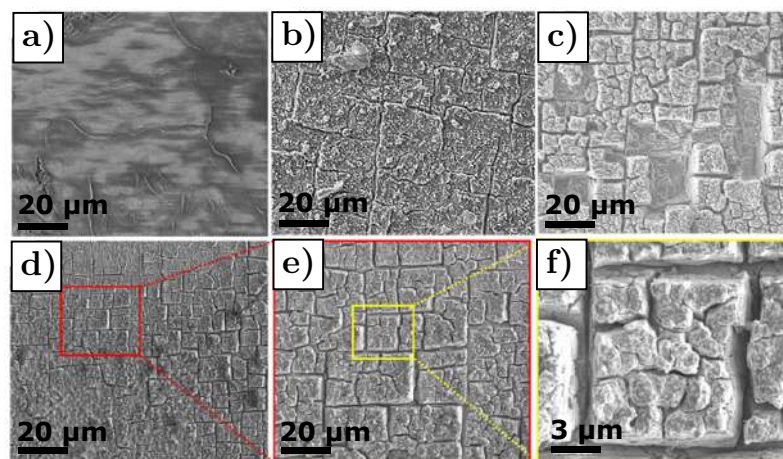
Figure 6. Crack growth as a function of lithiation cycles in thin film after (a) 3, (b) 8, and (c) 50 cycles. (d–f) Detail of crack pattern after 30 lithiation cycles. Reprinted with permission by Nature Publishing Group from [55], Copyright 2016.

The lithiation of thin film electrodes causes strains leading to the curvature of the film, which ultimately leads to surface cracks, resembling the ones occurring in drying media, as shown in Figure 6.

A particular crack pattern arises on the surface of the silicon thin film as a result of lithiation cycles, as observed with SEM [55,57]. Shi et al. [55] showed that the crack density is a function of the number of cycles, as shown in Figure 6. In addition, Li et al. [57] reported that crack density depends on the thickness of the film as well, and a critical size below which cracks do not propagate exists.

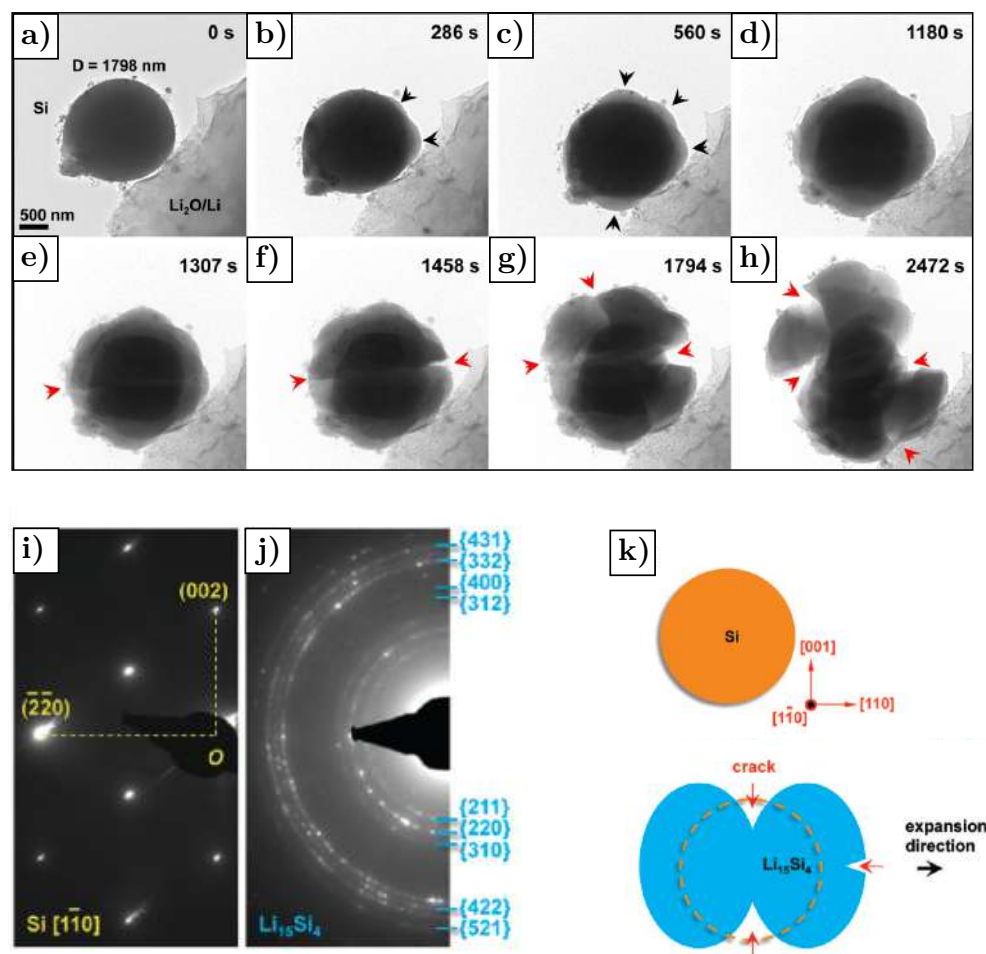
Figure 8. (a–h) Crack growth during single lithiation cycle in silicon nano-particle. The black arrows mark the bumps due to anisotropic lithiation of Si before crack formation, whereas the red arrows mark the cracks. (i,j) Electron diffraction pattern showing the silicon phase transformation from (i) crystalline structure (Si) to (j) polycrystalline structure ($\text{Li}_{15}\text{Si}_4$). (k) Anisotropic swelling in silicon nanoparticle favoring cracks in [110] direction. Reprinted with permission by American Chemical Society from [51], Copyright 2012.

Concerning silicon nano-particles, crack growth within the same particle was observed during a single lithiation, as reported in Figure 8a–h [51]. At the end of lithiation, the particle is heavily damaged, and cracks propagating along the [110] direction affect the structural stability considerably. Furthermore, the electron diffraction pattern (EDP) analysis reported in Figure 8i,j shows the phase transformation from crystalline (Si) (Figure 8i), to polycrystalline ($\text{Li}_{15}\text{Si}_4$) (Figure 8j) due to the lithiation process. Figure 8k explains the anisotropic swelling characteristic of silicon nano-particles, leading to cracks predominantly along the [110] direction [51,58].

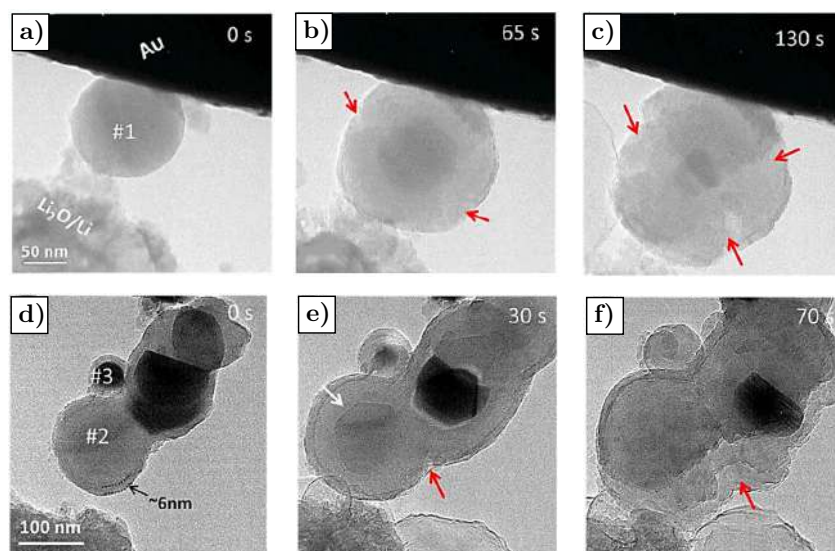
Figure 10. Lithiation of (a–c) uncoated silicon particle and (d–f) coated silicon particles. The time value depicted in the figure refers to the lithiation time. Reprinted with permission by Elsevier from [68], Copyright 2016.

Fractures were observed with TEM in carbon-coated silicon particles in some works [65,67,68]. Xu et al. [68] compared the lithiation of two sets of geometrically similar particles (130–150 nm), one with a 6 nm carbon coating and the other without coating. Few fractures were observed in the coated particles, depicted by the red arrows in Figure 10e,f. On the other hand, a greater number of fractures were observed in the uncoated particles, as confirmed by the red arrows in Figure 10a–c. During the lithiation of the coated particles, the coating thickness increases from 6 nm to 8 nm, because of the strong radial stress due to the silicon core expansion. Then, fractures are triggered in the coating thickness and they further propagate in the silicon core. These factors may explain the reason why fracture occurs in coated particles that are smaller than the critical fracture size, i.e., 150 nm as explained by Liu et al. [51].

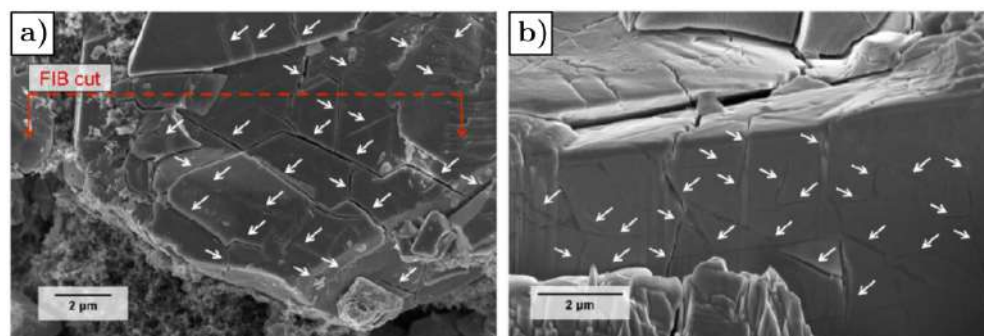
Figure 12. (a) Fracture in LMO particle after 16 deep discharge cycles with Jahn–Teller transformation and 51 cycles without Jahn–Teller transformation. (b) Internal view of LMO particle shown in (a) after FIB milling. White arrows point to the cracks. Reprinted with permission by Journal of The Electrochemical Society from [84], Copyright 2018.

McGrogan et al. [84] cycled the LMO electrode above Jahn–Teller transformation and milled the cycled electrode with FIB to study the internal cracking network, as shown in Figure 12a,b. The dense crack network, probably caused by Jahn–Teller transformation, allows the electrolyte to penetrate inside the particle, causing the dissolution of Mn^{2+} , as will be explained in Section 4.

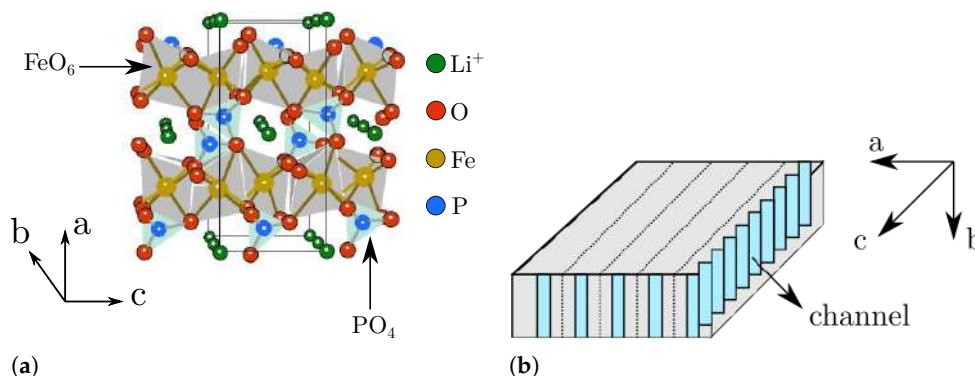
Figure 14. (a) Crystal structure of LFP. Reprinted with permission by Elsevier from [92], Copyright 2009. (b) Schematic illustration of lithium intercalation mechanism in LFP single crystal. Lithium ions diffuse along 1D channels in the b -direction, and channels are stacked in layers parallel to bc planes, indicated by the dotted lines.

LFP crystallizes in the olivine structure, consisting of FeO_6 octahedra and PO_4 tetrahedra, as shown in Figure 14a. The FeO_6 octahedra contact each other by sharing corners and forming layers in the bc planes. The FeO_6 layers are linked together by PO_4 tetrahedral units. Lithium ions are located in the interstitial voids of the framework, forming continuous linear chains along the c -axis in the alternate ac planes. In this structure, the most favorable lithium diffusion path is through channels aligned with the b -direction [91], as illustrated in Figure 14b.

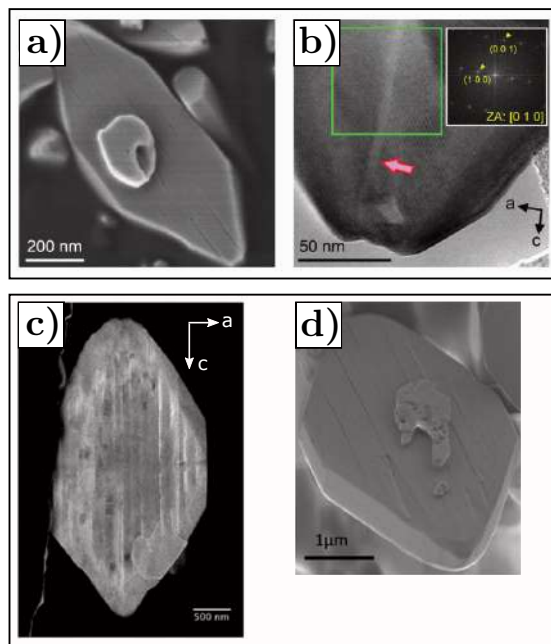
Figure 16. Top: Electron microscopy results for a micrometric plate-like LFP crystal subjected to partial chemical delithiation. (a) SEM image and (b) High-resolution transmission electron (HRTEM) image with the inset of the Fourier transform pattern obtained from the region marked with the green box. The red arrows indicate the crack running parallel to the c -axis. Reprinted with permission by American Chemical Society from [97], Copyright 2015. Bottom: SEM observations of partially delithiated $\text{Li}_{0.5}\text{PO}_4$ crystal. (c) SEM image and (d) STEM-HAADF image, showing cracks evenly spaced and oriented along the c -axis. Reprinted with permission by American Chemical Society from [96], Copyright 2013.

A similar mechanism, with the phase boundary oriented along the bc plane, was also supported by other experimental observations in ex-situ chemically delithiated LFP particles, as reported in [96,97] and illustrated in Figure 16a–d.

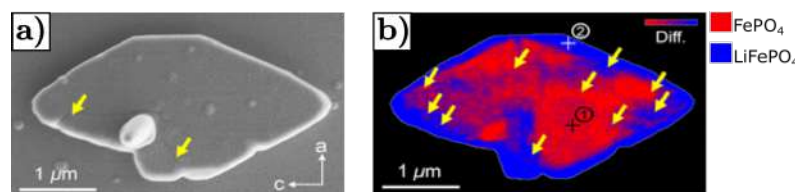
Figure 18. Relation between defects and phase distribution within micrometric LFP chemically delithiated plate-like crystal, with (a) SEM image and (b) Chemical phase distribution map. Reprinted with permission by American Chemical Society from [97], Copyright 2015.

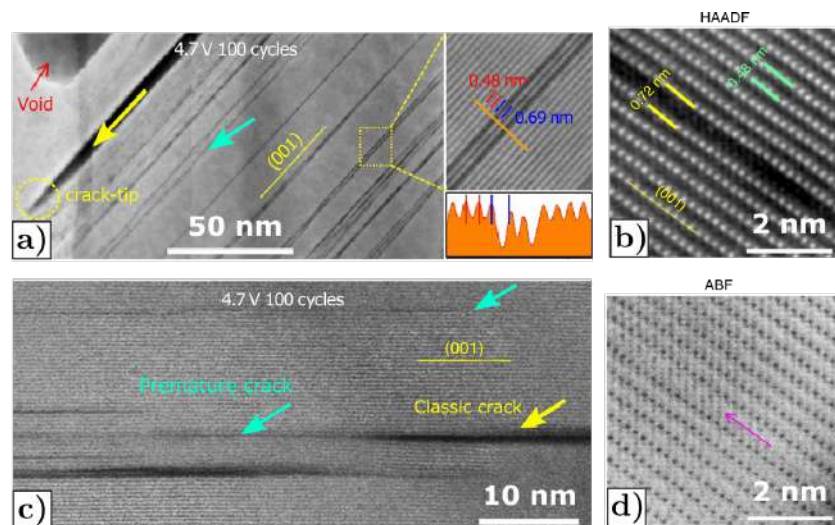
Figure 21. (a,c) HAADF images from cycled NMC333 cathode particle showing intragranular cracks along the (001) plane. The yellow and light blue arrows indicate classic and premature cracks, respectively. (b) HAADF and (d) ABF images along [010] axis of the premature crack showed in (a). Reprinted with permission from Springer Nature by [108], Copyright 2017.

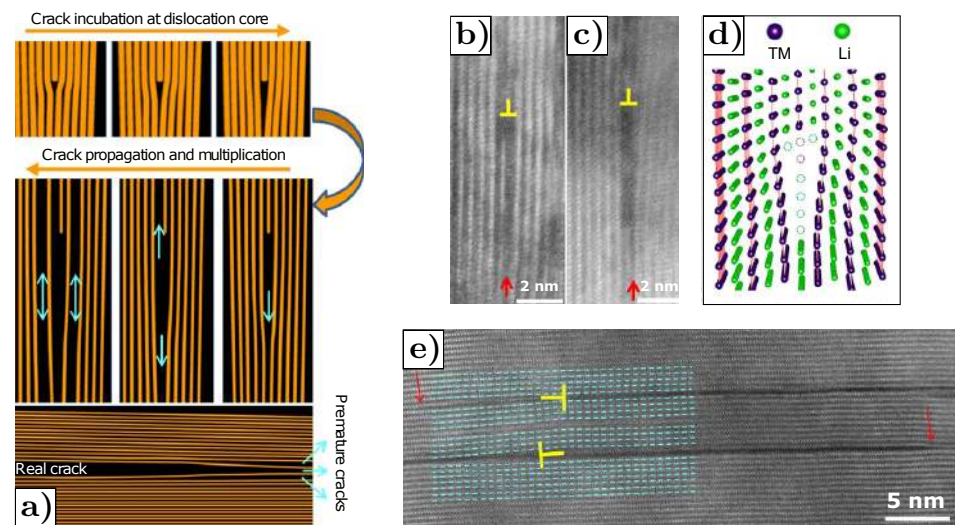
Figure 22. (a) Schematic diagrams of the dislocation-assisted crack incubation, propagation and multiplication process in NMC cathode particles. (b,c) Nucleation of premature cracks at the dislocation core in NMC333 cycled particles, also schematized in (d). (e) Edge dislocations associated with intragranular cracks in cycled NMC333 particles. Crack tip is indicated with the red arrows. Reprinted with permission from Springer Nature by [108], Copyright 2017.

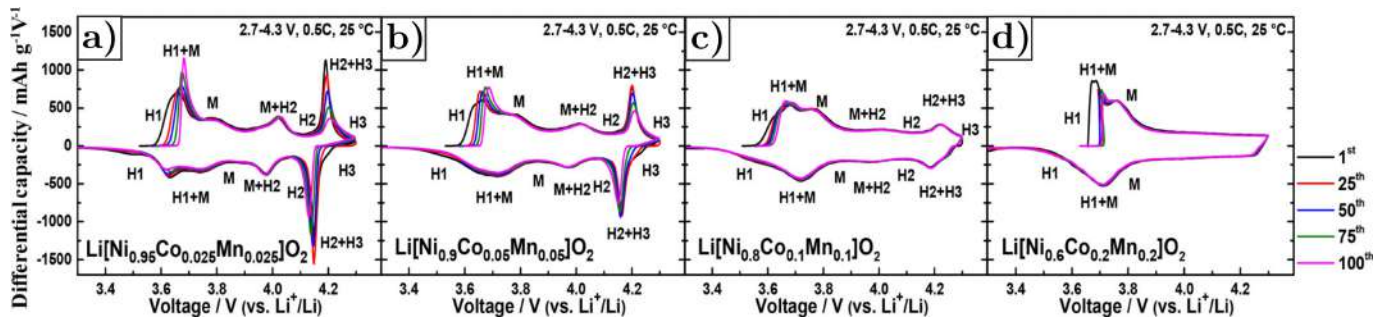
Figure 24. Differential capacity curves of $\text{Li}[\text{Ni}_x\text{Co}_y\text{Mn}_{1-x-y}]\text{O}_2$ with different Ni content: (a) $x = 0.95$, (b) $x = 0.9$, (c) $x = 0.8$, and (d) $x = 0.6$ as a function of the number of cycles. Reprinted with permission of [106], ©2018 American Chemical Society.

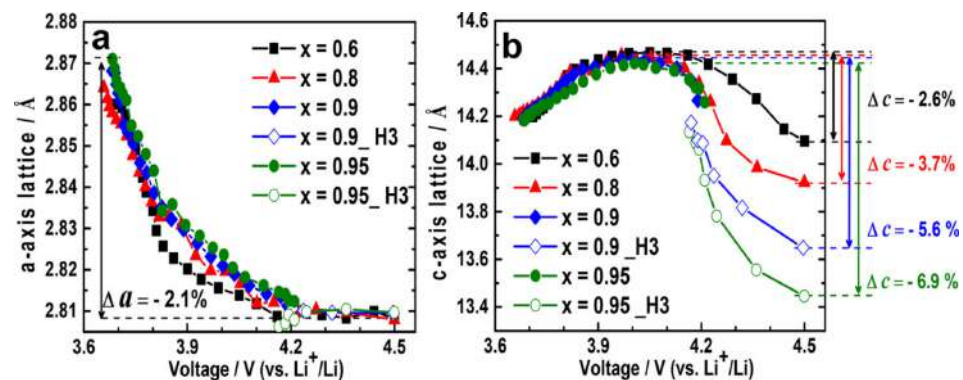
Figure 25. (a) a -axis and (b) c -axis lattice parameters of $\text{Li}[\text{Ni}_x\text{Co}_y\text{Mn}_{1-x-y}]\text{O}_2$ as a function of the Ni content ($x = 0.95$, $x = 0.9$, $x = 0.8$ and $x = 0.6$) and the cell voltage. Reprinted with permission of [106], ©2018 American Chemical Society.

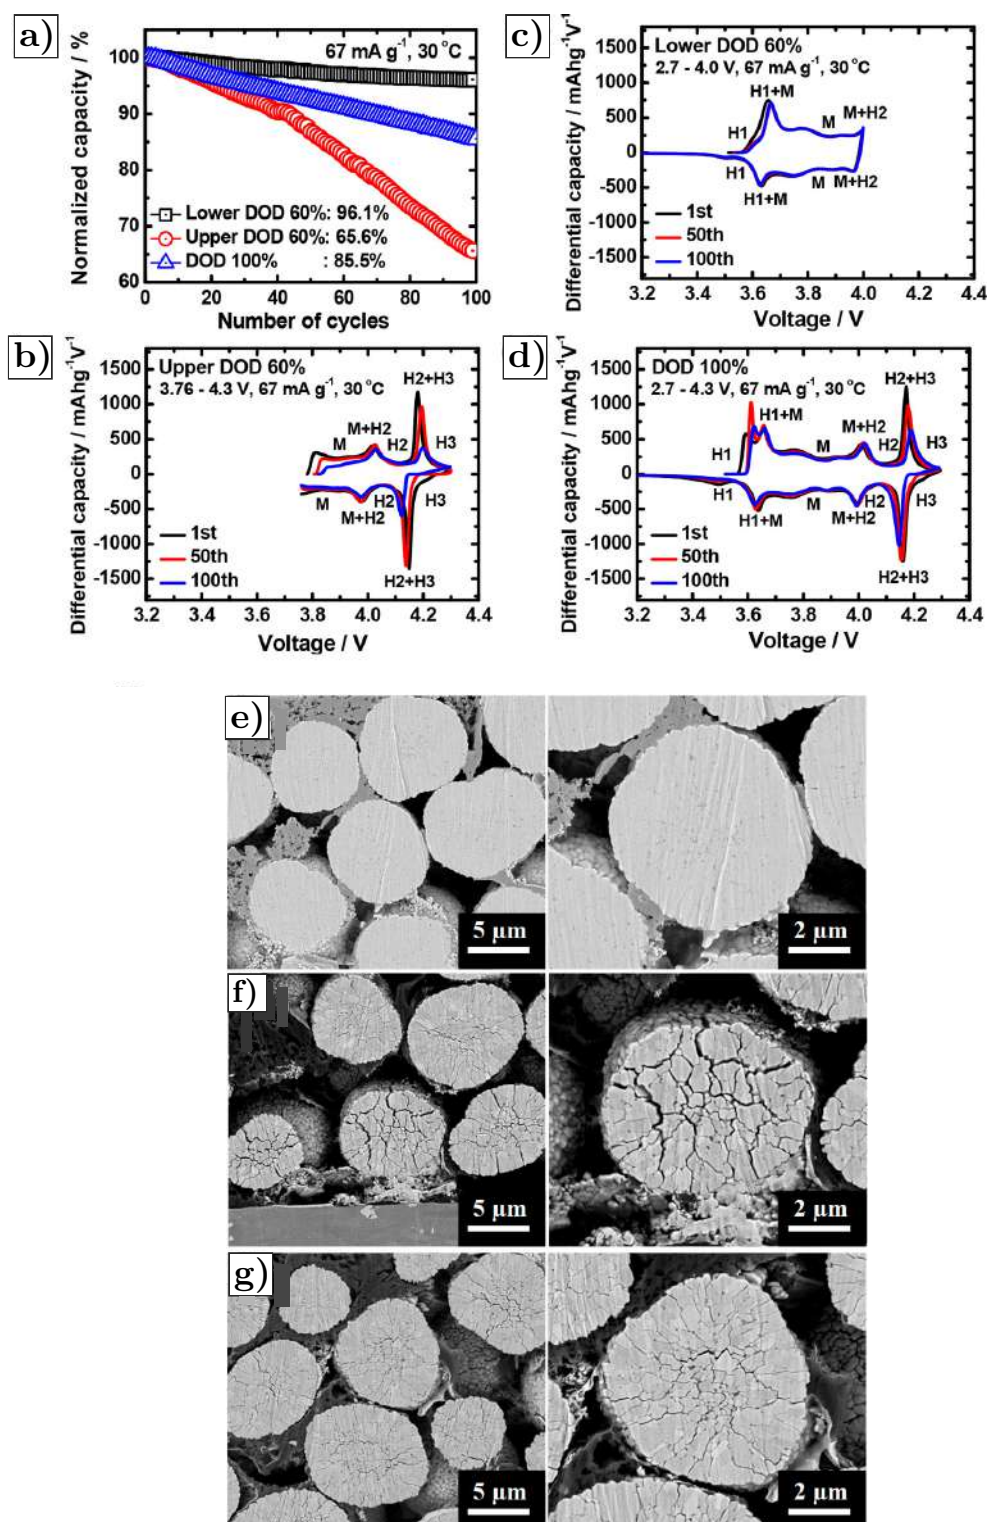
Figure 27. (a) Capacity decay of NCA95 during cycling at different DOD and initial SOC values. Derivative of charge-discharge curves of NCA95 cycled (b) from SOC 40 to 100% (3.76–4.3 V) (c) from SOC 0 to 60%, (d) from SOC 0 to 100%. Cross-sectional SEM images of NCA95 particles cycled for 100 cycles (e) from SOC 0 to 60%, (f) from SOC 40 to 100% and (g) from SOC 0 to 100%. Reprinted with permission by American Chemical Society from [132], Copyright 2019.

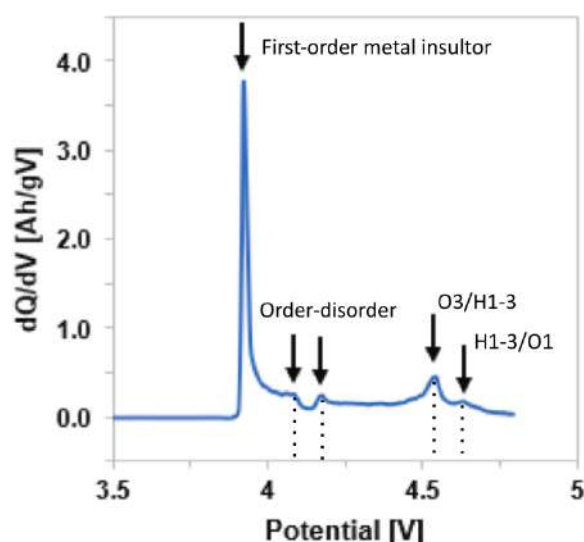
Figure 28. Differential capacity curve of a fresh LCO half-cell charged to 4.8 V at 0.05C. Most relevant phase transitions are highlighted by the black arrows. Adapted with permission by Elsevier from [137], Copyright 2022.

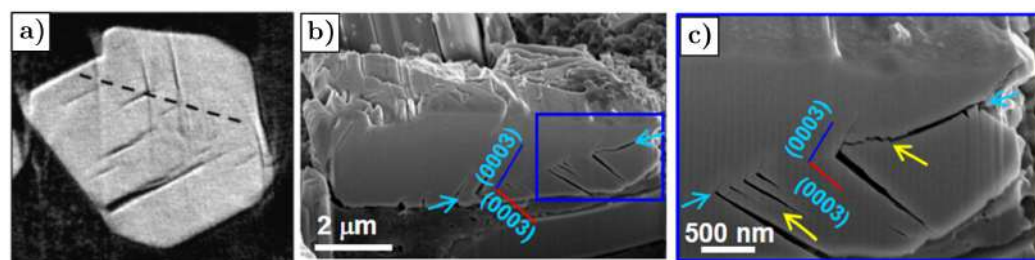
Figure 31. Cracking along the twin boundary. (a) Reconstructed image from X-ray nano-tomography reprinted from [137]. (b,c) SEM images of a cross-section of LCO particles (milled with FIB), showing cracks originating from twin boundary and their planes direction. Reprinted with permission by Elsevier from [136], Copyright 2020.

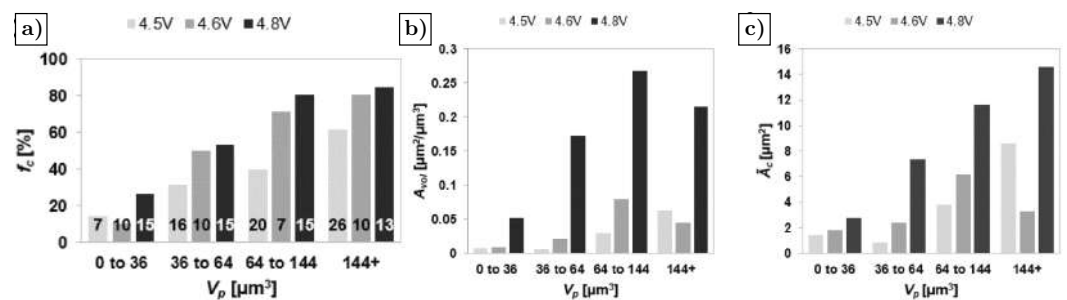
Figure 32. (a) The percentage of LCO particles within a given volume range that contains cracks after a single charge cycle to a given cutoff voltage. (b) The crack area per unit of volume for particles within a given volume range after a single charge cycle to a given cutoff voltage. (c) The average individual crack area (proportional to crack length) for particles within a given volume range after a single charge cycle to a given cutoff voltage. Reprinted with permission by Elsevier from [137], Copyright 2022.

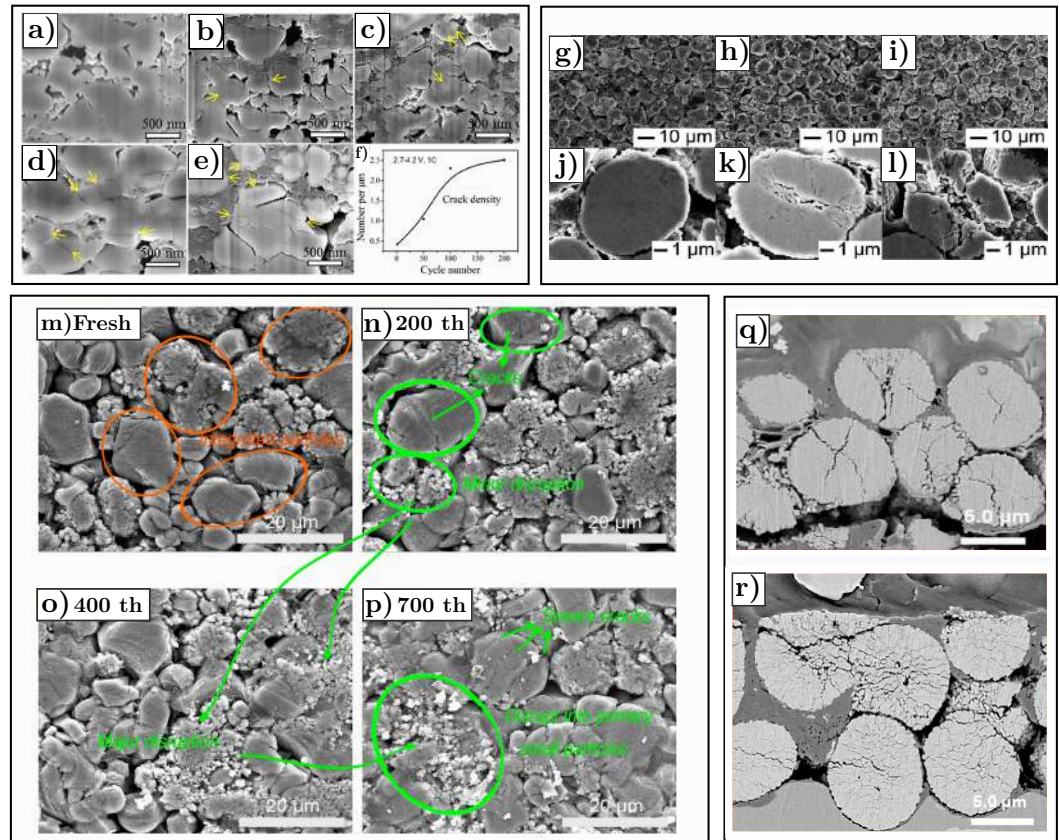
Figure 33. (a–f) Cross sectional SEM images of cracks evolution in LiFePO_4 cathode cycled at 1C. Samples (a) before cycling, (b) after 1 cycle, (c) after 50 cycles, (d) after 100 cycles, (e) after 200 cycles, and (f) crack density as a function of the cycle numbers. Reprinted with permission by American Chemical Society from [99], Copyright 2018. Top view and cross-sectional SEM images of the NCM851005 cathode (g,j) before cycling, (h,k) after 100 cycles and (i,l) after 500 cycles at 1C. Reprinted with permission by American Chemical Society from [154], Copyright 2019. (m–p) FESEM images of hervester LCO/NMC532 cathode electrodes at various cycle numbers. Reprinted with permission by MDPI from [153], Copyright 2017. (q,r) Cross-sectional SEM images of $\text{Li}[\text{Ni}_{0.90}\text{Co}_{0.05}\text{Mn}_{0.05}]\text{O}_2$ at first cycle and after 1000 cycles, respectively. Reprinted with permission by American Chemical Society from [152], Copyright 2019.

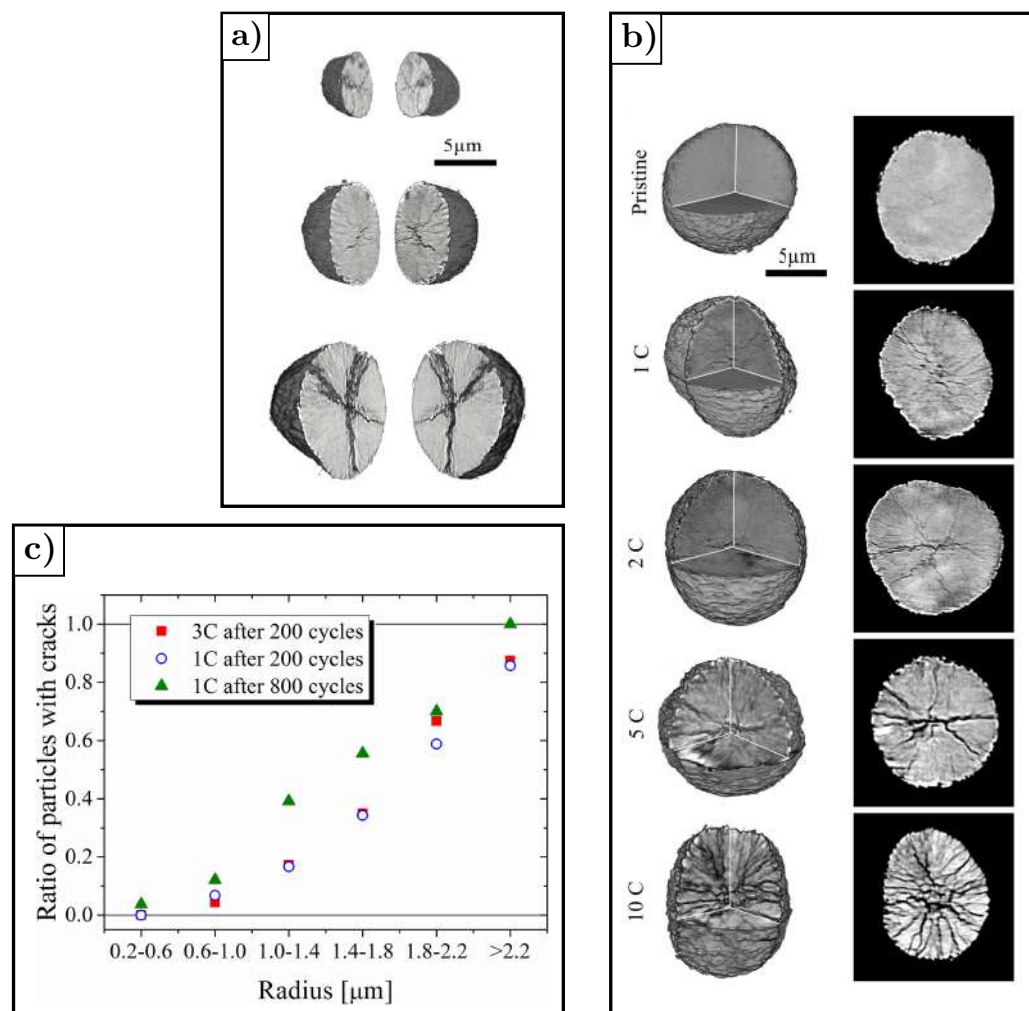
Figure 34. (a) Fracture in NMC particles of different size, after 50 cycles at 10C. (b) Fracture in NMC particles after 50 cycles at 1C, 2C, 3C, 5C and 10C. Reprinted with permission by Elsevier from [116], Copyright 2018. (c) Fracture occurrence in $\text{LiMn}_{1.95}\text{Al}_{0.05}\text{O}_4$ as a function of current rates and particles radius. Reprinted with permission by Elsevier from [155], Copyright 2017.

Cracks are found more frequently in larger particles than in smaller ones (Figure 34a,c).

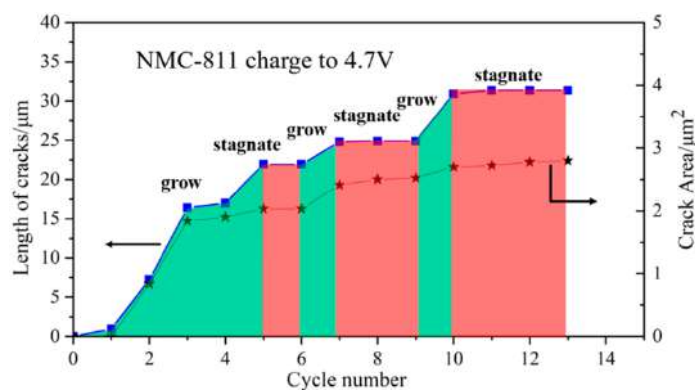
Figure 35. Measures of crack length and area as a function of number of cycles with in-situ SEM. The material is NMC811 cycled with a lithium counter electrode at 0.5C and 2.7 V–4.7 V. Reprinted with permission by Elsevier from [157], Copyright 2021.
