Review on the Experimental Characterization of Fracture in Active Material for Lithium-Ion Batteries

Review on the Experimental Characterization of Fracture in Active Material for Lithium-Ion Batteries / Pistorio, F., Clerici, D., Mocera, F., Soma, A.. - In: ENERGIES. - ISSN 1996-1073. - 15:23(2022), p. 9168. [10.3390/en15239168]

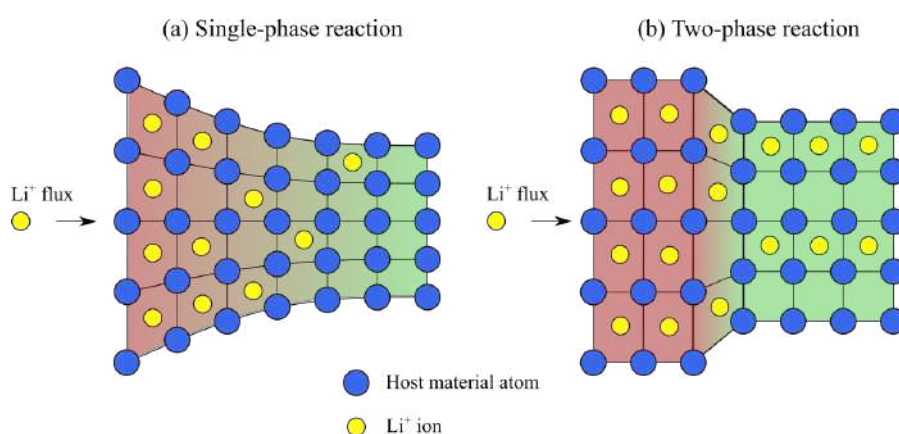
Figure 1. Mechanical stress resulting from inhomogeneous concentration due to (a) single phase-reaction and (b) phase transition.

Then, the inhomogeneous lithium concentration within the particle causes differential deformation of the lattice structure, leading to diffusion-induced stress (DIS) [8–13,21]. Furthermore, some materials show a two-phase behavior, i.e., two phases with a different lithium content coexist in the same particle, causing a significant strain mismatch at the interface between them, and thus stress, as illustrated in Figure 1b.

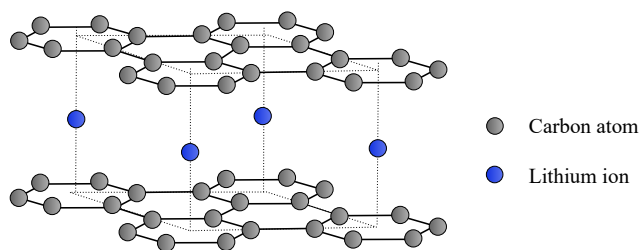
Figure 2. Crystalline structure of lithiated graphite. Lithium ions are depicted in blue and intercalate between the graphene planes. Carbon atoms are depicted in gray.

The structure of graphite is characterized by a stacking sequence of graphene layers, where carbon atoms are arranged in a hexagonal pattern. Lithium intercalates in the graphite structure occupying the interstitial defects between the graphene planes, as shown in Figure 2.

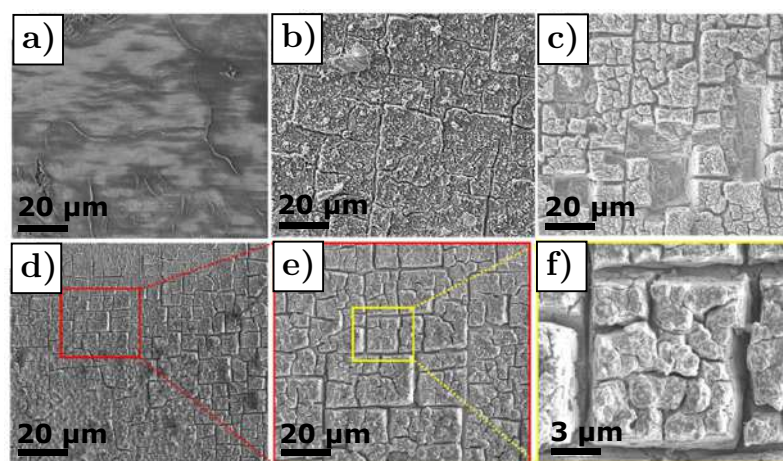
Figure 6. Crack growth as a function of lithiation cycles in thin film after (a) 3, (b) 8, and (c) 50 cycles. (d–f) Detail of crack pattern after 30 lithiation cycles. Reprinted with permission by Nature Publishing Group from [55], Copyright 2016.

The lithiation of thin film electrodes causes strains leading to the curvature of the film, which ultimately leads to surface cracks, resembling the ones occurring in drying media, as shown in Figure 6.

A particular crack pattern arises on the surface of the silicon thin film as a result of lithiation cycles, as observed with SEM [55,57]. Shi et al. [55] showed that the crack density is a function of the number of cycles, as shown in Figure 6. In addition, Li et al. [57] reported that crack density depends on the thickness of the film as well, and a critical size below which cracks do not propagate exists.

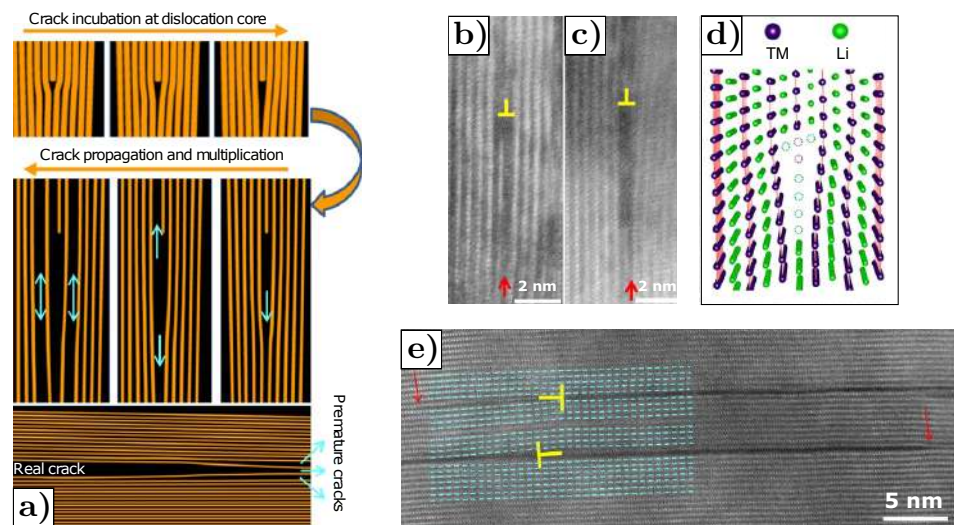
Figure 22. (a) Schematic diagrams of the dislocation-assisted crack incubation, propagation and multiplication process in NMC cathode particles. (b,c) Nucleation of premature cracks at the dislocation core in NMC333 cycled particles, also schematized in (d). (e) Edge dislocations associated with intragranular cracks in cycled NMC333 particles. Crack tip is indicated with the red arrows. Reprinted with permission from Springer Nature by [108], Copyright 2017.

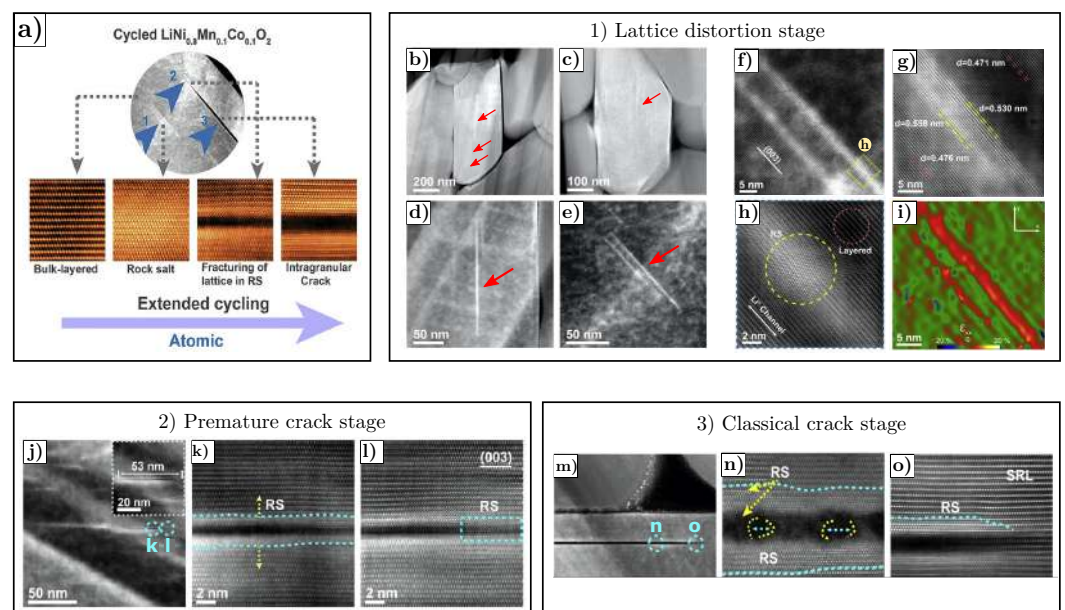
Figure 23. (a) Development process of intragranular cracks in NMC811: (b–i) Lattice distortion stage, (j–l) Premature crack stage and (m–o) Classical crack stage. STEM-HAADF images of cycled NMC811 particle in $\langle 010 \rangle$ zone projection, after (b–d) 50 cycles and (c–e) 20 cycles. The white lines appear with different length. (f) STEM-HAADF image of enlarged morphology of a white line shown in (a). (g) High-resolution STEM-HAADF image, showing the lattice distortion of the white line region. (h) Atomic-resolution STEM-HAADF image from the region marked by yellow dashed square box in (f), showing the detailed structure of the white line, with the formation of the rock-salt phase. (i) Strain map simulated by GPA due to lattice distortion. (j–l) Atomic-resolution STEM-HAADF images of premature intragranular crack in NMC811 particle after 50 cycles, showing the presence of the rock-salt phase both in the (k) partially cracked region and (l) uncracked tip. (m–o) Atomic-resolution STEM-HAADF images of mature intragranular crack in NMC811 particle after 100 cycles, showing the increase in the crack length along the (003) plane and in the rock-salt phase thickness. Reprinted with permission from Elsevier by [111], Copyright 2020.

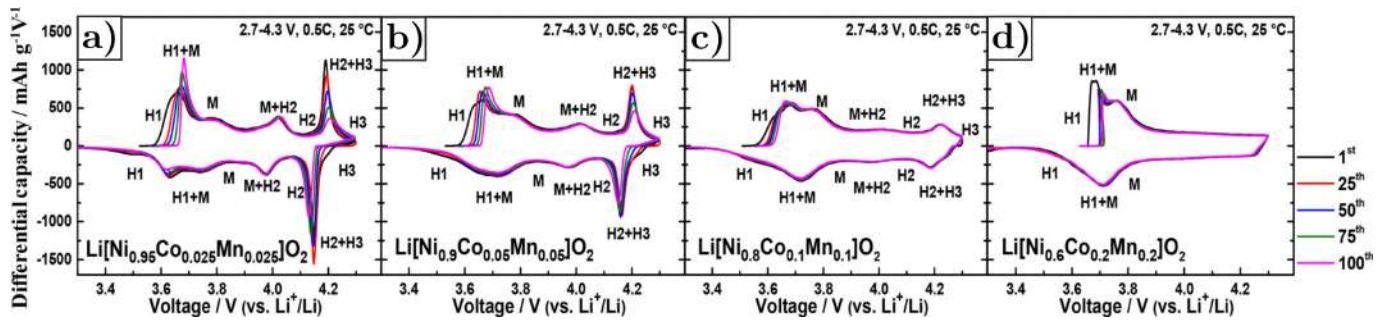
Figure 24. Differential capacity curves of $\text{Li}[\text{Ni}_x\text{Co}_y\text{Mn}_{1-x-y}]\text{O}_2$ with different Ni content: (a) $x = 0.95$, (b) $x = 0.9$, (c) $x = 0.8$, and (d) $x = 0.6$ as a function of the number of cycles. Reprinted with permission of [106], ©2018 American Chemical Society.

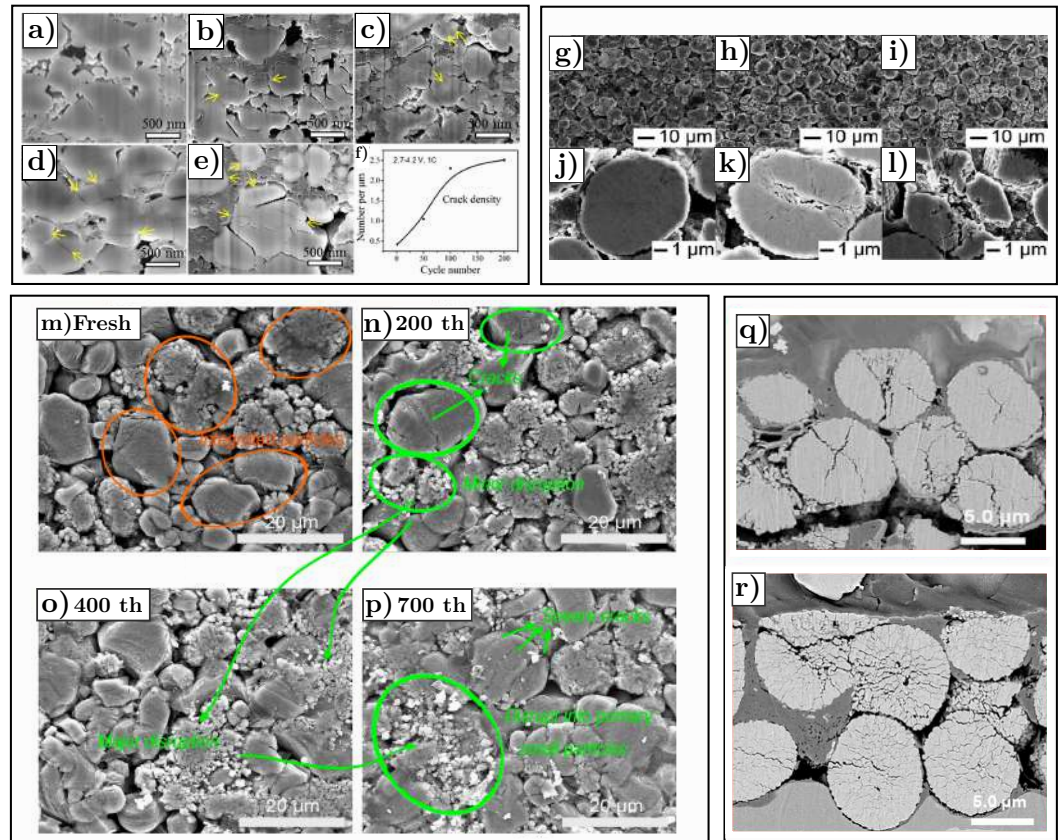
Figure 33. (a–f) Cross sectional SEM images of cracks evolution in LiFePO_4 cathode cycled at 1C. Samples (a) before cycling, (b) after 1 cycle, (c) after 50 cycles, (d) after 100 cycles, (e) after 200 cycles, and (f) crack density as a function of the cycle numbers. Reprinted with permission by American Chemical Society from [99], Copyright 2018. Top view and cross-sectional SEM images of the NCM851005 cathode (g,j) before cycling, (h,k) after 100 cycles and (i,l) after 500 cycles at 1C. Reprinted with permission by American Chemical Society from [154], Copyright 2019. (m–p) FESEM images of hervester LCO/NMC532 cathode electrodes at various cycle numbers. Reprinted with permission by MDPI from [153], Copyright 2017. (q,r) Cross-sectional SEM images of $\text{Li}[\text{Ni}_{0.90}\text{Co}_{0.05}\text{Mn}_{0.05}]\text{O}_2$ at first cycle and after 1000 cycles, respectively. Reprinted with permission by American Chemical Society from [152], Copyright 2019.
