Review on the Experimental Characterization of Fracture in Active Material for Lithium-Ion Batteries

Review on the Experimental Characterization of Fracture in Active Material for Lithium-Ion Batteries / Pistorio, Francesca; Clerici, Davide; Mocera, Francesco; Soma, Aurelio. - In: ENERGIES. - ISSN 1996-1073. - 15:23(2022), p. 9168. [10.3390/en15239168]

# Review on the Experimental Characterization of Fracture in Active Material for Lithium-Ion Batteries

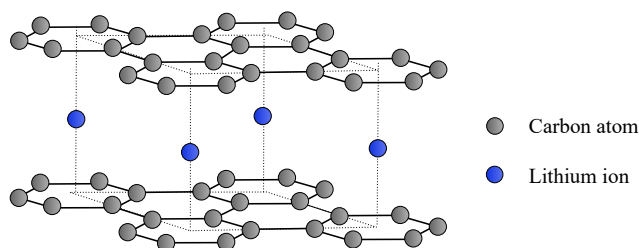
**Figure 2.** Crystalline structure of lithiated graphite. Lithium ions are depicted in blue and intercalate between the graphene planes. Carbon atoms are depicted in gray.

The structure of graphite is characterized by a stacking sequence of graphene layers, where carbon atoms are arranged in a hexagonal pattern. Lithium intercalates in the graphite structure occupying the interstitial defects between the graphene planes, as shown in Figure 2.

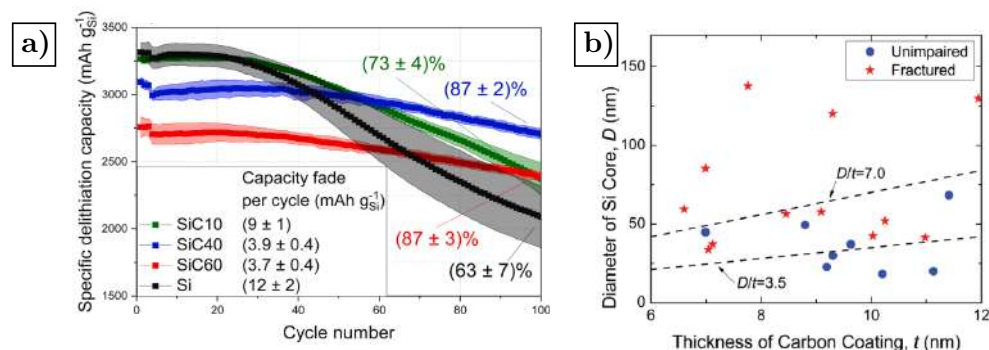
**Figure 9.** Effect of carbon coating on capacity fade. (a) Specific delithiation capacity as a function of the number of cycles for silicon thin film with carbon coating of different thickness, namely 10 nm, 40 nm, and 80 nm, for SiC10, SiC40 and SiC80, respectively. Reprinted with permission by Elsevier from [64], Copyright 2021. (b) Occurrence of fracture as a function of the ratio between particle diameter ( $D$ ) and coating thickness ( $t$ ). Reprinted with permission by Royal Society of Chemistry from [65], Copyright 2016.

In particular, Casino et al. [64] demonstrated that carbon coating mitigates the capacity fade. They observed that an increased coating thickness reduces the capacity drop, but a thickness greater than 60 nm does not have greater beneficial effects. On the other hand, the greater the coating thickness, the lower the nominal capacity. Consequently, a trade-off should be found to obtain the best performance; Casino et al. showed that a coating thickness of 60 nm guarantees good nominal capacity and capacity fade mitigation, as depicted in Figure 9a.

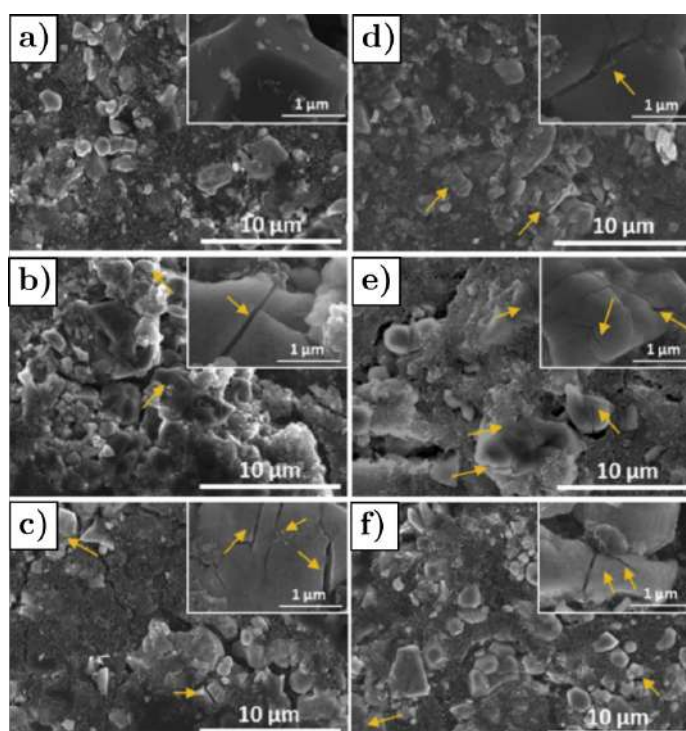
**Figure 13.** SEM images of the electrode structure (a) before cycling and after (b) 40 cycles, (c) 125 cycles, (d) 500 cycles, (e) cycled at low voltage to trigger Jahn-Teller transformation and (f) cycled at high temperature. Reprinted with permission by Elsevier from [88], Copyright 2017.

Some works tried to correlate the capacity fade in LMO with the occurrence of fracture due to cycling. Liu et al. [88] compared the increase in free surfaces created by cracks with capacity loss, observing an interesting correlation. They analyzed different samples subjected to an increasing number of cycles with TXM and SEM (Figure 13), and measured the increase in free surfaces created by cracks with an image processing tool.

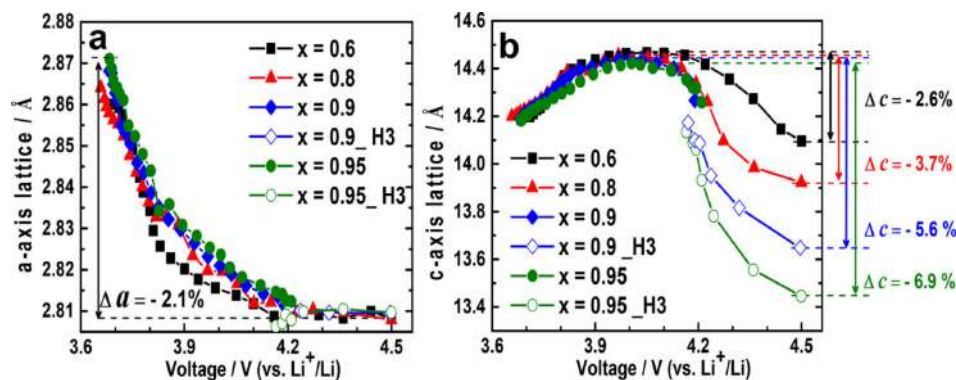
**Figure 25.** (a)  $a$ -axis and (b)  $c$ -axis lattice parameters of  $\text{Li}[\text{Ni}_x\text{Co}_y\text{Mn}_{1-x-y}]\text{O}_2$  as a function of the Ni content ( $x = 0.95$ ,  $x = 0.9$ ,  $x = 0.8$  and  $x = 0.6$ ) and the cell voltage. Reprinted with permission of [106], ©2018 American Chemical Society.

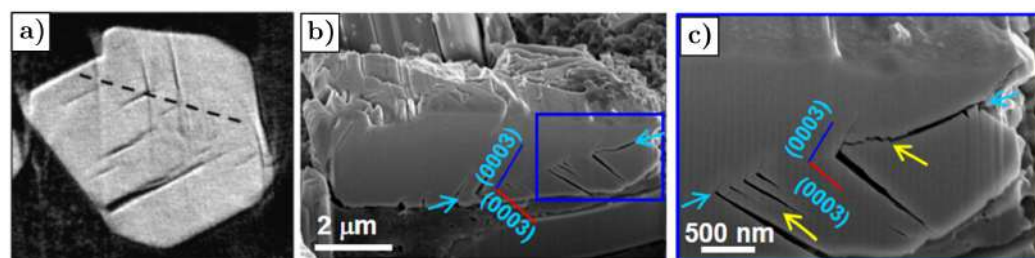
**Figure 31.** Cracking along the twin boundary. (a) Reconstructed image from X-ray nano-tomography reprinted from [137]. (b,c) SEM images of a cross-section of LCO particles (milled with FIB), showing cracks originating from twin boundary and their planes direction. Reprinted with permission by Elsevier from [136], Copyright 2020.

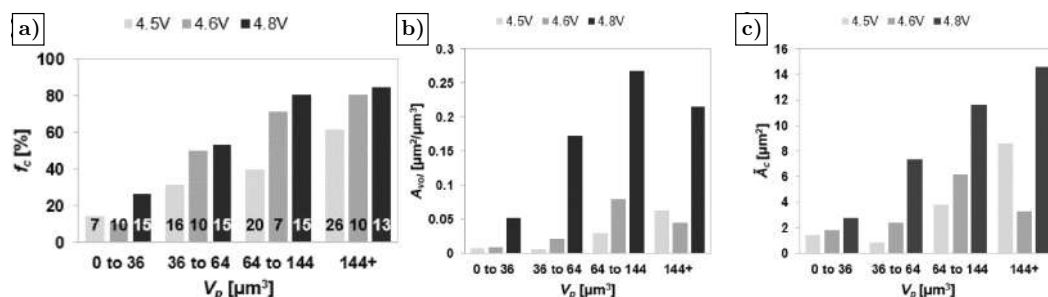
**Figure 32.** (a) The percentage of LCO particles within a given volume range that contains cracks after a single charge cycle to a given cutoff voltage. (b) The crack area per unit of volume for particles within a given volume range after a single charge cycle to a given cutoff voltage. (c) The average individual crack area (proportional to crack length) for particles within a given volume range after a single charge cycle to a given cutoff voltage. Reprinted with permission by Elsevier from [137], Copyright 2022.

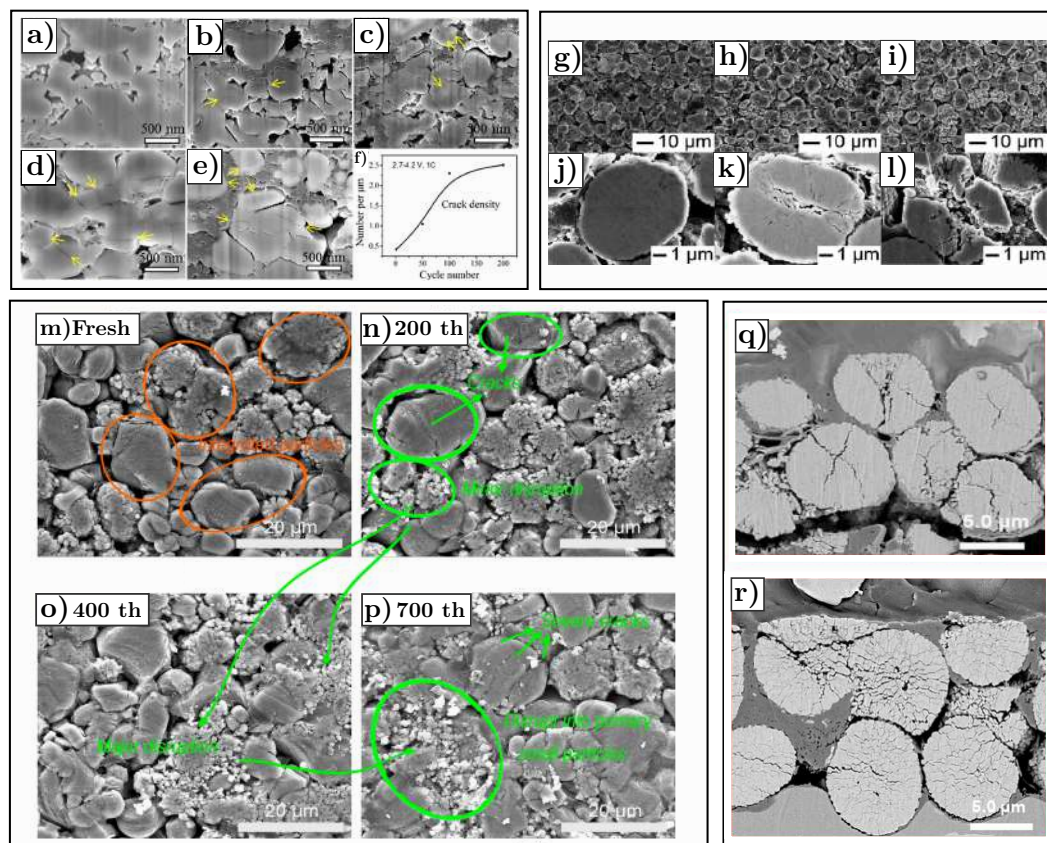
**Figure 33.** (a–f) Cross sectional SEM images of cracks evolution in  $\text{LiFePO}_4$  cathode cycled at 1C. Samples (a) before cycling, (b) after 1 cycle, (c) after 50 cycles, (d) after 100 cycles, (e) after 200 cycles, and (f) crack density as a function of the cycle numbers. Reprinted with permission by American Chemical Society from [99], Copyright 2018. Top view and cross-sectional SEM images of the NCM851005 cathode (g,j) before cycling, (h,k) after 100 cycles and (i,l) after 500 cycles at 1C. Reprinted with permission by American Chemical Society from [154], Copyright 2019. (m–p) FESEM images of hervester LCO/NMC532 cathode electrodes at various cycle numbers. Reprinted with permission by MDPI from [153], Copyright 2017. (q,r) Cross-sectional SEM images of  $\text{Li}[\text{Ni}_{0.90}\text{Co}_{0.05}\text{Mn}_{0.05}]\text{O}_2$  at first cycle and after 1000 cycles, respectively. Reprinted with permission by American Chemical Society from [152], Copyright 2019.
