Review on the Experimental Characterization of Fracture in Active Material for Lithium-Ion Batteries / Pistorio, Francesca; Clerici, Davide; Mocera, Francesco; Soma, Aurelio. - In: ENERGIES. - ISSN 1996-1073. - 15:23(2022), p. 9168. [10.3390/en15239168]

# Review on the Experimental Characterization of Fracture in Active Material for Lithium-Ion Batteries

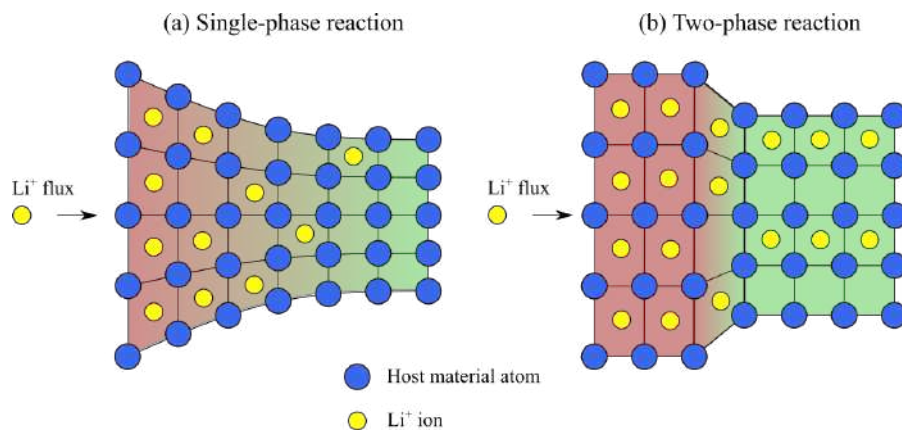
**Figure 1.** Mechanical stress resulting from inhomogeneous concentration due to (a) single phase-reaction and (b) phase transition.

Then, the inhomogeneous lithium concentration within the particle causes differential deformation of the lattice structure, leading to diffusion-induced stress (DIS) [8–13,21]. Furthermore, some materials show a two-phase behavior, i.e., two phases with a different lithium content coexist in the same particle, causing a significant strain mismatch at the interface between them, and thus stress, as illustrated in Figure 1b.

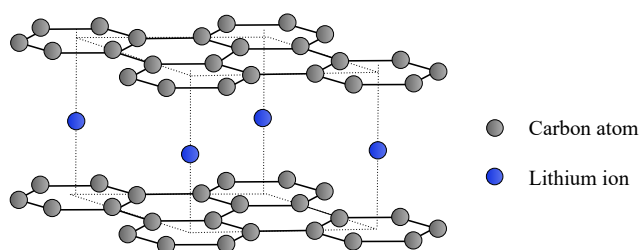
**Figure 2.** Crystalline structure of lithiated graphite. Lithium ions are depicted in blue and intercalate between the graphene planes. Carbon atoms are depicted in gray.

The structure of graphite is characterized by a stacking sequence of graphene layers, where carbon atoms are arranged in a hexagonal pattern. Lithium intercalates in the graphite structure occupying the interstitial defects between the graphene planes, as shown in Figure 2.

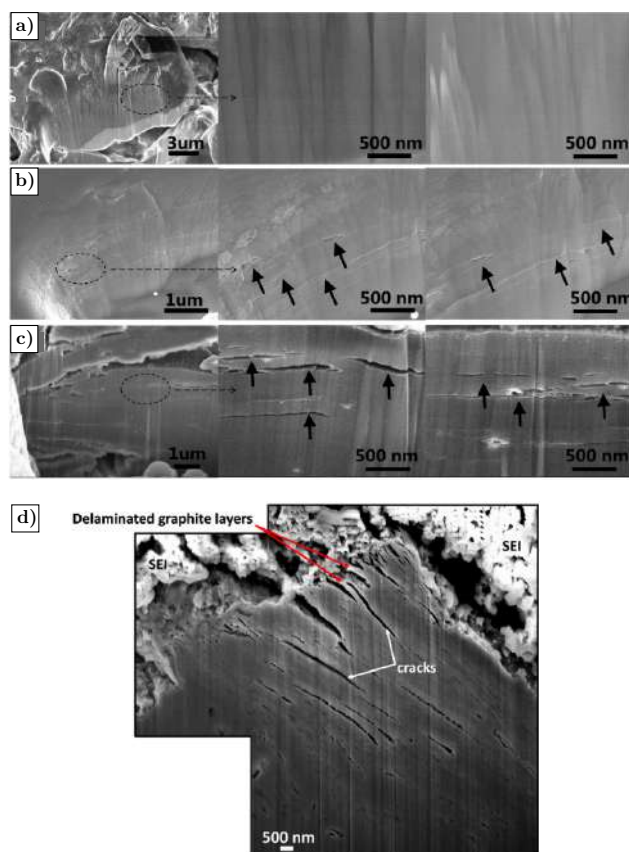
**Figure 3.** Cross-sectional SEM image of the (a) pristine graphite and graphite particles from cells cycled at 1C for (b) 200 and (c) 800 cycles. Black arrows point to the cracks. Reproduced with permission from Elsevier from [40], Copyright 2017. (d) Cross-section SEM image of graphite particle and SEI layer; parallel cracks may cause delamination. Reproduced with permission from Elsevier from [45], Copyright 2011.

Cracks in graphite particles are reported in the literature, and the research community is in agreement that the number of cycles and current rate are the main factors affecting the crack growth [40–44] (Figure 3), and that the formation of SEI over the fresh active material surfaces is the ultimate cause of capacity fade. Cracks are observed parallel to the larger external surface, leading the graphite to exfoliate [40,45], as shown in Figure 3c,d.

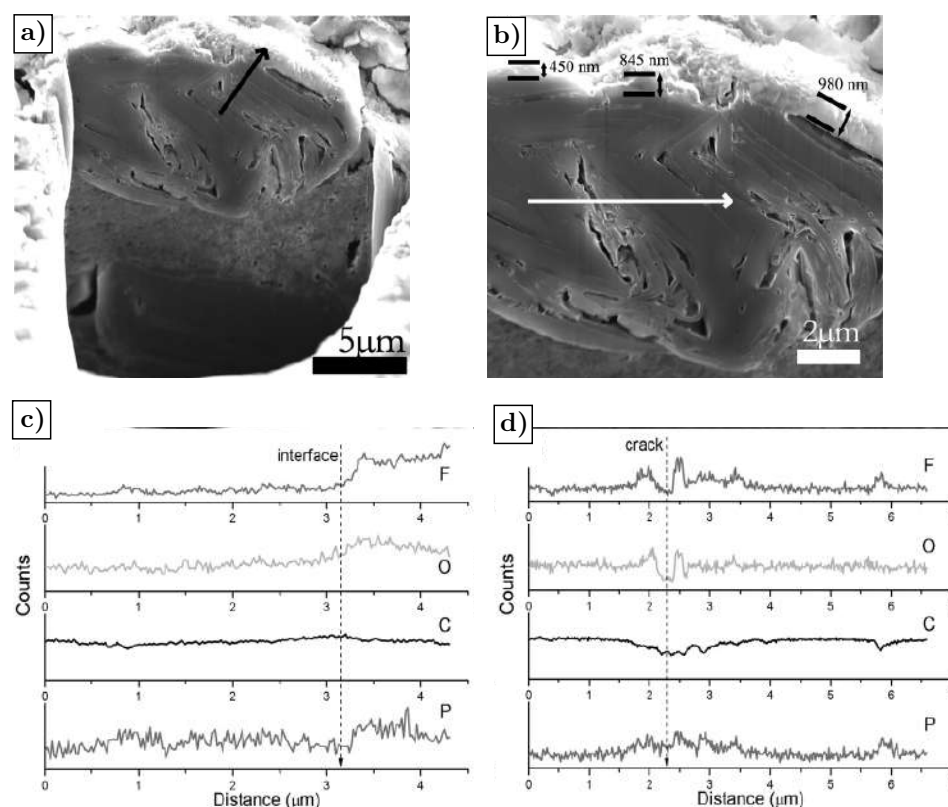
**Figure 4.** (a,b) Secondary electron FIB images of the cross-section of a graphite particle. (c,d) The elemental line scan analysis along the black and white lines in panels (a,b), respectively. Adapted with permission by American Chemical Society from [46], Copyright 2005.

Zhang et al. [46] used element scan analysis (ELSA) to identify the location and composition of the SEI layer. According to Figure 4, ELSA shows peaks in F, O and P elements when SEI is encountered, as it is composed of fluorides (LiF), Li-alkyl carbonates ( $\text{CH}_3\text{OCO}_2\text{Li}$ ,  $(\text{CH}_3\text{OCO}_2\text{Li})_2$ ) from EC/DMC decomposition and electrolytes ( $\text{LiPF}_6$ ). Then, they observed the SEI layer both on the particle surface and at the core, confirming the presence of surface and internal cracks.

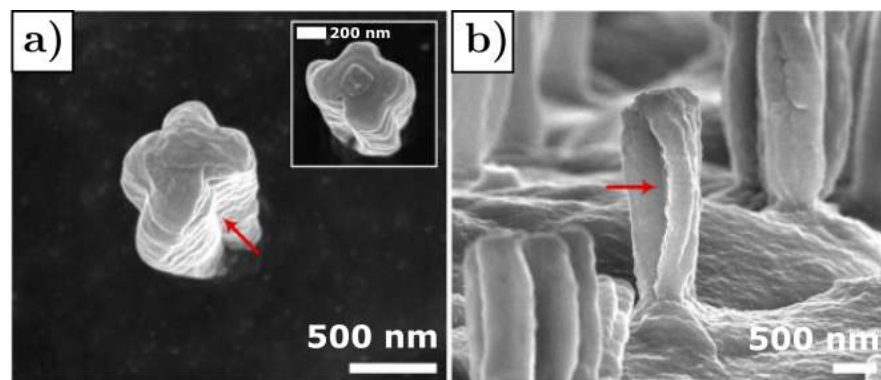
**Figure 5.** SEM images showing cracks in silicon nanowire, pointed out by the red arrow. (a) Top view and (b) Side view. Reprinted with permission from [54], Copyright 2012.

Concerning nanowires, they are characterized by a continuous 1D electronic pathway that facilitates efficient charge transport, as compared to nanoparticles [48]. Furthermore, they can grow directly from the current collector, making binder and conductive agents unnecessary but limiting the lithium flux and current rate as a consequence. Several studies observed an anisotropic expansion during the alloying process, which is greater in the [110] direction, making the cross-section elliptical [52,53]. As a result, intense tensile hoop stress arises along the shorter axis of the ellipse, causing severe crack propagation [54], as confirmed by the SEM images in Figure 5.

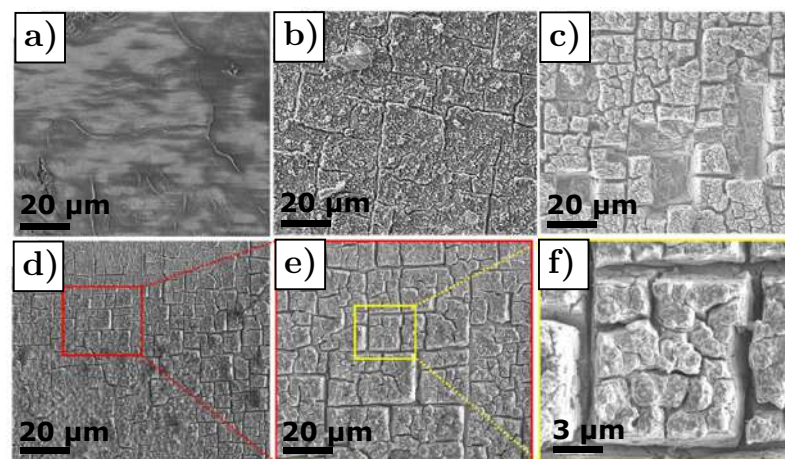
**Figure 6.** Crack growth as a function of lithiation cycles in thin film after (a) 3, (b) 8, and (c) 50 cycles. (d–f) Detail of crack pattern after 30 lithiation cycles. Reprinted with permission by Nature Publishing Group from [55], Copyright 2016.

The lithiation of thin film electrodes causes strains leading to the curvature of the film, which ultimately leads to surface cracks, resembling the ones occurring in drying media, as shown in Figure 6.

A particular crack pattern arises on the surface of the silicon thin film as a result of lithiation cycles, as observed with SEM [55,57]. Shi et al. [55] showed that the crack density is a function of the number of cycles, as shown in Figure 6. In addition, Li et al. [57] reported that crack density depends on the thickness of the film as well, and a critical size below which cracks do not propagate exists.

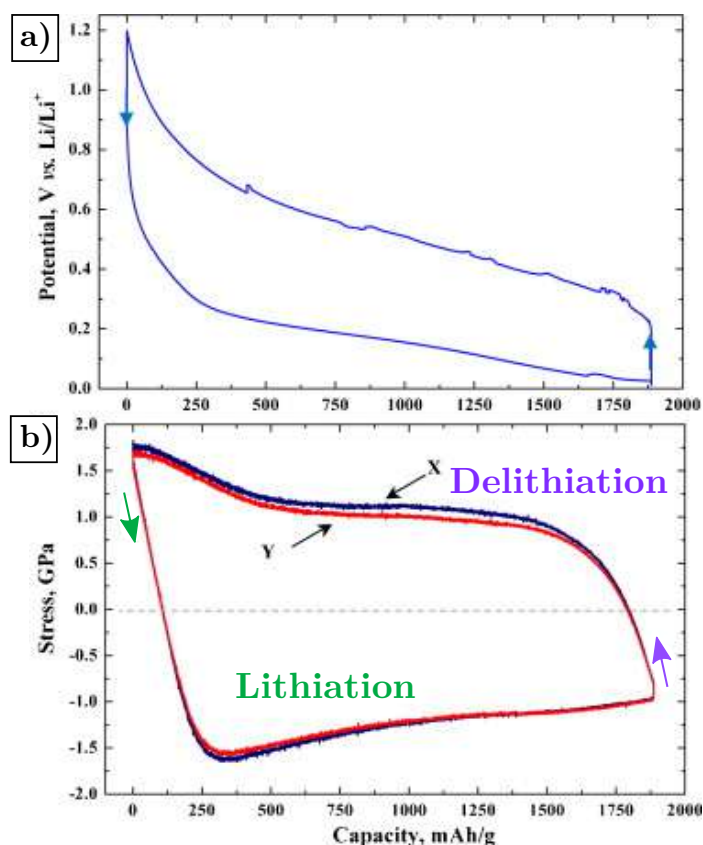
**Figure 7.** (a) Cell potential vs. capacity curve corresponding to lithiation and delithiation Si thin-film electrode cycled at C/4 rate, and (b) the corresponding average stress computed from the measured curvature of the substrate. Adapted with permission by Elsevier from [56], Copyright 2010.

Sethuraman et al. [56] computed the average stress of silicon thin film from the substrate curvature with a Multi-beam Optical Sensor (MOS) during lithiation and delithiation. The results of their in-situ experiments are reported in Figure 7.

It was shown that the average stress becomes elastically compressive during lithiation until 12% of the total capacity, reaching  $-1.75$  GPa. Then, plastic flow occurs until the end of lithiation. Stress is reversed during delithiation and becomes elastically tensile until 75% capacity, reaching 1 GPa, followed by plastic flow. Therefore, delithiation is the critical phase from the fracture point of view, as the electrode is subjected to severe tensile stress.

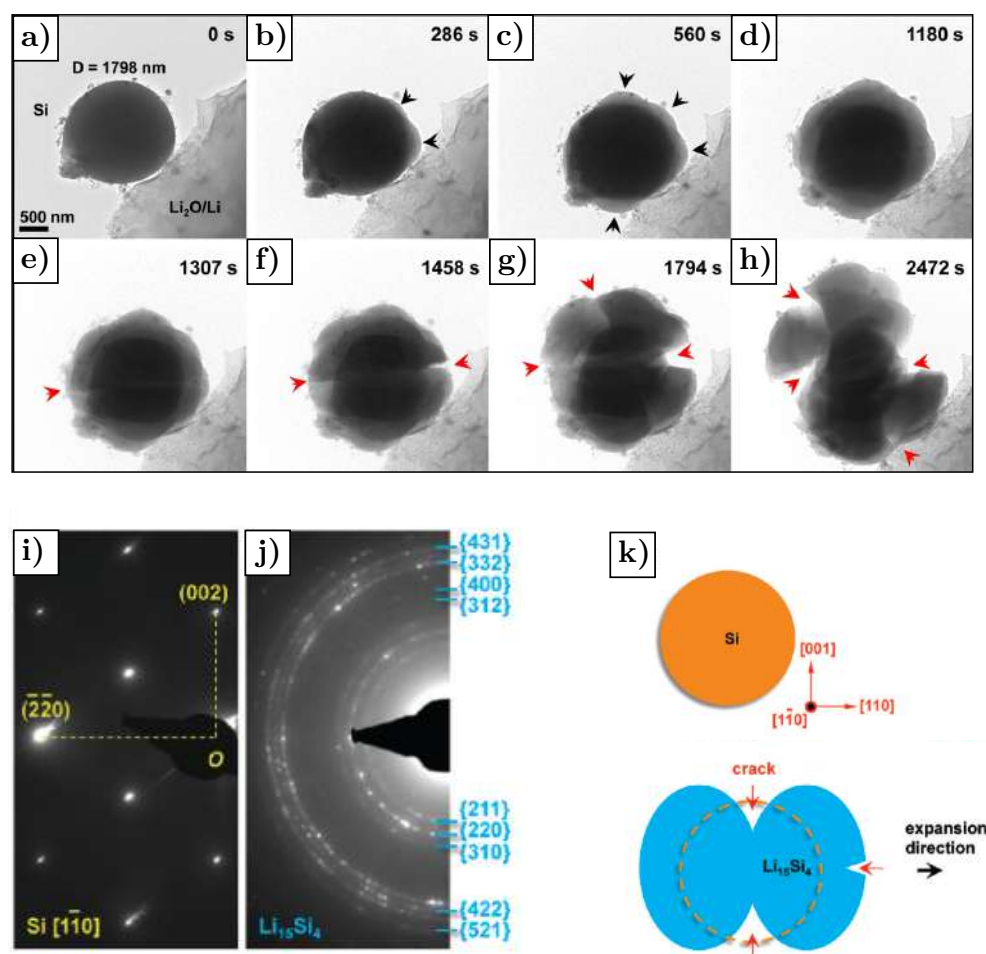
**Figure 8.** (a–h) Crack growth during single lithiation cycle in silicon nano-particle. The black arrows mark the bumps due to anisotropic lithiation of Si before crack formation, whereas the red arrows mark the cracks. (i,j) Electron diffraction pattern showing the silicon phase transformation from (i) crystalline structure (Si) to (j) polycrystalline structure ( $\text{Li}_{15}\text{Si}_4$ ). (k) Anisotropic swelling in silicon nanoparticle favoring cracks in [110] direction. Reprinted with permission by American Chemical Society from [51], Copyright 2012.

Concerning silicon nano-particles, crack growth within the same particle was observed during a single lithiation, as reported in Figure 8a–h [51]. At the end of lithiation, the particle is heavily damaged, and cracks propagating along the [110] direction affect the structural stability considerably. Furthermore, the electron diffraction pattern (EDP) analysis reported in Figure 8i,j shows the phase transformation from crystalline (Si) (Figure 8i), to polycrystalline ( $\text{Li}_{15}\text{Si}_4$ ) (Figure 8j) due to the lithiation process. Figure 8k explains the anisotropic swelling characteristic of silicon nano-particles, leading to cracks predominantly along the [110] direction [51,58].

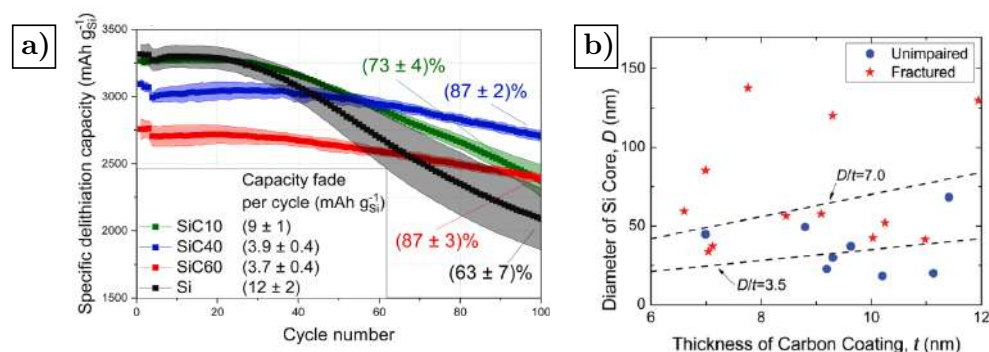
**Figure 9.** Effect of carbon coating on capacity fade. (a) Specific delithiation capacity as a function of the number of cycles for silicon thin film with carbon coating of different thickness, namely 10 nm, 40 nm, and 80 nm, for SiC10, SiC40 and SiC80, respectively. Reprinted with permission by Elsevier from [64], Copyright 2021. (b) Occurrence of fracture as a function of the ratio between particle diameter ( $D$ ) and coating thickness ( $t$ ). Reprinted with permission by Royal Society of Chemistry from [65], Copyright 2016.

In particular, Casino et al. [64] demonstrated that carbon coating mitigates the capacity fade. They observed that an increased coating thickness reduces the capacity drop, but a thickness greater than 60 nm does not have greater beneficial effects. On the other hand, the greater the coating thickness, the lower the nominal capacity. Consequently, a trade-off should be found to obtain the best performance; Casino et al. showed that a coating thickness of 60 nm guarantees good nominal capacity and capacity fade mitigation, as depicted in Figure 9a.

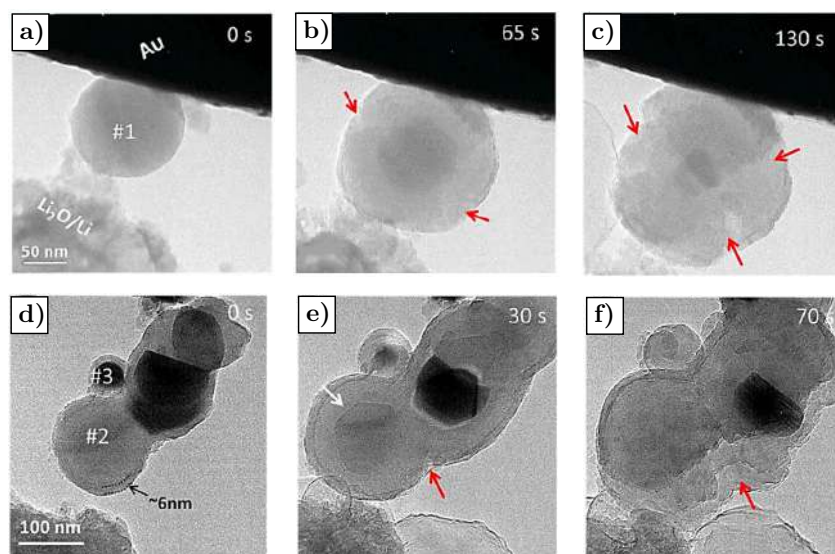
**Figure 10.** Lithiation of (a–c) uncoated silicon particle and (d–f) coated silicon particles. The time value depicted in the figure refers to the lithiation time. Reprinted with permission by Elsevier from [68], Copyright 2016.

Fractures were observed with TEM in carbon-coated silicon particles in some works [65,67,68]. Xu et al. [68] compared the lithiation of two sets of geometrically similar particles (130–150 nm), one with a 6 nm carbon coating and the other without coating. Few fractures were observed in the coated particles, depicted by the red arrows in Figure 10e,f. On the other hand, a greater number of fractures were observed in the uncoated particles, as confirmed by the red arrows in Figure 10a–c. During the lithiation of the coated particles, the coating thickness increases from 6 nm to 8 nm, because of the strong radial stress due to the silicon core expansion. Then, fractures are triggered in the coating thickness and they further propagate in the silicon core. These factors may explain the reason why fracture occurs in coated particles that are smaller than the critical fracture size, i.e., 150 nm as explained by Liu et al. [51].

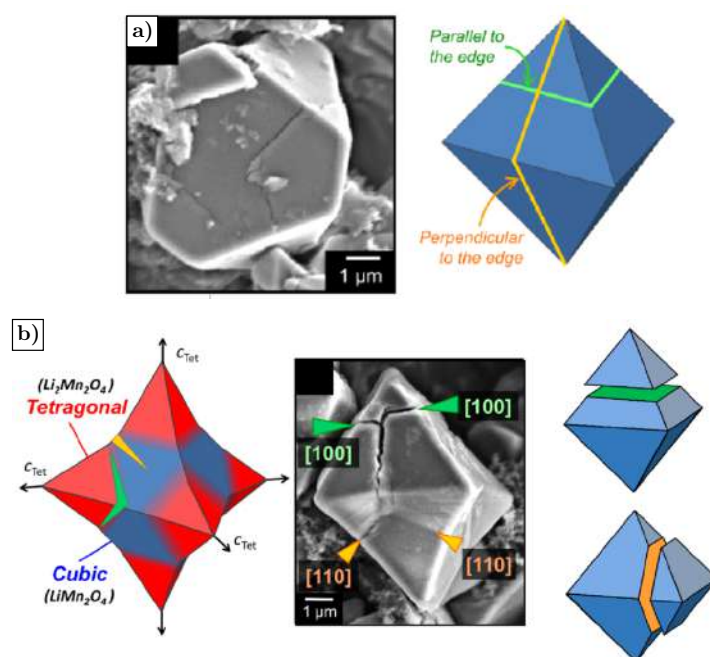
**Figure 11.** (a) Cubic and (b) tetragonal structure of LMO with the corresponding preferential cracks directions. Reprinted with permission by American Chemical Society from [83], Copyright 2021.

Severe cracking is observed when the LMO undergoes Jahn–Teller transformation, and intragranular cracks are observed at the cubic/tetragonal ([100] direction) and tetragonal/tetragonal ([110] direction) grain boundaries, indicated in green and orange in Figure 11b, respectively. Thus, cracks appear oriented along the [100] and [110] directions [83].

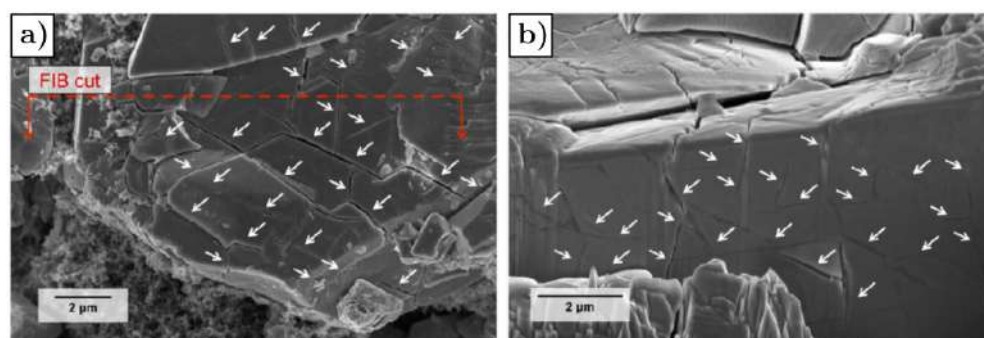
**Figure 12.** (a) Fracture in LMO particle after 16 deep discharge cycles with Jahn–Teller transformation and 51 cycles without Jahn–Teller transformation. (b) Internal view of LMO particle shown in (a) after FIB milling. White arrows point to the cracks. Reprinted with permission by Journal of The Electrochemical Society from [84], Copyright 2018.

McGrogan et al. [84] cycled the LMO electrode above Jahn–Teller transformation and milled the cycled electrode with FIB to study the internal cracking network, as shown in Figure 12a,b. The dense crack network, probably caused by Jahn–Teller transformation, allows the electrolyte to penetrate inside the particle, causing the dissolution of  $Mn^{2+}$ , as will be explained in Section 4.

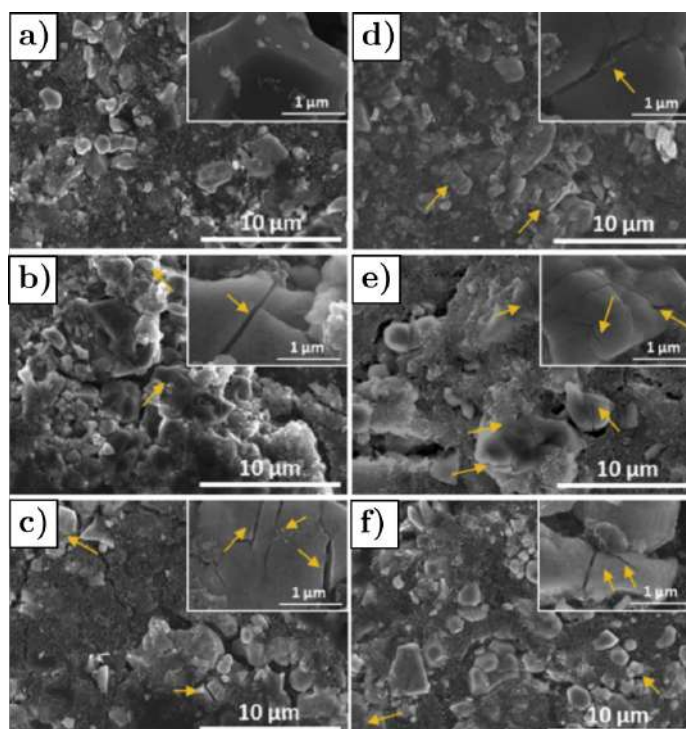
**Figure 13.** SEM images of the electrode structure (a) before cycling and after (b) 40 cycles, (c) 125 cycles, (d) 500 cycles, (e) cycled at low voltage to trigger Jahn-Teller transformation and (f) cycled at high temperature. Reprinted with permission by Elsevier from [88], Copyright 2017.

Some works tried to correlate the capacity fade in LMO with the occurrence of fracture due to cycling. Liu et al. [88] compared the increase in free surfaces created by cracks with capacity loss, observing an interesting correlation. They analyzed different samples subjected to an increasing number of cycles with TXM and SEM (Figure 13), and measured the increase in free surfaces created by cracks with an image processing tool.

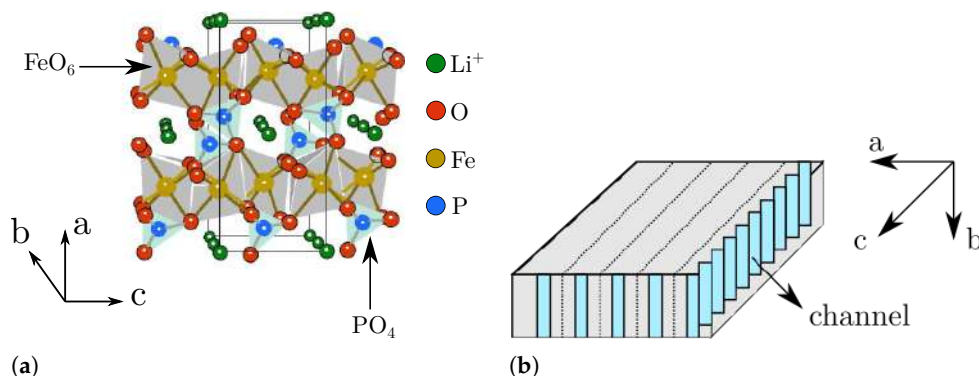
**Figure 14.** (a) Crystal structure of LFP. Reprinted with permission by Elsevier from [92], Copyright 2009. (b) Schematic illustration of lithium intercalation mechanism in LFP single crystal. Lithium ions diffuse along 1D channels in the  $b$ -direction, and channels are stacked in layers parallel to  $bc$  planes, indicated by the dotted lines.

LFP crystallizes in the olivine structure, consisting of  $\text{FeO}_6$  octahedra and  $\text{PO}_4$  tetrahedra, as shown in Figure 14a. The  $\text{FeO}_6$  octahedra contact each other by sharing corners and forming layers in the  $bc$  planes. The  $\text{FeO}_6$  layers are linked together by  $\text{PO}_4$  tetrahedral units. Lithium ions are located in the interstitial voids of the framework, forming continuous linear chains along the  $c$ -axis in the alternate  $ac$  planes. In this structure, the most favorable lithium diffusion path is through channels aligned with the  $b$ -direction [91], as illustrated in Figure 14b.

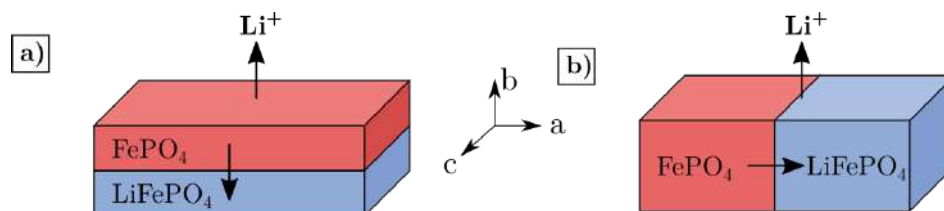
**Figure 15.** Scheme of the phase boundary movement for LFP. (a) Phase boundary moving along the  $b$ -axis; (b) Phase boundary moving along the  $a$ -axis.

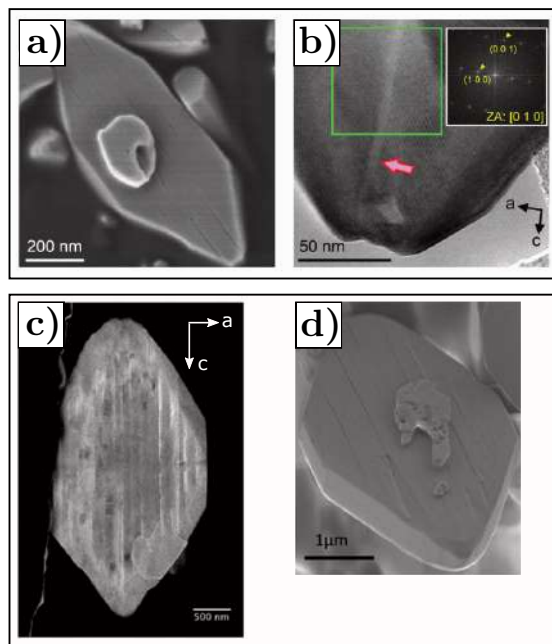
**Figure 16.** Top: Electron microscopy results for a micrometric plate-like LFP crystal subjected to partial chemical delithiation. (a) SEM image and (b) High-resolution transmission electron (HRTEM) image with the inset of the Fourier transform pattern obtained from the region marked with the green box. The red arrows indicate the crack running parallel to the  $c$ -axis. Reprinted with permission by American Chemical Society from [97], Copyright 2015. Bottom: SEM observations of partially delithiated  $\text{Li}_{0.5}\text{PO}_4$  crystal. (c) SEM image and (d) STEM-HAADF image, showing cracks evenly spaced and oriented along the  $c$ -axis. Reprinted with permission by American Chemical Society from [96], Copyright 2013.

A similar mechanism, with the phase boundary oriented along the  $bc$  plane, was also supported by other experimental observations in ex-situ chemically delithiated LFP particles, as reported in [96,97] and illustrated in Figure 16a–d.

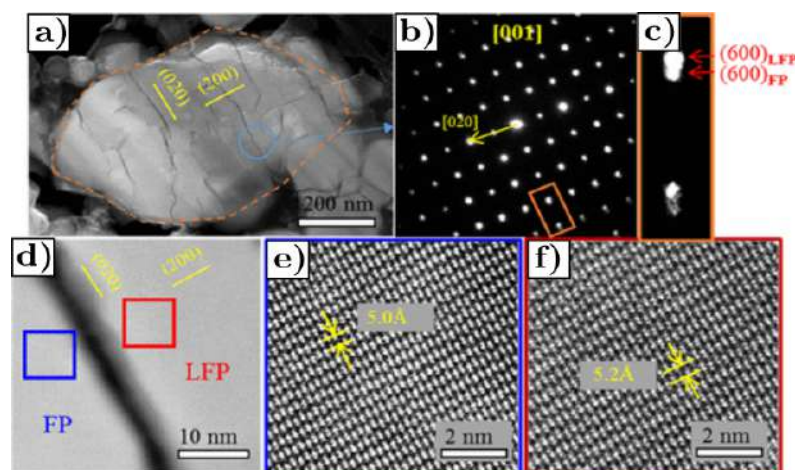
**Figure 17.**  $\text{LiFePO}_4$  and  $\text{PO}_4$  phases separated by  $ac$  plane cracks in a LFP crystal electrochemically cycled, with (a) STEM-HAADF image of the crystal at 100% SOC, (b,c) SAED patterns and (d–f) STEM-HAADF images. Reprinted with permission by American Chemical Society from [99], Copyright 2020.

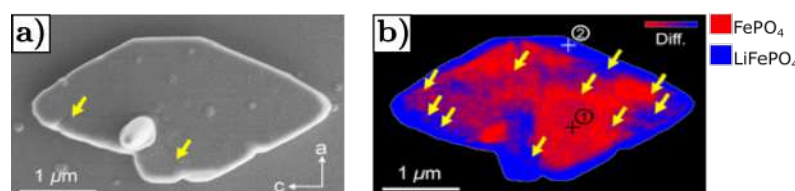
**Figure 18.** Relation between defects and phase distribution within micrometric LFP chemically delithiated plate-like crystal, with (a) SEM image and (b) Chemical phase distribution map. Reprinted with permission by American Chemical Society from [97], Copyright 2015.

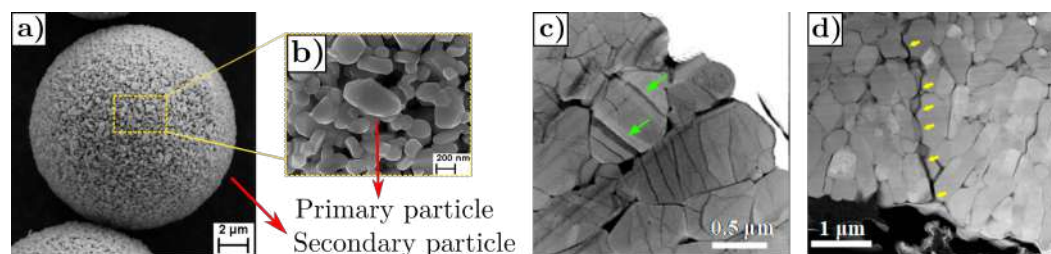
**Figure 19.** (a,b) SEM images of NMC secondary and primary particles. Reproduced with permission from [105], ©2020 American Chemical Society. (c,d) TEM images of the cross-section of discharged NMC cathode after 100 cycles: intragranular cracks within primary particles are marked with green arrows, whereas intergranular cracks developing along grain boundaries are marked with yellow arrows. Reprinted with permission by American Chemical Society from [106], Copyright 2018.

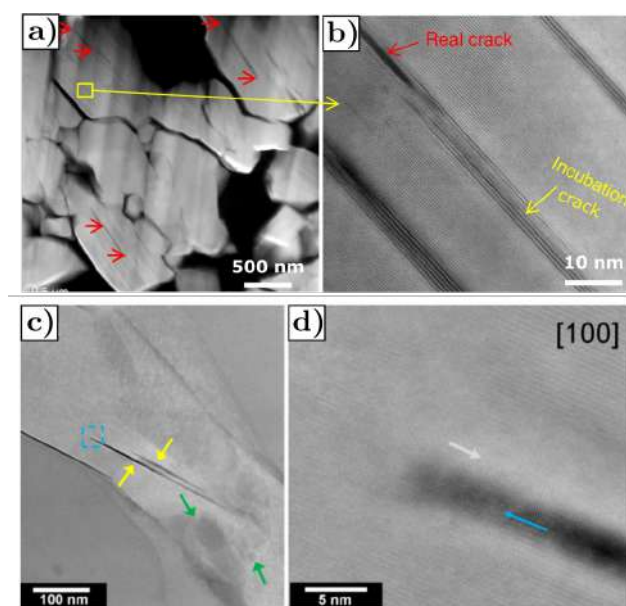
**Figure 20.** (a,b) SEM image of electrochemically cycled  $\text{LiNi}_{0.6}\text{Mn}_{0.2}\text{Co}_{0.2}\text{O}_2$  (NMC622) particles, showing cracks parallel to the (003) planes. Cracks are marked with red arrows. Reprinted with permission of [109] ©2018 Springer Nature. (c) Intragranular cracks in  $\text{Li}_{1+x}(\text{Ni}_{0.85}\text{Co}_{0.1}\text{Mn}_{0.05})_{1-x}\text{O}_2$  (NCM851005) after 200 cycles, with (d) High-resolution image of the marked area in (c) showing the rock-salt phase along the crack surface. The direction parallel to (003) planes, cracks and the rock-salt phase are marked with grey, yellow and blue arrows, respectively. Reprinted with permission from American Chemical Society by [110], Copyright 2019.

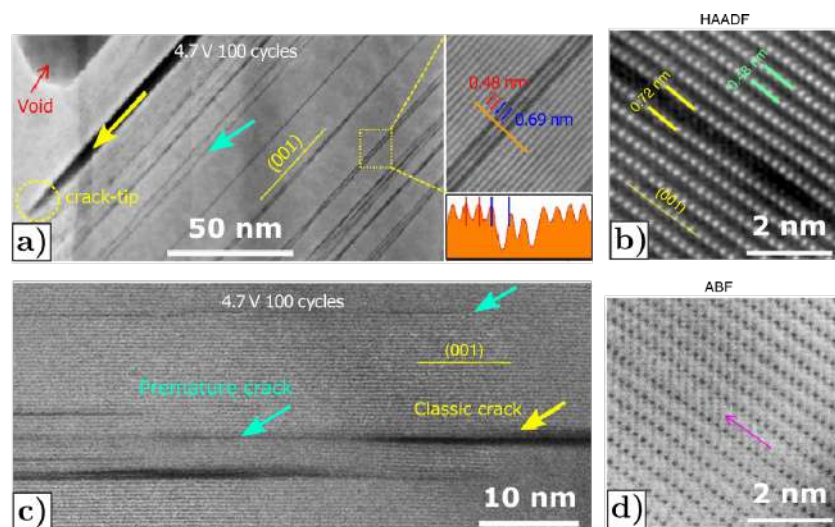
**Figure 21.** (a,c) HAADF images from cycled NMC333 cathode particle showing intragranular cracks along the (001) plane. The yellow and light blue arrows indicate classic and premature cracks, respectively. (b) HAADF and (d) ABF images along [010] axis of the premature crack showed in (a). Reprinted with permission from Springer Nature by [108], Copyright 2017.

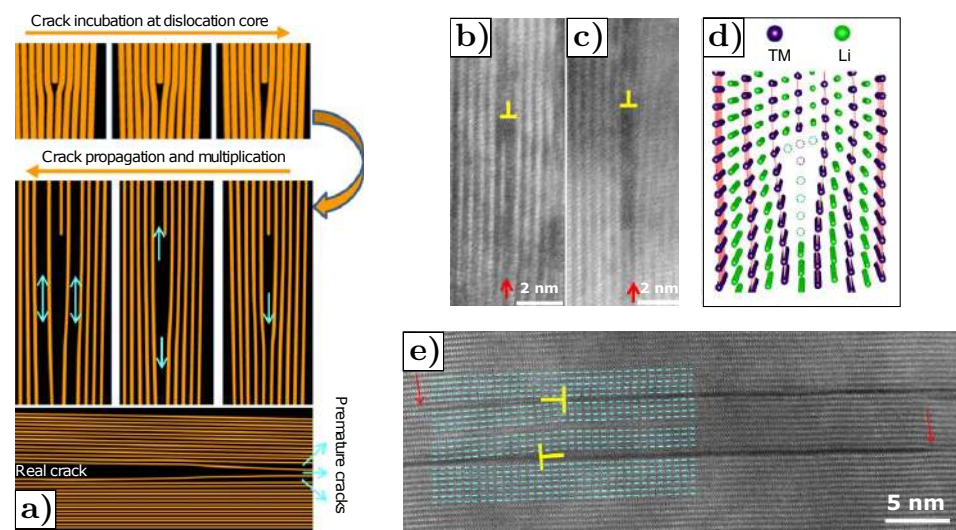
**Figure 22.** (a) Schematic diagrams of the dislocation-assisted crack incubation, propagation and multiplication process in NMC cathode particles. (b,c) Nucleation of premature cracks at the dislocation core in NMC333 cycled particles, also schematized in (d). (e) Edge dislocations associated with intragranular cracks in cycled NMC333 particles. Crack tip is indicated with the red arrows. Reprinted with permission from Springer Nature by [108], Copyright 2017.

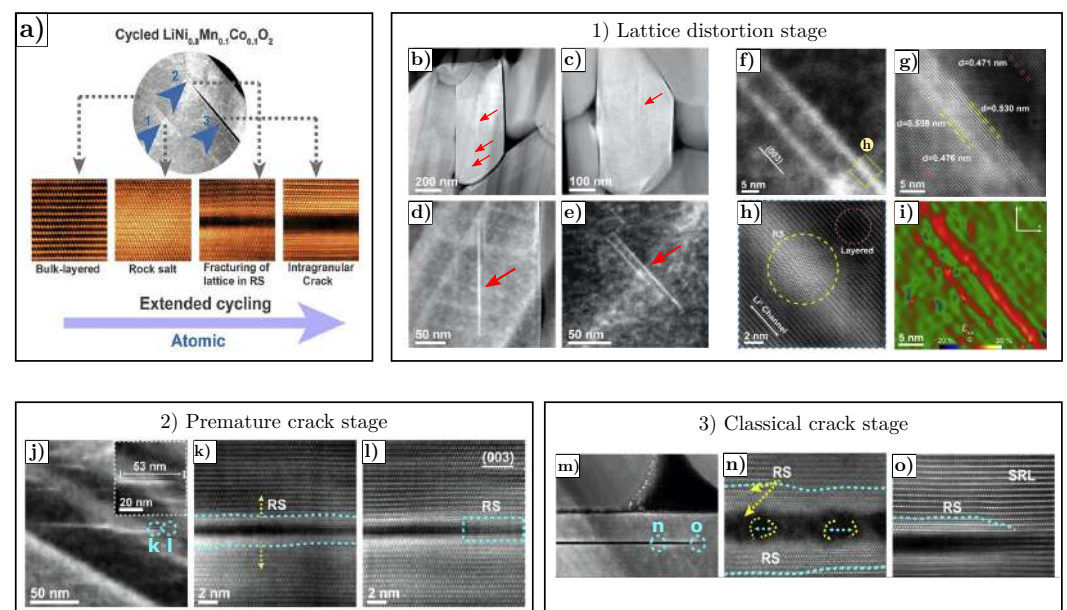
**Figure 23.** (a) Development process of intragranular cracks in NMC811: (b–i) Lattice distortion stage, (j–l) Premature crack stage and (m–o) Classical crack stage. STEM-HAADF images of cycled NMC811 particle in <010> zone projection, after (b–d) 50 cycles and (c–e) 20 cycles. The white lines appear with different length. (f) STEM-HAADF image of enlarged morphology of a white line shown in (a). (g) High-resolution STEM-HAADF image, showing the lattice distortion of the white line region. (h) Atomic-resolution STEM-HAADF image from the region marked by yellow dashed square box in (f), showing the detailed structure of the white line, with the formation of the rock-salt phase. (i) Strain map simulated by GPA due to lattice distortion. (j–l) Atomic-resolution STEM-HAADF images of premature intragranular crack in NMC811 particle after 50 cycles, showing the presence of the rock-salt phase both in the (k) partially cracked region and (l) uncracked tip. (m–o) Atomic-resolution STEM-HAADF images of mature intragranular crack in NMC811 particle after 100 cycles, showing the increase in the crack length along the (003) plane and in the rock-salt phase thickness. Reprinted with permission from Elsevier by [111], Copyright 2020.

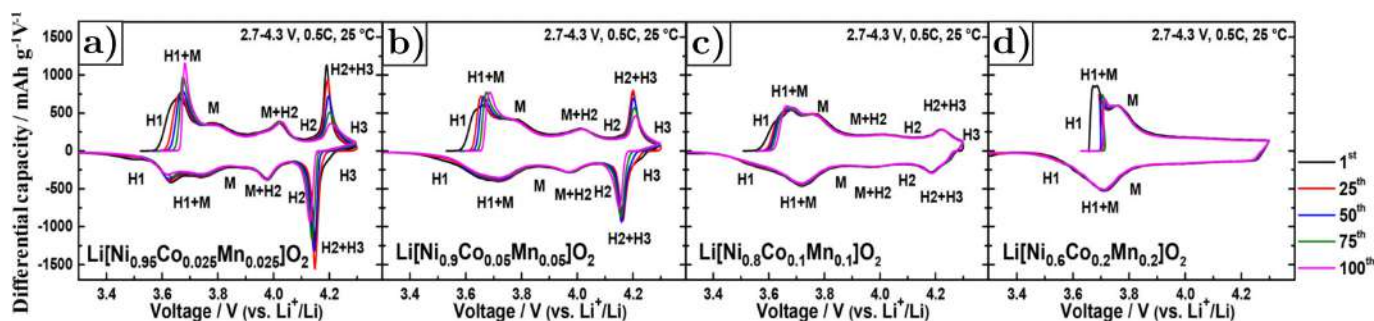
**Figure 24.** Differential capacity curves of  $\text{Li}[\text{Ni}_x\text{Co}_y\text{Mn}_{1-x-y}]\text{O}_2$  with different Ni content: (a)  $x = 0.95$ , (b)  $x = 0.9$ , (c)  $x = 0.8$ , and (d)  $x = 0.6$  as a function of the number of cycles. Reprinted with permission of [106], ©2018 American Chemical Society.

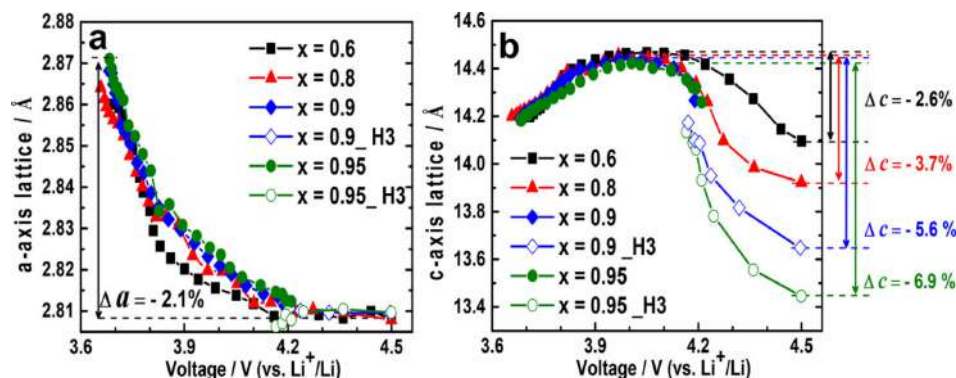
**Figure 25.** (a)  $a$ -axis and (b)  $c$ -axis lattice parameters of  $\text{Li}[\text{Ni}_x\text{Co}_y\text{Mn}_{1-x-y}]\text{O}_2$  as a function of the Ni content ( $x = 0.95$ ,  $x = 0.9$ ,  $x = 0.8$  and  $x = 0.6$ ) and the cell voltage. Reprinted with permission of [106], ©2018 American Chemical Society.

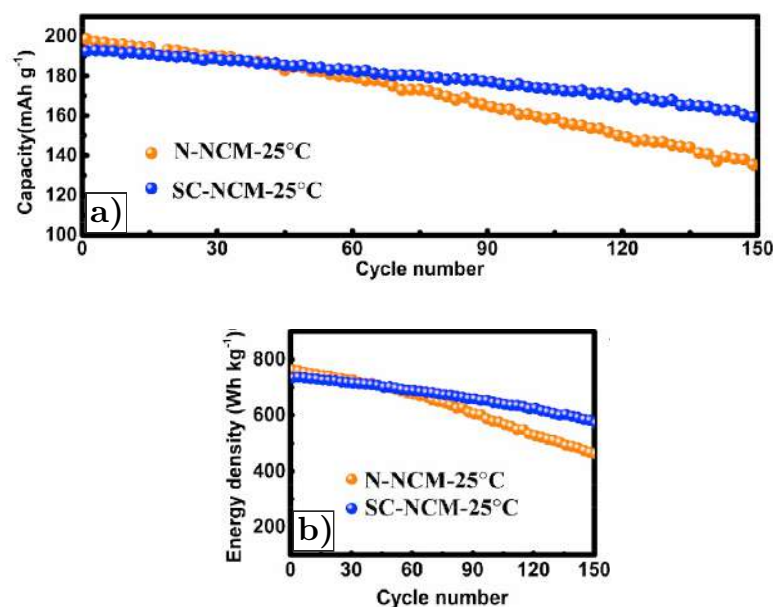
**Figure 26.** (a) Comparison of capacity and (b) Energy density decay between single-crystalline (SC-NCM) and commercial polycrystalline (N-NCM) NMC831106 cycled at 1C in the voltage range of 2.75–4.4 V over 150 cycles. Reprinted with permission of [123], ©2020 Elsevier.

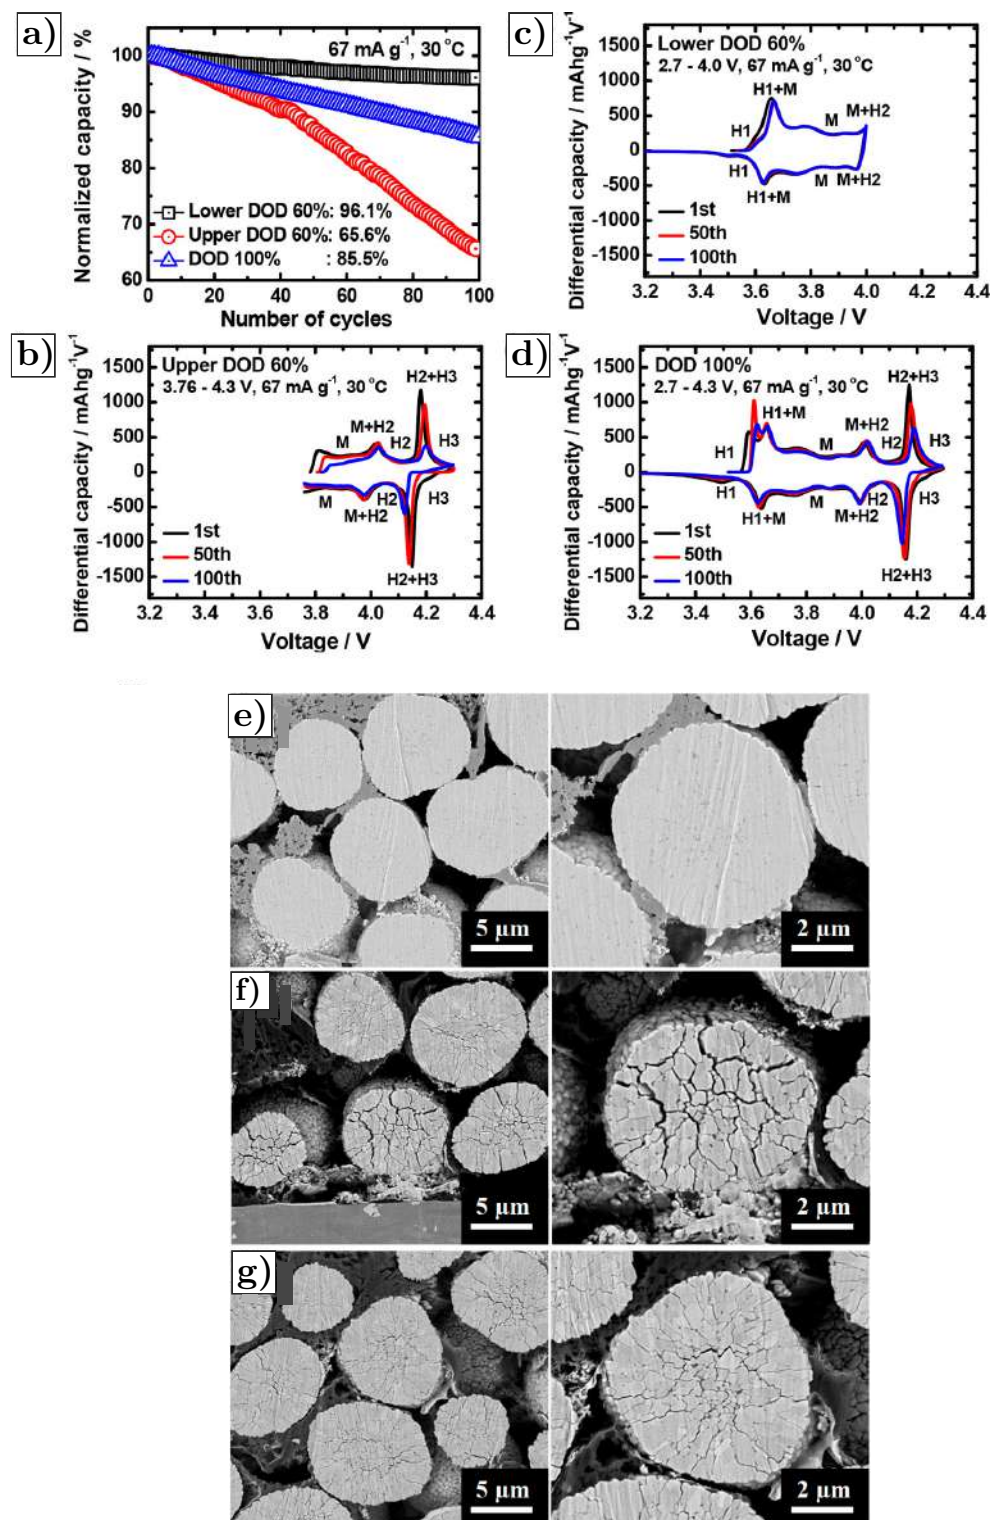
**Figure 27.** (a) Capacity decay of NCA95 during cycling at different DOD and initial SOC values. Derivative of charge-discharge curves of NCA95 cycled (b) from SOC 40 to 100% (3.76–4.3 V) (c) from SOC 0 to 60%, (d) from SOC 0 to 100%. Cross-sectional SEM images of NCA95 particles cycled for 100 cycles (e) from SOC 0 to 60%, (f) from SOC 40 to 100% and (g) from SOC 0 to 100%. Reprinted with permission by American Chemical Society from [132], Copyright 2019.

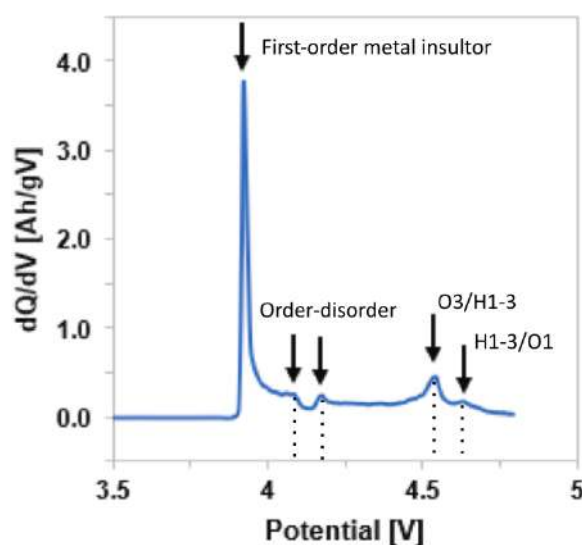
**Figure 28.** Differential capacity curve of a fresh LCO half-cell charged to 4.8 V at 0.05C. Most relevant phase transitions are highlighted by the black arrows. Adapted with permission by Elsevier from [137], Copyright 2022.

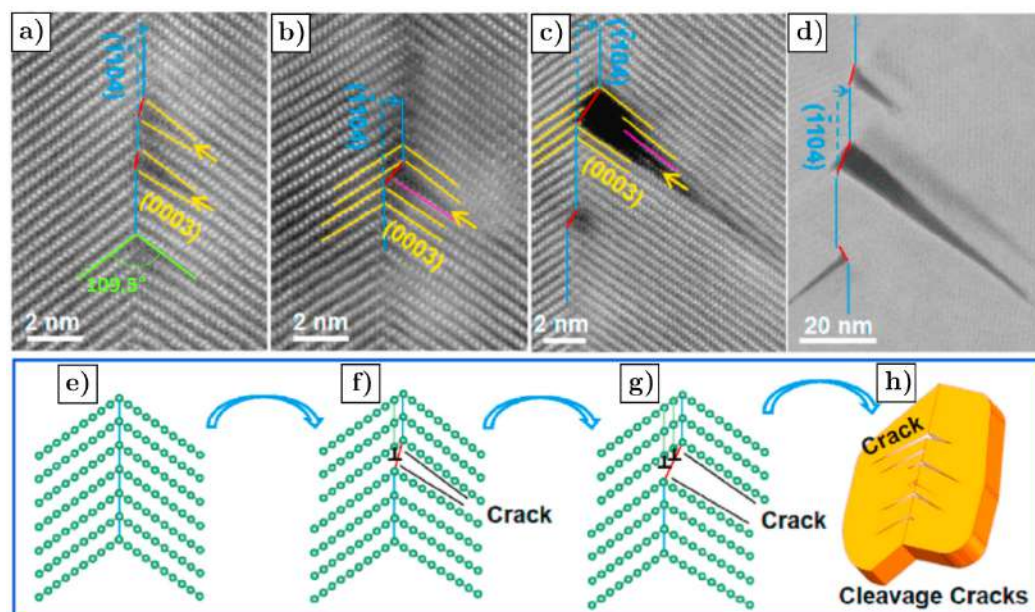
**Figure 29.** Cleavage crack's nucleation and propagation. (a) STEM-HAADF image showing the nucleation of cleavage cracks at the kinks occurring after 50 cycles. The (0003) plane is highly strained as indicated by the yellow arrows. (b,c) Further deformation-induced crack growth at the twin boundary. Pink lines indicate the extra (0003) planes generated to release the local strain. (d) V-shaped cleavage cracks induced by deformation. (e–h) Schematic diagrams to illustrate the cleavage crack nucleation and growth process. Reprinted with permission by Elsevier from [136], Copyright 2020.

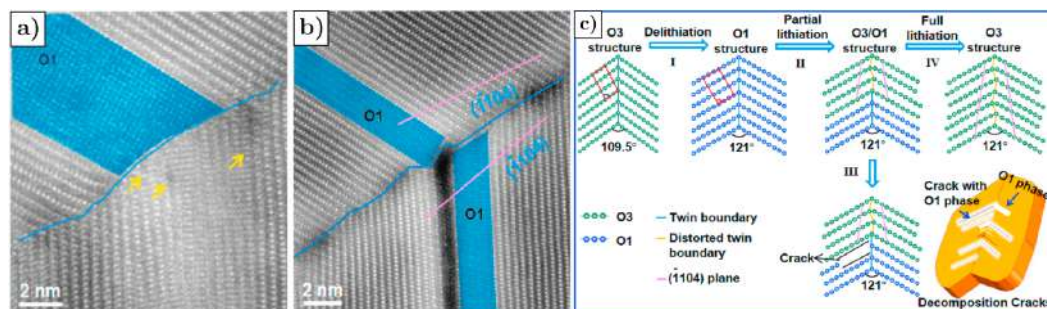
**Figure 30.** Phase transition induced cracking at the twin boundary. (a) A STEM-HAADF image showing the O1 phase (light blue region) formed at the highly distorted twin boundary, indicated by the light blue line. Incubation cracks at the twin boundary are marked by yellow arrows. (b) Decomposition crack formed along an O1 phase strip. (c) Schematic diagrams illustrating the cracking mechanism induced by phase transition at the twin boundary. Reprinted with permission by Elsevier from [136], Copyright 2020.

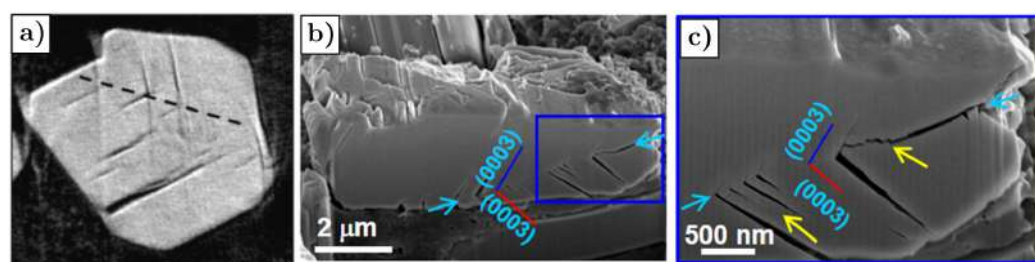
**Figure 31.** Cracking along the twin boundary. (a) Reconstructed image from X-ray nano-tomography reprinted from [137]. (b,c) SEM images of a cross-section of LCO particles (milled with FIB), showing cracks originating from twin boundary and their planes direction. Reprinted with permission by Elsevier from [136], Copyright 2020.

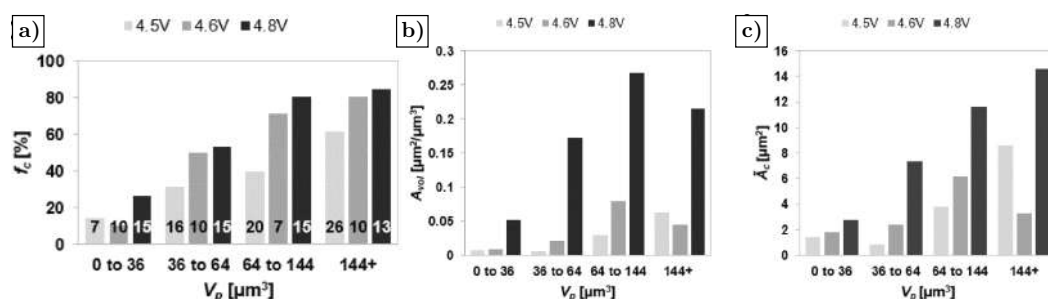
**Figure 32.** (a) The percentage of LCO particles within a given volume range that contains cracks after a single charge cycle to a given cutoff voltage. (b) The crack area per unit of volume for particles within a given volume range after a single charge cycle to a given cutoff voltage. (c) The average individual crack area (proportional to crack length) for particles within a given volume range after a single charge cycle to a given cutoff voltage. Reprinted with permission by Elsevier from [137], Copyright 2022.

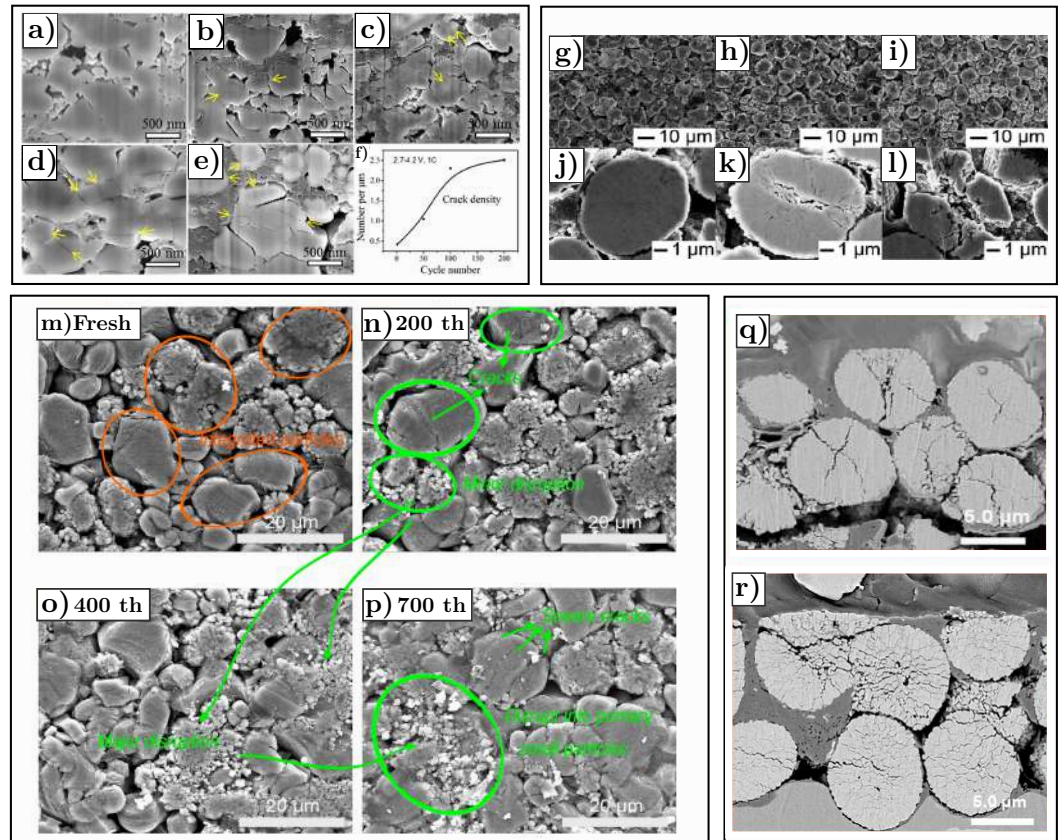
**Figure 33.** (a–f) Cross sectional SEM images of cracks evolution in  $\text{LiFePO}_4$  cathode cycled at 1C. Samples (a) before cycling, (b) after 1 cycle, (c) after 50 cycles, (d) after 100 cycles, (e) after 200 cycles, and (f) crack density as a function of the cycle numbers. Reprinted with permission by American Chemical Society from [99], Copyright 2018. Top view and cross-sectional SEM images of the NCM851005 cathode (g,j) before cycling, (h,k) after 100 cycles and (i,l) after 500 cycles at 1C. Reprinted with permission by American Chemical Society from [154], Copyright 2019. (m–p) FESEM images of hervester LCO/NMC532 cathode electrodes at various cycle numbers. Reprinted with permission by MDPI from [153], Copyright 2017. (q,r) Cross-sectional SEM images of  $\text{Li}[\text{Ni}_{0.90}\text{Co}_{0.05}\text{Mn}_{0.05}]\text{O}_2$  at first cycle and after 1000 cycles, respectively. Reprinted with permission by American Chemical Society from [152], Copyright 2019.

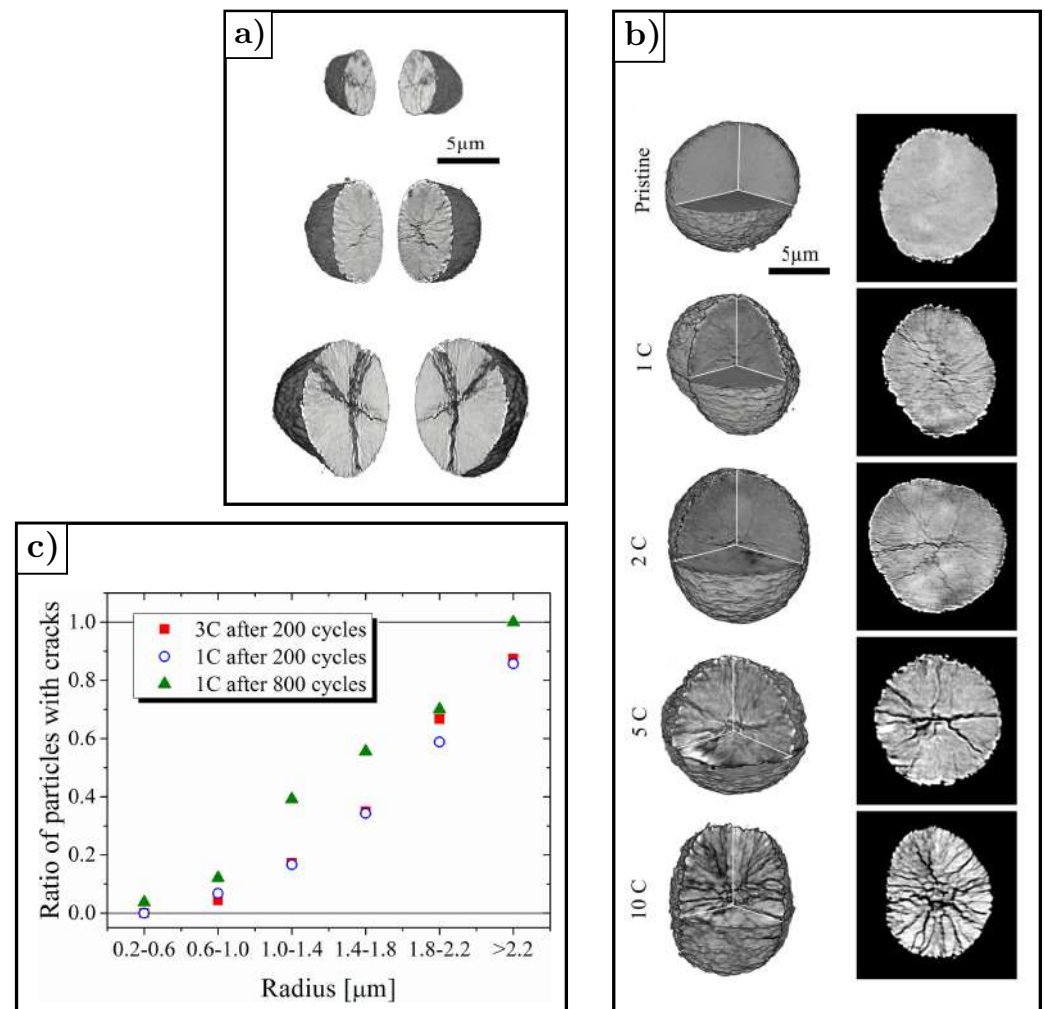
**Figure 34.** (a) Fracture in NMC particles of different size, after 50 cycles at 10C. (b) Fracture in NMC particles after 50 cycles at 1C, 2C, 3C, 5C and 10C. Reprinted with permission by Elsevier from [116], Copyright 2018. (c) Fracture occurrence in  $\text{LiMn}_{1.95}\text{Al}_{0.05}\text{O}_4$  as a function of current rates and particles radius. Reprinted with permission by Elsevier from [155], Copyright 2017.
