Review on the Experimental Characterization of Fracture in Active Material for Lithium-Ion Batteries / Pistorio, Francesca; Clerici, Davide; Mocera, Francesco; Soma, Aurelio. - In: ENERGIES. - ISSN 1996-1073. - 15:23(2022), p. 9168. [10.3390/en15239168]

# Review on the Experimental Characterization of Fracture in Active Material for Lithium-Ion Batteries

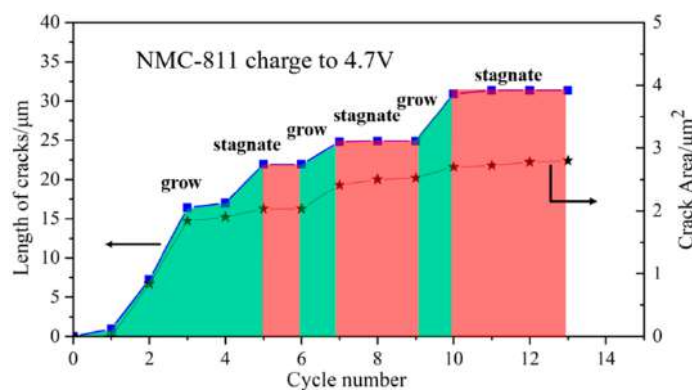
**Figure 35.** Measures of crack length and area as a function of number of cycles with in-situ SEM. The material is NMC811 cycled with a lithium counter electrode at 0.5C and 2.7 V–4.7 V. Reprinted with permission by Elsevier from [157], Copyright 2021.
