Review on the Experimental Characterization of Fracture in Active Material for Lithium-Ion Batteries

Review on the Experimental Characterization of Fracture in Active Material for Lithium-Ion Batteries / Pistorio, Francesca; Clerici, Davide; Mocera, Francesco; Soma, Aurelio. - In: ENERGIES. - ISSN 1996-1073. - 15:23(2022), p. 9168. [10.3390/en15239168]

Keywords: fracture mechanics; battery damage; experimental mechanics; damage mechanisms; lithium-ion batteries

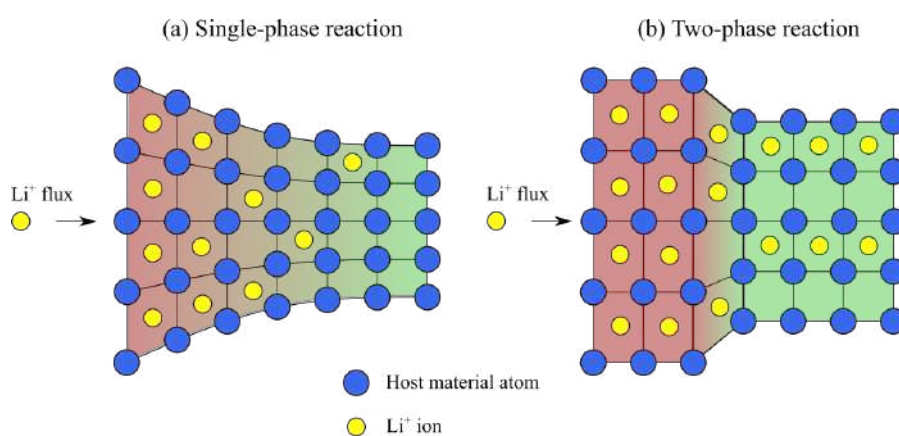
Figure 1. Mechanical stress resulting from inhomogeneous concentration due to (a) single phase-reaction and (b) phase transition.

Then, the inhomogeneous lithium concentration within the particle causes differential deformation of the lattice structure, leading to diffusion-induced stress (DIS) [8–13,21]. Furthermore, some materials show a two-phase behavior, i.e., two phases with a different lithium content coexist in the same particle, causing a significant strain mismatch at the interface between them, and thus stress, as illustrated in Figure 1b.

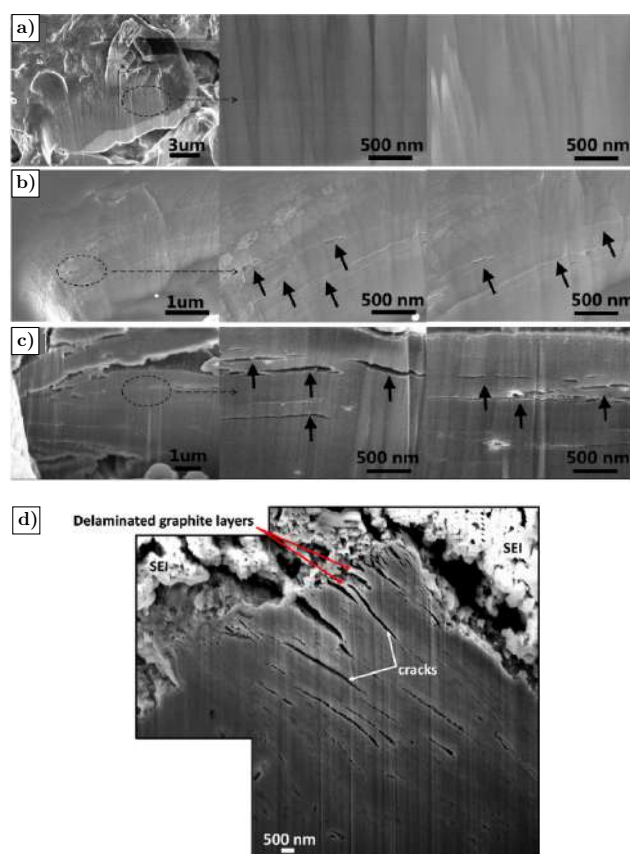
Figure 3. Cross-sectional SEM image of the (a) pristine graphite and graphite particles from cells cycled at 1C for (b) 200 and (c) 800 cycles. Black arrows point to the cracks. Reproduced with permission from Elsevier from [40], Copyright 2017. (d) Cross-section SEM image of graphite particle and SEI layer; parallel cracks may cause delamination. Reproduced with permission from Elsevier from [45], Copyright 2011.

Cracks in graphite particles are reported in the literature, and the research community is in agreement that the number of cycles and current rate are the main factors affecting the crack growth [40–44] (Figure 3), and that the formation of SEI over the fresh active material surfaces is the ultimate cause of capacity fade. Cracks are observed parallel to the larger external surface, leading the graphite to exfoliate [40,45], as shown in Figure 3c,d.

The EDX analysis revealed the presence of SEI inside the graphite particles, because electrolyte components react with the fresh active material, thereby increasing the SEI growth rate [43,45]. On the other hand, the formation of SEI on the cracks surfaces is supposed to reduce the stress intensity factor, hindering the crack growth. This phenomenon is known as roughness or asperity-induced crack closure, and it is caused by the physical contact of the SEI layers grown on the opposite flanks of the crack [45].

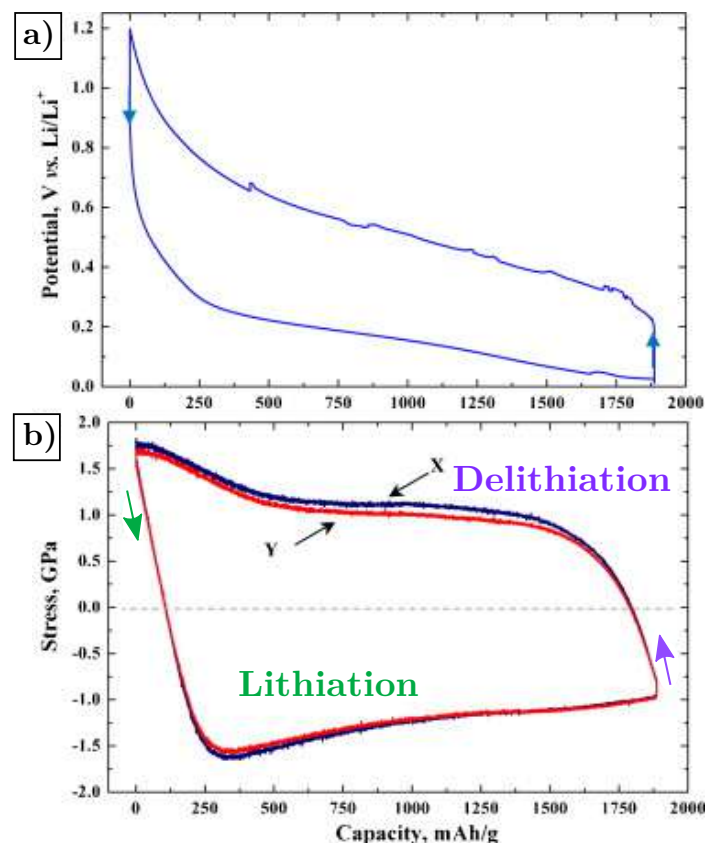
Figure 7. (a) Cell potential vs. capacity curve corresponding to lithiation and delithiation Si thin-film electrode cycled at C/4 rate, and (b) the corresponding average stress computed from the measured curvature of the substrate. Adapted with permission by Elsevier from [56], Copyright 2010.

Sethuraman et al. [56] computed the average stress of silicon thin film from the substrate curvature with a Multi-beam Optical Sensor (MOS) during lithiation and delithiation. The results of their in-situ experiments are reported in Figure 7.

It was shown that the average stress becomes elastically compressive during lithiation until 12% of the total capacity, reaching -1.75 GPa. Then, plastic flow occurs until the end of lithiation. Stress is reversed during delithiation and becomes elastically tensile until 75% capacity, reaching 1 GPa, followed by plastic flow. Therefore, delithiation is the critical phase from the fracture point of view, as the electrode is subjected to severe tensile stress.

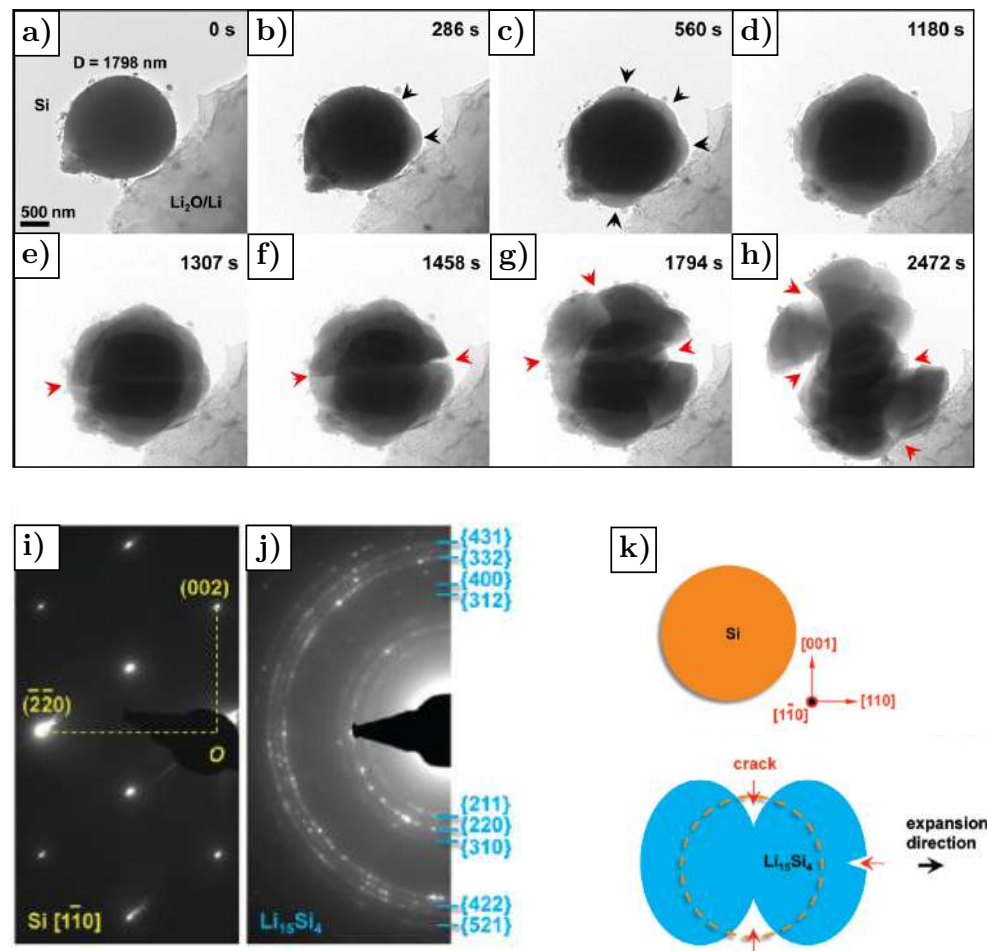
Figure 8. (a–h) Crack growth during single lithiation cycle in silicon nano-particle. The black arrows mark the bumps due to anisotropic lithiation of Si before crack formation, whereas the red arrows mark the cracks. (i,j) Electron diffraction pattern showing the silicon phase transformation from (i) crystalline structure (Si) to (j) polycrystalline structure ($\text{Li}_{15}\text{Si}_4$). (k) Anisotropic swelling in silicon nanoparticle favoring cracks in [110] direction. Reprinted with permission by American Chemical Society from [51], Copyright 2012.

Concerning silicon nano-particles, crack growth within the same particle was observed during a single lithiation, as reported in Figure 8a–h [51]. At the end of lithiation, the particle is heavily damaged, and cracks propagating along the [110] direction affect the structural stability considerably. Furthermore, the electron diffraction pattern (EDP) analysis reported in Figure 8i,j shows the phase transformation from crystalline (Si) (Figure 8i), to polycrystalline ($\text{Li}_{15}\text{Si}_4$) (Figure 8j) due to the lithiation process. Figure 8k explains the anisotropic swelling characteristic of silicon nano-particles, leading to cracks predominantly along the [110] direction [51,58].

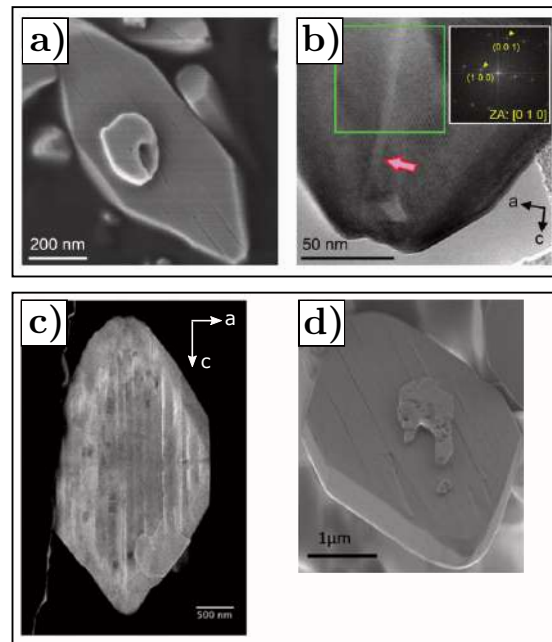
Figure 16. Top: Electron microscopy results for a micrometric plate-like LFP crystal subjected to partial chemical delithiation. (a) SEM image and (b) High-resolution transmission electron (HRTEM) image with the inset of the Fourier transform pattern obtained from the region marked with the green box. The red arrows indicate the crack running parallel to the c -axis. Reprinted with permission by American Chemical Society from [97], Copyright 2015. Bottom: SEM observations of partially delithiated $\text{Li}_{0.5}\text{PO}_4$ crystal. (c) SEM image and (d) STEM-HAADF image, showing cracks evenly spaced and oriented along the c -axis. Reprinted with permission by American Chemical Society from [96], Copyright 2013.

A similar mechanism, with the phase boundary oriented along the bc plane, was also supported by other experimental observations in ex-situ chemically delithiated LFP particles, as reported in [96,97] and illustrated in Figure 16a–d.

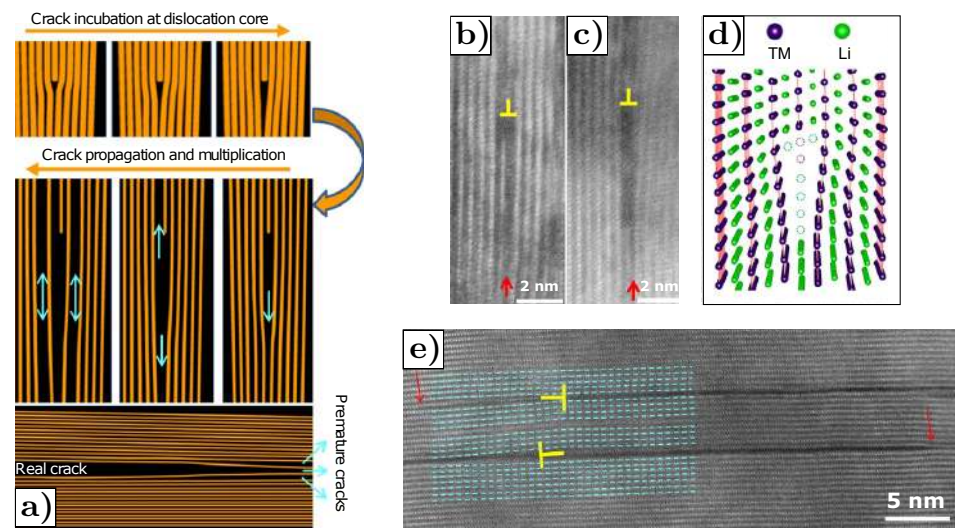
Figure 22. (a) Schematic diagrams of the dislocation-assisted crack incubation, propagation and multiplication process in NMC cathode particles. (b,c) Nucleation of premature cracks at the dislocation core in NMC333 cycled particles, also schematized in (d). (e) Edge dislocations associated with intragranular cracks in cycled NMC333 particles. Crack tip is indicated with the red arrows. Reprinted with permission from Springer Nature by [108], Copyright 2017.

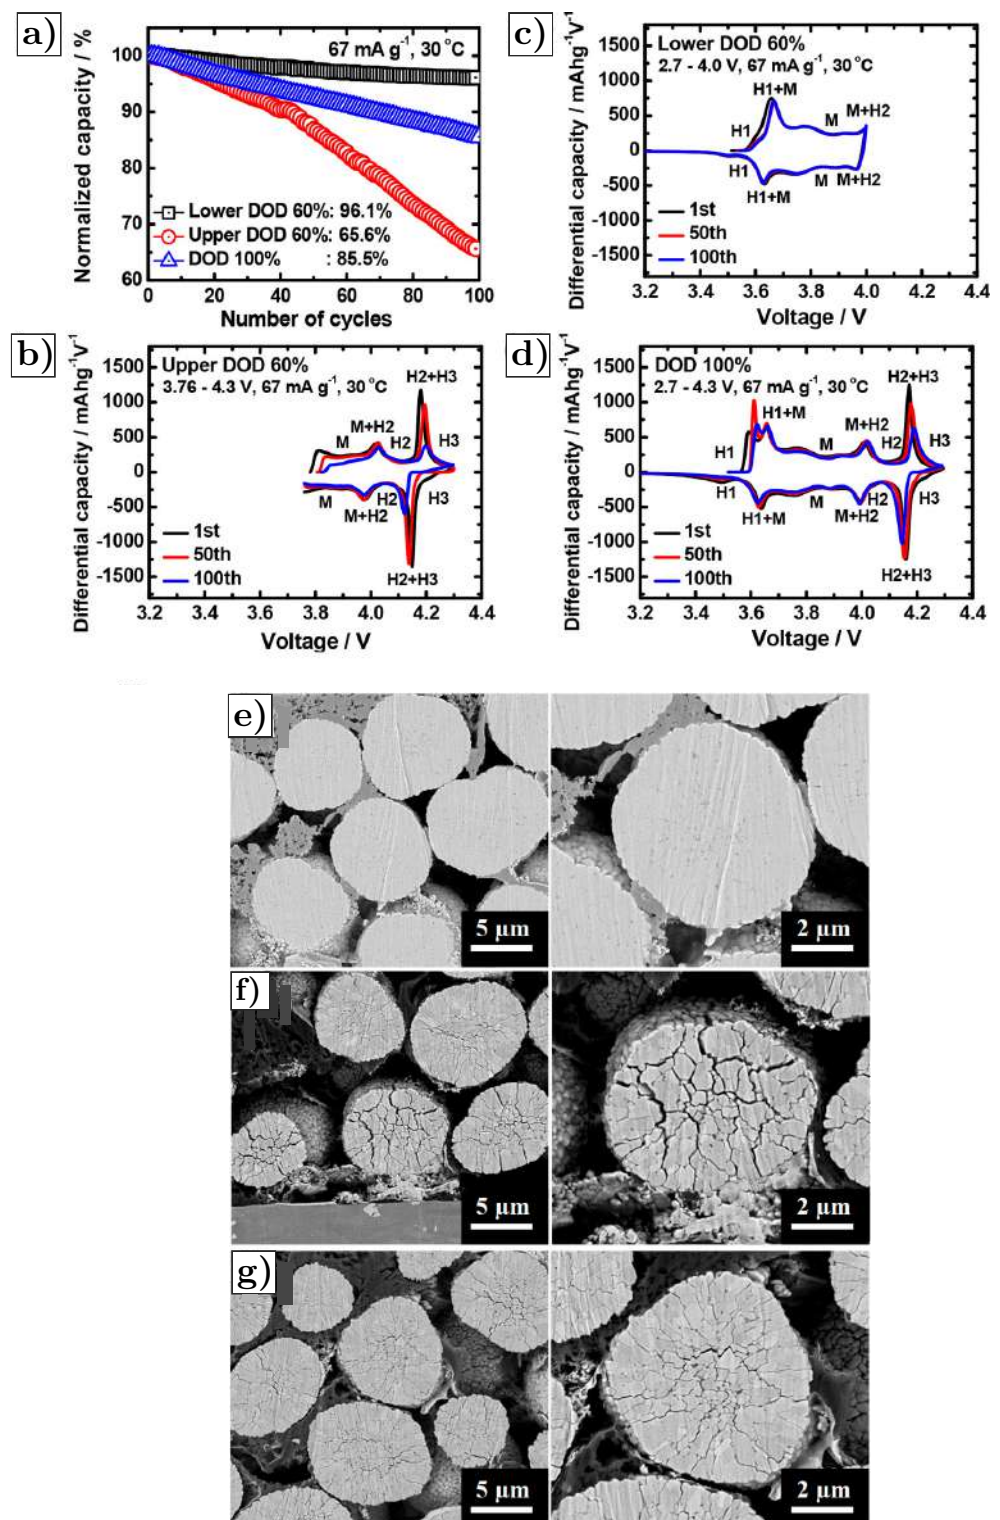
Figure 27. (a) Capacity decay of NCA95 during cycling at different DOD and initial SOC values. Derivative of charge-discharge curves of NCA95 cycled (b) from SOC 40 to 100% (3.76–4.3 V) (c) from SOC 0 to 60%, (d) from SOC 0 to 100%. Cross-sectional SEM images of NCA95 particles cycled for 100 cycles (e) from SOC 0 to 60%, (f) from SOC 40 to 100% and (g) from SOC 0 to 100%. Reprinted with permission by American Chemical Society from [132], Copyright 2019.

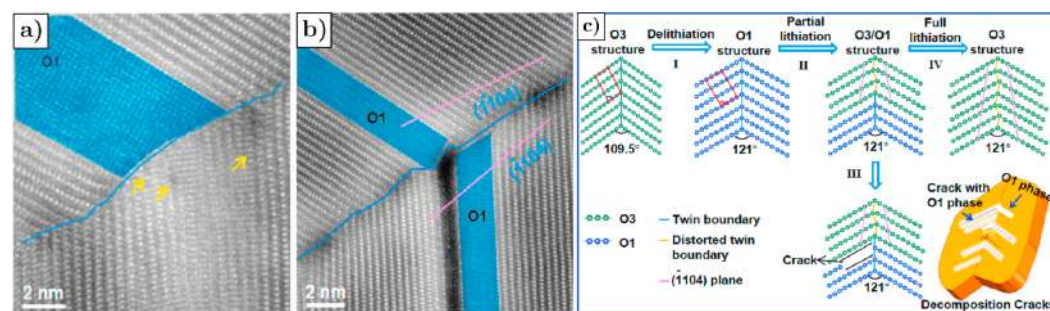
Figure 30. Phase transition induced cracking at the twin boundary. (a) A STEM-HAADF image showing the O1 phase (light blue region) formed at the highly distorted twin boundary, indicated by the light blue line. Incubation cracks at the twin boundary are marked by yellow arrows. (b) Decomposition crack formed along an O1 phase strip. (c) Schematic diagrams illustrating the cracking mechanism induced by phase transition at the twin boundary. Reprinted with permission by Elsevier from [136], Copyright 2020.

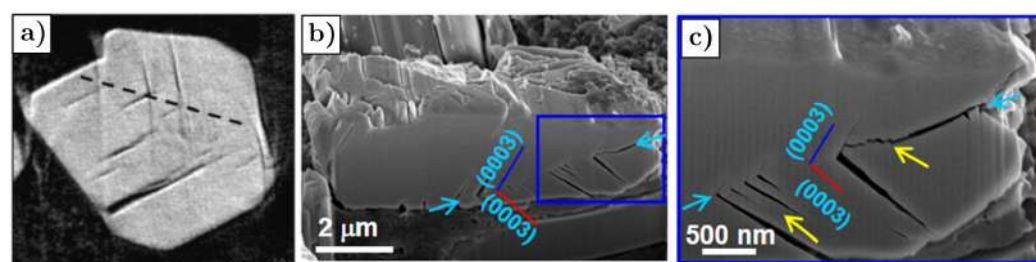
Figure 31. Cracking along the twin boundary. (a) Reconstructed image from X-ray nano-tomography reprinted from [137]. (b,c) SEM images of a cross-section of LCO particles (milled with FIB), showing cracks originating from twin boundary and their planes direction. Reprinted with permission by Elsevier from [136], Copyright 2020.

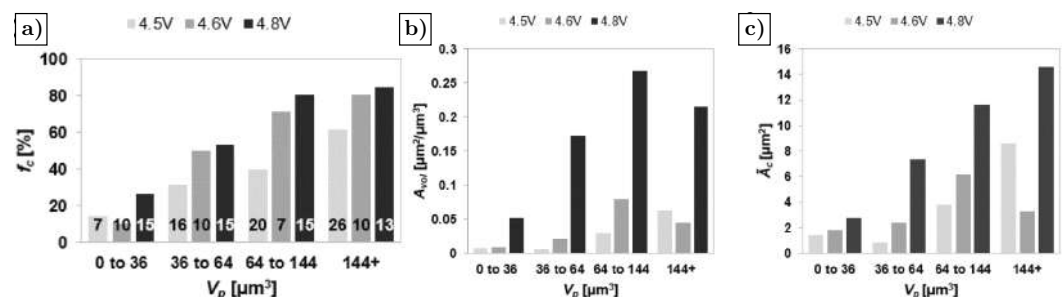
Figure 32. (a) The percentage of LCO particles within a given volume range that contains cracks after a single charge cycle to a given cutoff voltage. (b) The crack area per unit of volume for particles within a given volume range after a single charge cycle to a given cutoff voltage. (c) The average individual crack area (proportional to crack length) for particles within a given volume range after a single charge cycle to a given cutoff voltage. Reprinted with permission by Elsevier from [137], Copyright 2022.

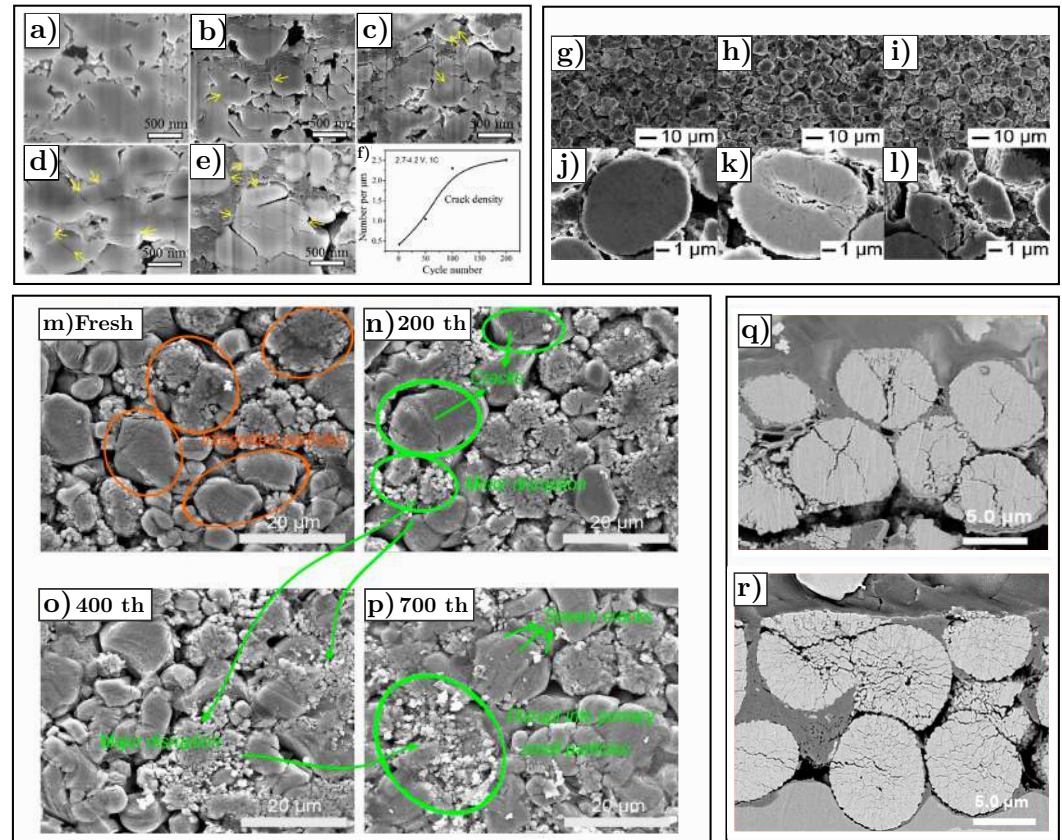
Figure 33. (a–f) Cross sectional SEM images of cracks evolution in LiFePO₄ cathode cycled at 1C. Samples (a) before cycling, (b) after 1 cycle, (c) after 50 cycles, (d) after 100 cycles, (e) after 200 cycles, and (f) crack density as a function of the cycle numbers. Reprinted with permission by American Chemical Society from [99], Copyright 2018. Top view and cross-sectional SEM images of the NCM851005 cathode (g,j) before cycling, (h,k) after 100 cycles and (i,l) after 500 cycles at 1C. Reprinted with permission by American Chemical Society from [154], Copyright 2019. (m–p) FESEM images of hervester LCO/NMC532 cathode electrodes at various cycle numbers. Reprinted with permission by MDPI from [153], Copyright 2017. (q,r) Cross-sectional SEM images of Li[Ni_{0.90}Co_{0.05}Mn_{0.05}]O₂ at first cycle and after 1000 cycles, respectively. Reprinted with permission by American Chemical Society from [152], Copyright 2019.

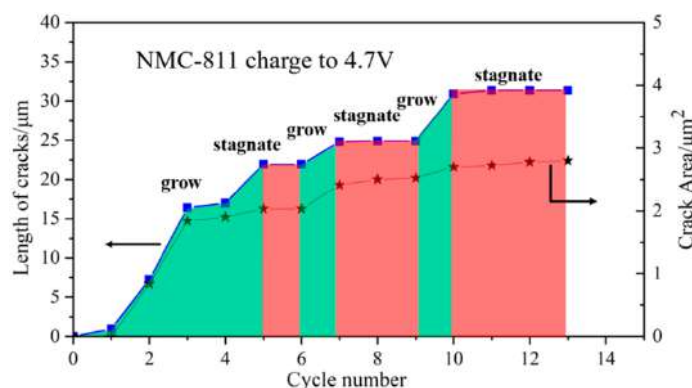
Figure 35. Measures of crack length and area as a function of number of cycles with in-situ SEM. The material is NMC811 cycled with a lithium counter electrode at 0.5C and 2.7 V–4.7 V. Reprinted with permission by Elsevier from [157], Copyright 2021.
