An analysis of metal wear in rock excavation by TBM

M. Cardu, A. Di Giovanni & S. Saltarin

DIATI Politecnico di Torino, Italy

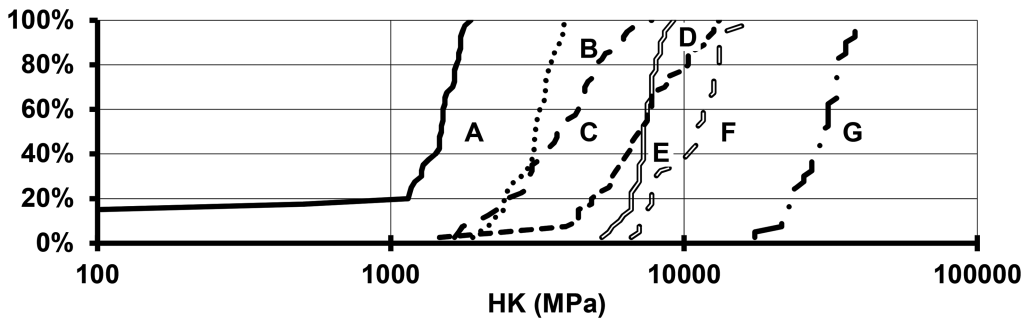
Figure 1. Examples of microhardness frequency distribution diagrams. Semilog charts are employed due to the extremely wide hardness range. A: travertine (negligible hardness points, amounting to 18-20 %, are pores); B: dolomitic limestone; C: serpentinite; D: fine-grained white granite; E: hard steel, from a crusher jaw; F: hard steel, from a TBM disc; G: sintered carbide prism, from stone chain cutter.

The second difficulty has been solved by adopting a statistical representation (frequency distribution diagram) of the measured punctual hardness values, represented on a semi-logarithmic scale. A reproducible distribution diagram can be drawn based on at least 40 readings, even in inhomogeneous materials (i.e. granitic rocks). Diagrams presented in this report are obtained according to the suggested number of readings, both for rocks and for metals. Examples are shown in Figure 1. To be noticed the significant inhomogeneity at the micro-metric scale, featured by visually homogeneous materials like metals. Only homogeneous glasses are exempt from small-scale inhomogeneity. In the case of TBMs, the well-known and theorized dependence of the disk replacement on its position (center, mid, periphery) on the TBM head can be explained simply by the different amounts of excavation work allocated to the different discs. Apart from that, tool service life depends on the "sensitivity" to the metal loss of the tool, which means, the amount of metal loss tolerated without serious impairment of the efficiency (for example, drag bits are more sensitive than discs, and small discs more sensitive than large discs). Lastly, service life depends, jointly, on the rock excavated and on the metal employed to make the tools (Oñate Salazar et al. 2018).

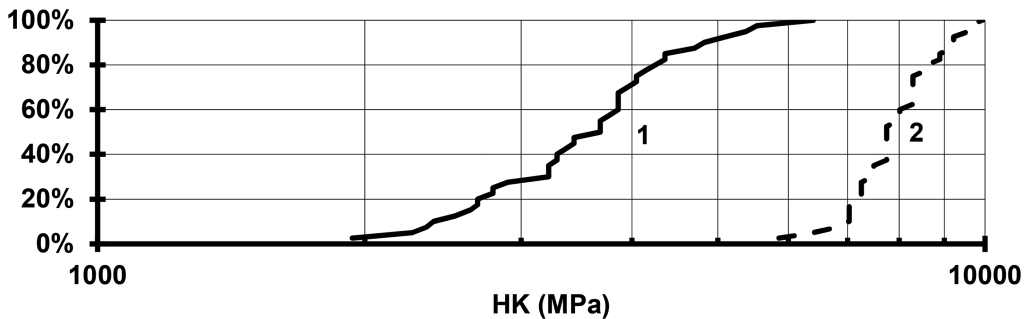
Figure 2. Micro-hardness cumulated frequency distribution diagrams for a serpentinite (A) quarried for railroad ballast, and for the steel tools (B) of which the jaws of the crusher employed are composed.

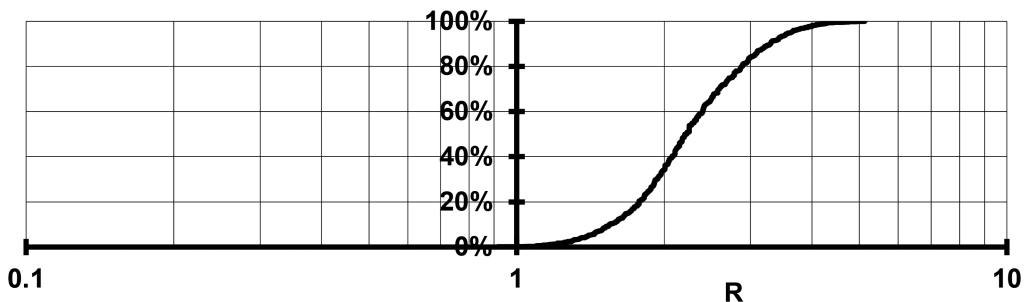
Figure 3. Hardness ratio distribution diagram for case of Figure 2.

diagrams so drawn proved to be highly reproducible. The hardness ratio distribution diagram can show how frequent are random contacts where the hardness ratio between metal and rock falls below a “safe limit” excluding damage to the wear part; the more displaced towards the right is the diagram, the less serious should be the wear problem. When R is lower than 1, the microhardness of the rock is higher than that of one of the steel tools.

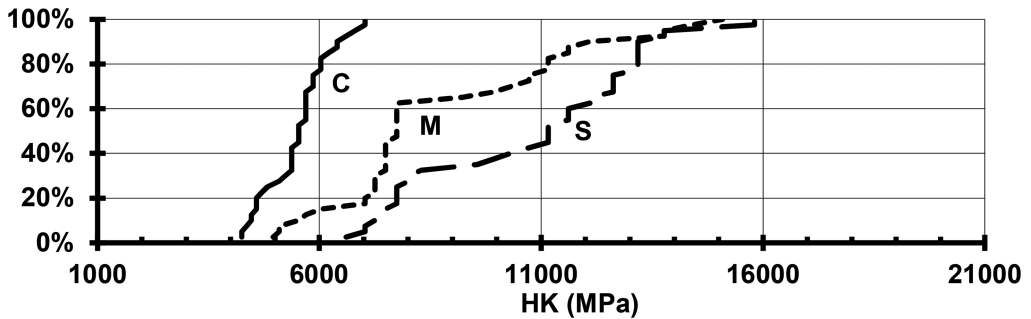
Figure 4. Hardness distribution diagram obtained from tests on different parts of the cross-section of the cutting ring of the TBM disc of case A. S: testing area close to the cutting edge (down to 1 cm depth); C: the core of the ring; M: 40 points randomly distributed in the cross-section.

Hardness analysis of the cross-section of the discs reveals different metal hardening strategies: in some cases, the same hardness distribution diagram is obtained, irrespective of the distance of the tested area from the cutting edge, in other cases (case A) the metal close to the cutting edge is harder than the core (Figure 4). Analysing Figure 4, it can be deemed that a different hardening process has been employed in order to save the toughness of the core metal.

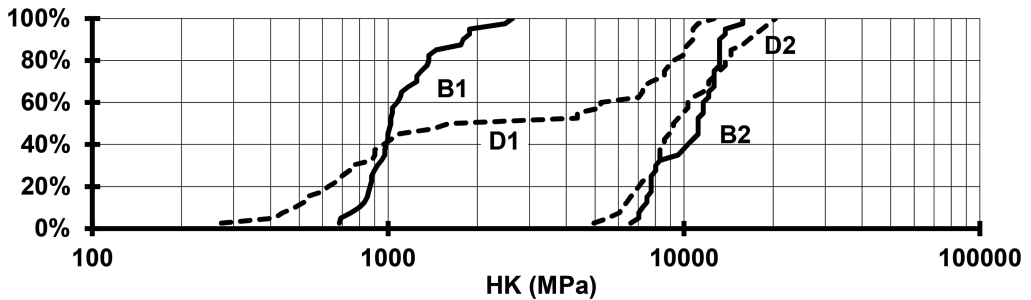
Figure 5. Rock and metal hardness distribution diagrams for the two TBM operations: B1: dolomitic limestone; B2: TBM disc employed in dolomitic limestone boring; D1: hard gneiss; D2: TBM disc employed (failed attempt).

Figures 5-6 refer to cases B and D (hydropower tunnels). As reported in Table 1, rocks were a dolomitic limestone in case B and a hard gneiss in case D. A somewhat harder, but not dif-

ferent hardened, steel was selected for the discs employed in the latter case. Tunnel B was successfully driven, with reasonable tool consumption (0.0022 discs/m³, see Table 3) while case D was unsuccessful. In detail, in case D operation was discontinued at 30 m chainage, being all discs out of service (the rock was probably beyond the practical limit for steel discs).

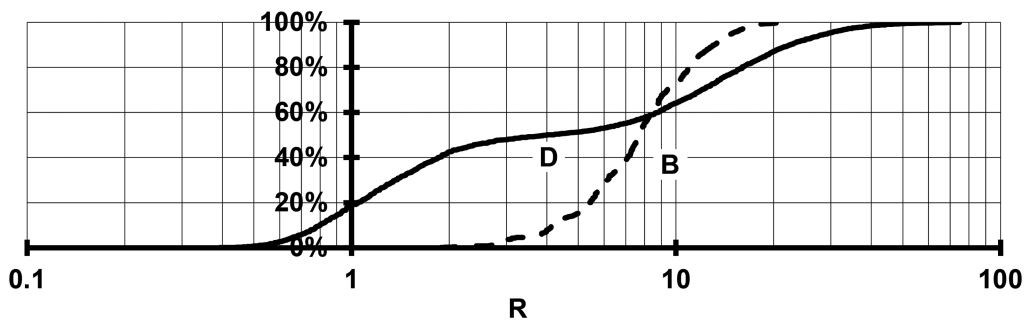
Figure 6. Hardness ratio distribution diagrams for the two cases of Figure 5. B: steel B2 v/ dolomitic limestone B1; D: steel D2 v/ gneiss D1. The problem related to case D can be easily noticed, where the hardness of the metal is lower than that of the rock in ~20% of the interactions. In fact, case D was unsuccessful.

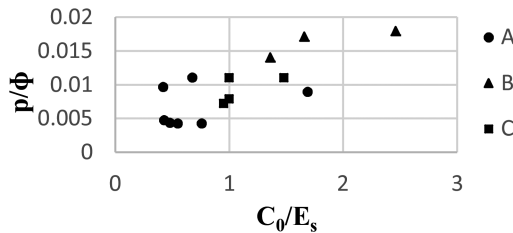
Figure 7. Left: Relationship between p/ϕ , and C_0/E_s for the cases A, B, and C of Table 1.

$$C_0/E_s \sim 100 p/\phi \tag{2}$$

Figures 7-8 show the trends found in cases A, B, C relating to (1) and (2).

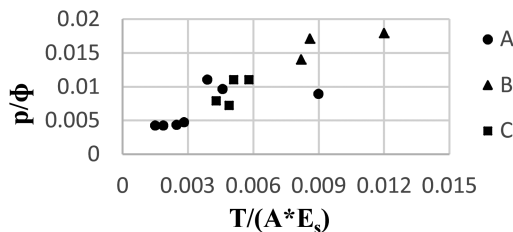
Figure 8. Right: Relationship between p/ϕ and $T/(A \cdot E_s)$ for the cases A, B, and C of Table 1.

$$T/(A \cdot E_s) \sim 0.5 p/\phi \tag{1}$$

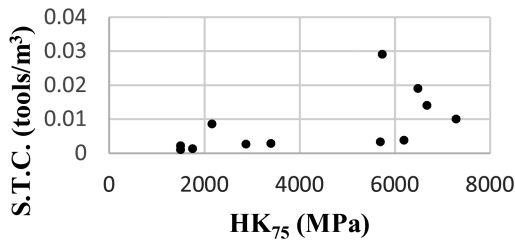
Figure 9. S.T.C. vs HK_{75} .

Tools performance is as a rule characterized by the S.T.C., the number of tools replaced per m^3 excavated. Rocks are usually characterized by abrasiveness indicators, such as the NCB Indenter index (Szlavin 1971), the Schimanek coefficient (Schimanek 1970), the quartz content, the indexes from drillability tests with small diameter bits, CERCHAR indices, micro-hardness and so on (Alber 2008, Deketh 2020). A clear trend may be noted in Figure 9 between S.T.C. and the rock micro-hardness (HK_{75}). The trend of the S.T.C. vs. s/q , where s is the flattened surface (mm^2) of the bit after one minute of drilling and q is the volume (mm^3) of the rock drilled during the same time, appears less significant in Figure 10: the rocks tested fall into two broad families: scarcely abrasive at left (sedimentary rocks), and abrasive at right (volcanic or highly metamorphosed rocks). The dispersion still observed inside each group is due to machine and tools variability and to reasons tentatively explained in the following.

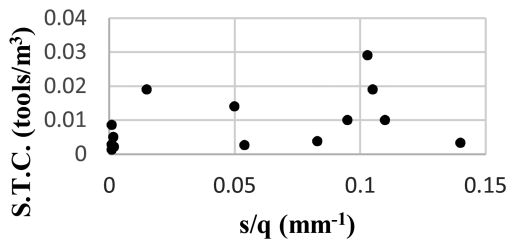
Figure 10. S.T.C. vs s/q .

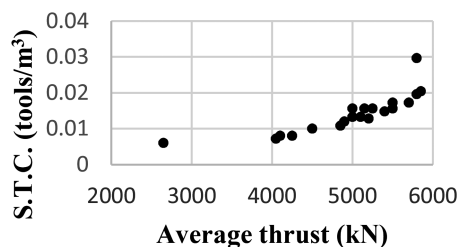
Figure 11. S.T.C. vs average thrust.

Of course, the specific tool consumption also depends on the machine parameters. The example in Figure 11 shows, for the cases examined, the influence of the average thrust on this parameter: as the thrust increases the specific consumption of tools increases. However, this simple statement hides a more complex phenomenon that requires to be better discussed since different factors play an important role on the wear. Firstly, the increase in thrust, considering a given penetration (corresponding to a given forward speed), is commonly performed when encountering a harder rock. In any case, the thrust cannot be indefinitely increased (due to mechanical constraints of the cutters and/or machine advancement system), consequently the penetration decreases above a certain rock strength, therefore more machine-head revolutions are necessary to cover the feed unit. Secondly, the hardness of cutting rings should also be considered for the wear phenomenon, since it is possible that by increasing the thrust, the embrittlement phenomenon also increases with a consequent increase in wear. Finally, the direction of advance of the machine and the presence of water during the excavation process also play an important role in wear. In conclusion, with reference to Figure 11, it can be hypothesized that the increase in S.T.C. could be due to the increase in the machine-head revolutions, as well as the increase in the embrittlement phenomenon. As for the last two factors, no information is available on the presence of water, while only a comparison between projects with differently oriented heading directions could highlight the important role of this factor on the tools wear. Concluding, to limit the wear, it is necessary to accept more limited performance in terms of advancement of the TBM.
