An analysis of metal wear in rock excavation by TBM

M. Cardu, A. Di Giovanni & S. Saltarin

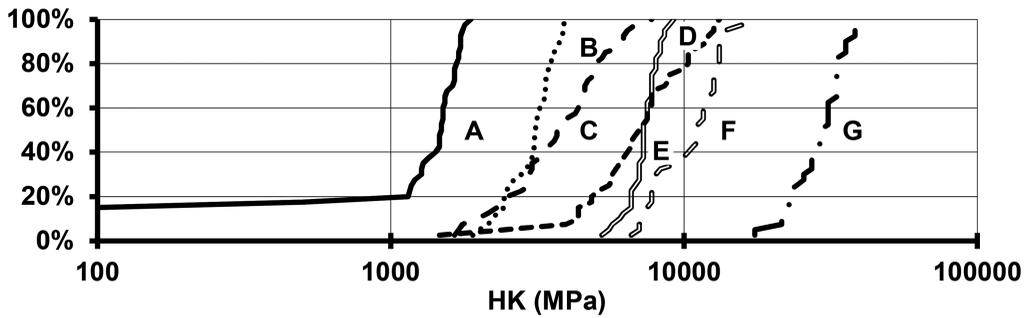
Figure 1. Examples of microhardness frequency distribution diagrams. Semilog charts are employed due to the extremely wide hardness range. A: travertine (negligible hardness points, amounting to 18-20 %, are pores); B: dolomitic limestone; C: serpentinite; D: fine-grained white granite; E: hard steel, from a crusher jaw; F: hard steel, from a TBM disc; G: sintered carbide prism, from stone chain cutter.

The second difficulty has been solved by adopting a statistical representation (frequency distribution diagram) of the measured punctual hardness values, represented on a semi-logarithmic scale. A reproducible distribution diagram can be drawn based on at least 40 readings, even in inhomogeneous materials (i.e. granitic rocks). Diagrams presented in this report are obtained according to the suggested number of readings, both for rocks and for metals. Examples are shown in Figure 1. To be noticed the significant inhomogeneity at the micro-metric scale, featured by visually homogeneous materials like metals. Only homogeneous glasses are exempt from small-scale inhomogeneity. In the case of TBMs, the well-known and theorized dependence of the disk replacement on its position (center, mid, periphery) on the TBM head can be explained simply by the different amounts of excavation work allocated to the different discs. Apart from that, tool service life depends on the "sensitivity" to the metal loss of the tool, which means, the amount of metal loss tolerated without serious impairment of the efficiency (for example, drag bits are more sensitive than discs, and small discs more sensitive than large discs). Lastly, service life depends, jointly, on the rock excavated and on the metal employed to make the tools (Oñate Salazar et al. 2018).

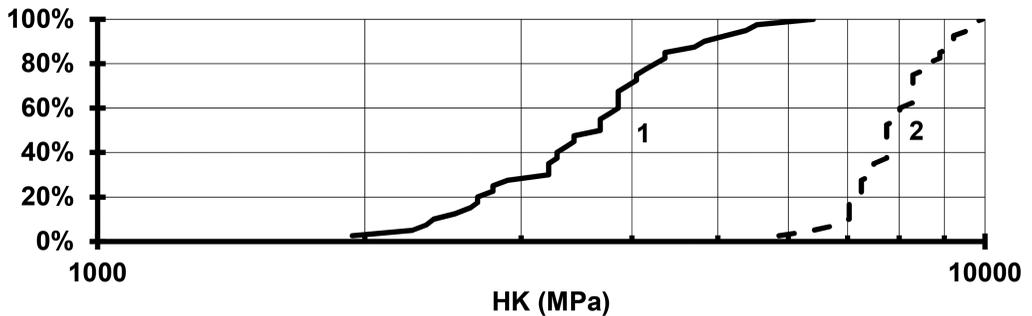
Figure 2. Micro-hardness cumulated frequency distribution diagrams for a serpentinite (A) quarried for railroad ballast, and for the steel tools (B) of which the jaws of the crusher employed are composed.

It is assumed that, during operation, the rock elements and the metal parts come in contact repeatedly, and that instantaneous contact points are randomly distributed on the rock elements and on the metal parts. The hardness ratio between metal and rock at the contact point is linked to the severity of the elementary wear event. The pair can be therefore characterized by the cumulated frequency distribution diagram of the metal-rock hardness ratio at randomly distributed contact points. As already reported, the diagram can be obtained by 40 metal and 40 rock hardness values employed to characterize the individual materials: it consists of a total number of 1600 equiprobable hardness ratio values (R). As an example, Figure 2 depicts two curves related to the micro-hardness cumulated frequency distribution of a serpentinite (1) and of the steel of which the employed jaw crusher is made up (2). Figure 3 instead reports the 1600 equiprobable hardness ratio values (R) and the relative cumulated frequency distribution. The

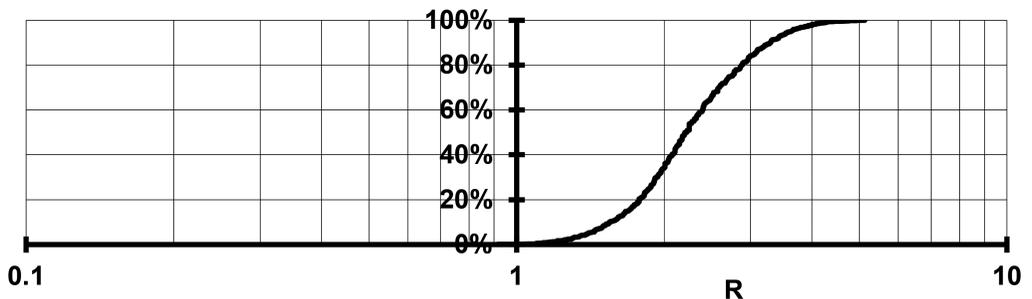
Figure 3. Hardness ratio distribution diagram for case of Figure 2.

diagrams so drawn proved to be highly reproducible. The hardness ratio distribution diagram can show how frequent are random contacts where the hardness ratio between metal and rock falls below a “safe limit” excluding damage to the wear part; the more displaced towards the right is the diagram, the less serious should be the wear problem. When R is lower than 1, the microhardness of the rock is higher than that of one of the steel tools.

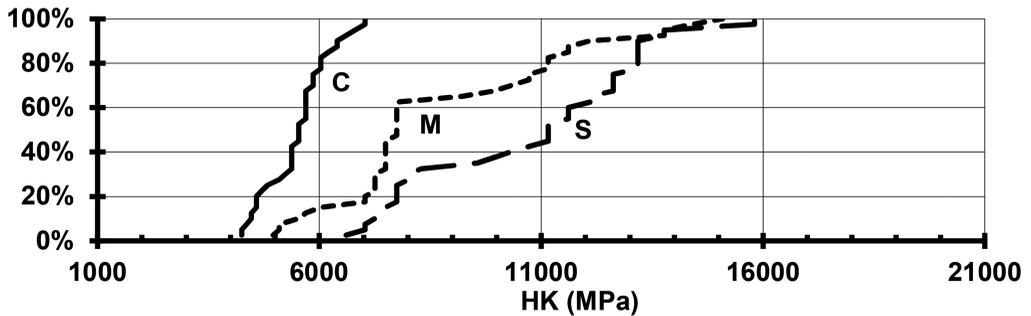
Figure 4. Hardness distribution diagram obtained from tests on different parts of the cross-section of the cutting ring of the TBM disc of case A. S: testing area close to the cutting edge (down to 1 cm depth); C: the core of the ring; M: 40 points randomly distributed in the cross-section.

Hardness analysis of the cross-section of the discs reveals different metal hardening strategies: in some cases, the same hardness distribution diagram is obtained, irrespective of the distance of the tested area from the cutting edge, in other cases (case A) the metal close to the cutting edge is harder than the core (Figure 4). Analysing Figure 4, it can be deemed that a different hardening process has been employed in order to save the toughness of the core metal.

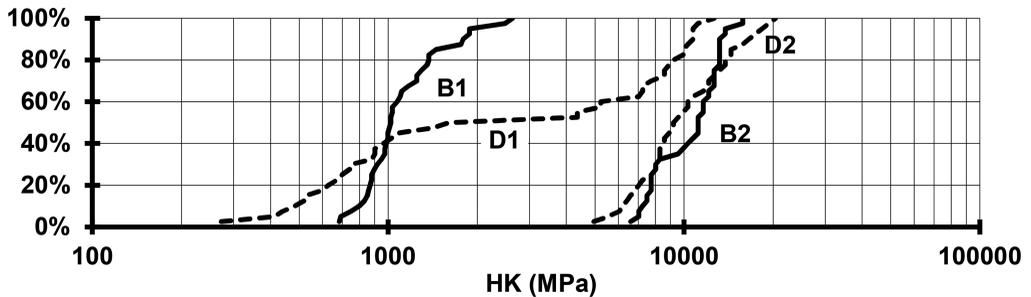
Figure 5. Rock and metal hardness distribution diagrams for the two TBM operations: B1: dolomitic limestone; B2: TBM disc employed in dolomitic limestone boring; D1: hard gneiss; D2: TBM disc employed (failed attempt).

Figures 5-6 refer to cases B and D (hydropower tunnels). As reported in Table 1, rocks were a dolomitic limestone in case B and a hard gneiss in case D. A somewhat harder, but not dif-

ferent hardened, steel was selected for the discs employed in the latter case. Tunnel B was successfully driven, with reasonable tool consumption (0.0022 discs/m^3 , see Table 3) while case D was unsuccessful. In detail, in case D operation was discontinued at 30 m chainage, being all discs out of service (the rock was probably beyond the practical limit for steel discs).

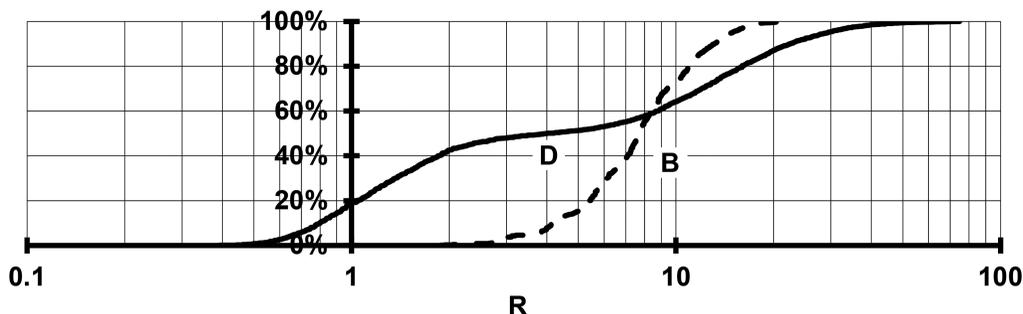
Figure 6. Hardness ratio distribution diagrams for the two cases of Figure 5. B: steel B2 v/ dolomitic limestone B1; D: steel D2 v/ gneiss D1. The problem related to case D can be easily noticed, where the hardness of the metal is lower than that of the rock in ~20% of the interactions. In fact, case D was unsuccessful.

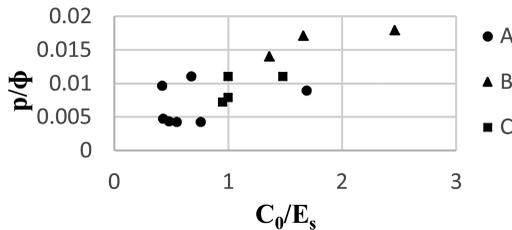
Figure 7. Left: Relationship between p/ϕ , and C_0/E_s for the cases A, B, and C of Table 1.

The description of the behavior of the TBM can however be synthesized, as far as the net progression rate is concerned, with the relationships linking three dimensionless ratios, that are: p/ϕ , C_0/E_s , $T/(A \cdot E_s)$, where p is TBM's penetration per revolution (mm), ϕ is the disc diameter (mm), E_s is the specific energy (MJ/m³), T the thrust (MN), A is the cross-section of the tunnel (m²). In Figures 7-8, p/ϕ is plotted against C_0/E_s and $T/(A \cdot E_s)$ respectively. With reference to Table 1, only cases A, B, and C were considered for the analysis. Despite the wide scatter, both suggest linear relationships that can be synthesized with equations (1) and (2):

$$C_0/E_s \sim 100 p/\phi \tag{2}$$

Figures 7-8 show the trends found in cases A, B, C relating to (1) and (2).

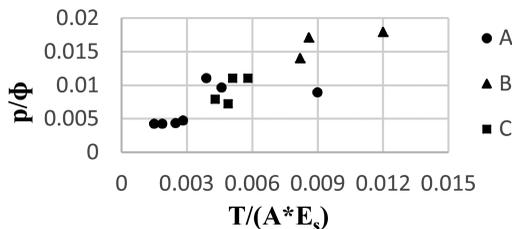
Figure 8. Right: Relationship between p/ϕ and $T/(A \cdot E_s)$ for the cases A, B, and C of Table 1.

$$T/(A \cdot E_s) \sim 0.5 p/\phi \tag{1}$$

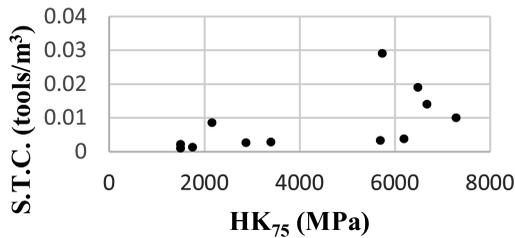
Figure 9. S.T.C. vs HK_{75} .

Tools performance is as a rule characterized by the S.T.C., the number of tools replaced per m^3 excavated. Rocks are usually characterized by abrasiveness indicators, such as the NCB Indenter index (Szlavin 1971), the Schimanek coefficient (Schimanek 1970), the quartz content, the indexes from drillability tests with small diameter bits, CERCHAR indices, micro-hardness and so on (Alber 2008, Deketh 2020). A clear trend may be noted in Figure 9 between S.T.C. and the rock micro-hardness (HK_{75}). The trend of the S.T.C. vs. s/q , where s is the flattened surface (mm^2) of the bit after one minute of drilling and q is the volume (mm^3) of the rock drilled during the same time, appears less significant in Figure 10: the rocks tested fall into two broad families: scarcely abrasive at left (sedimentary rocks), and abrasive at right (volcanic or highly metamorphosed rocks). The dispersion still observed inside each group is due to machine and tools variability and to reasons tentatively explained in the following.

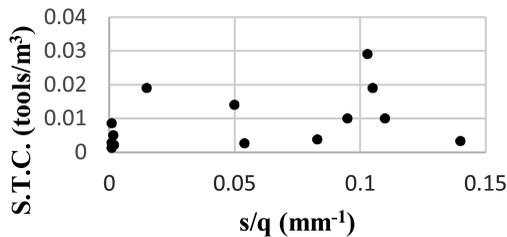
Figure 10. S.T.C. vs s/q .

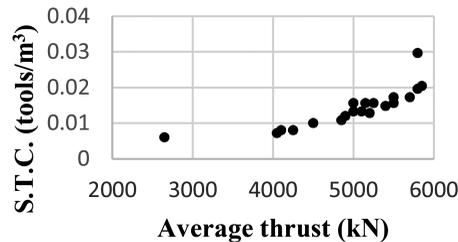
Figure 11. S.T.C. vs average thrust.

Of course, the specific tool consumption also depends on the machine parameters. The example in Figure 11 shows, for the cases examined, the influence of the average thrust on this parameter: as the thrust increases the specific consumption of tools increases. However, this simple statement hides a more complex phenomenon that requires to be better discussed since different factors play an important role on the wear. Firstly, the increase in thrust, considering a given penetration (corresponding to a given forward speed), is commonly performed when encountering a harder rock. In any case, the thrust cannot be indefinitely increased (due to mechanical constraints of the cutters and/or machine advancement system), consequently the penetration decreases above a certain rock strength, therefore more machine-head revolutions are necessary to cover the feed unit. Secondly, the hardness of cutting rings should also be considered for the wear phenomenon, since it is possible that by increasing the thrust, the embrittlement phenomenon also increases with a consequent increase in wear. Finally, the direction of advance of the machine and the presence of water during the excavation process also play an important role in wear. In conclusion, with reference to Figure 11, it can be hypothesized that the increase in S.T.C. could be due to the increase in the machine-head revolutions, as well as the increase in the embrittlement phenomenon. As for the last two factors, no information is available on the presence of water, while only a comparison between projects with differently oriented heading directions could highlight the important role of this factor on the tools wear. Concluding, to limit the wear, it is necessary to accept more limited performance in terms of advancement of the TBM.
