Raw Earth Construction Perspectives in Italy: An Overview Through the Rehabilitations of Casa Fenu in Villamassargia, Sardinia, and Casa di Teresa in Casalincontrada, Abruzzo

Raw Earth Construction Perspectives in Italy: An Overview Through the Rehabilitations of Casa Fenu in Villamassargia, Sardinia, and Casa di Teresa in Casalincontrada, Abruzzo / Bocci, Martina. - In: JOURNAL OF TRADITIONAL BUILDING, ARCHITECTURE AND URBANISM. - ISSN 2660-583X. - 2(2021), pp. 409-422. [10.51303/jtbau.vi2.529]

Martina Bocci

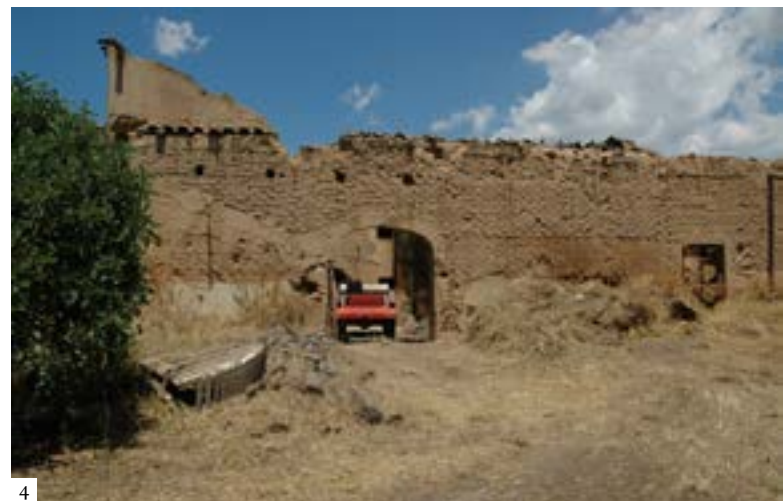
Figure 4: The arch between courtyards I and II in 2005 (Ignazio Garau)

The ox yard (II) was the center of the complex, with a portico for sheltering animals and storing materials (Fig. 4).

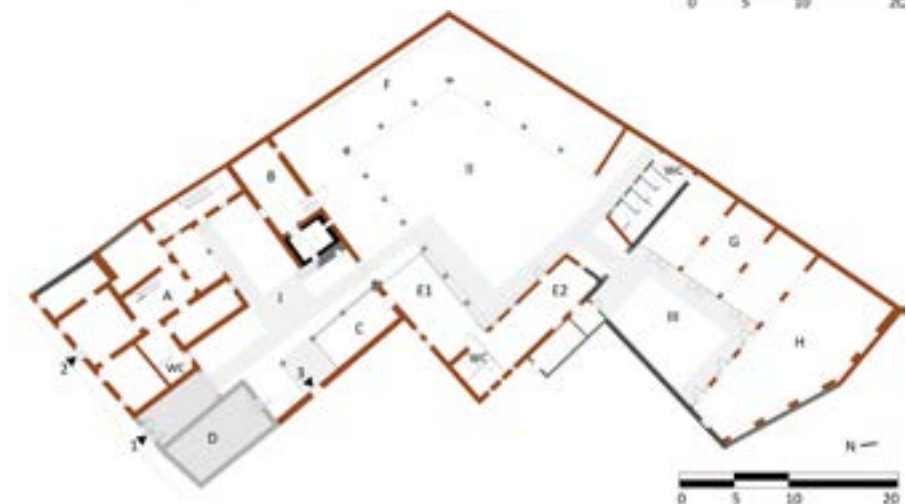
Figure 6: Project plan, ground floor.
 Courtyard I: A) exhibition rooms and tourist agency; B) storerooms; C) tasting rooms; D) Villa Fenu; 1) portal and entrance hall to the courtyard; 2) main entrance; 3) connection to Villa Fenu.
 Courtyard II: E1) cafeteria and E2) kitchens; F) exhibition area.
 Courtyard III: G) workshop and laboratories; H) conference room.
 Red: ladriri masonry; black: concrete; dark grey: stone masonry; grey: fired bricks and hollow bricks

The restoration was based on different approaches in each part of the complex (Figs. 5 and 6); raw earth was used even in partially or completely rebuilt parts.

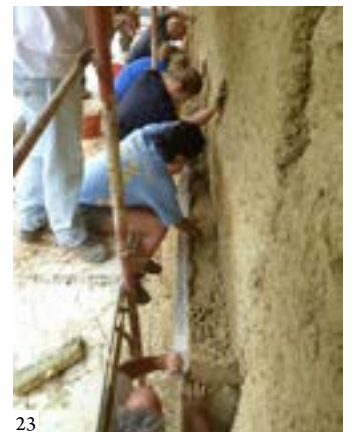
23

Figure 23: Laying of *massoni* by workshop participants: they can be thrown with force, to allow the release of excess water, or laid on beds of dry straw and pressed to adhere and penetrate each pore (CEDTerra)
