Raw Earth Construction Perspectives in Italy: An Overview Through the Rehabilitations of Casa Fenu in Villamassargia, Sardinia, and Casa di Teresa in Casalincontrada, Abruzzo

Raw Earth Construction Perspectives in Italy: An Overview Through the Rehabilitations of Casa Fenu in Villamassargia, Sardinia, and Casa di Teresa in Casalincontrada, Abruzzo / Bocci, Martina. - In: JOURNAL OF TRADITIONAL BUILDING, ARCHITECTURE AND URBANISM. - ISSN 2660-583X. - 2(2021), pp. 409-422. [10.51303/jtbau.vi2.529]

Martina Bocci

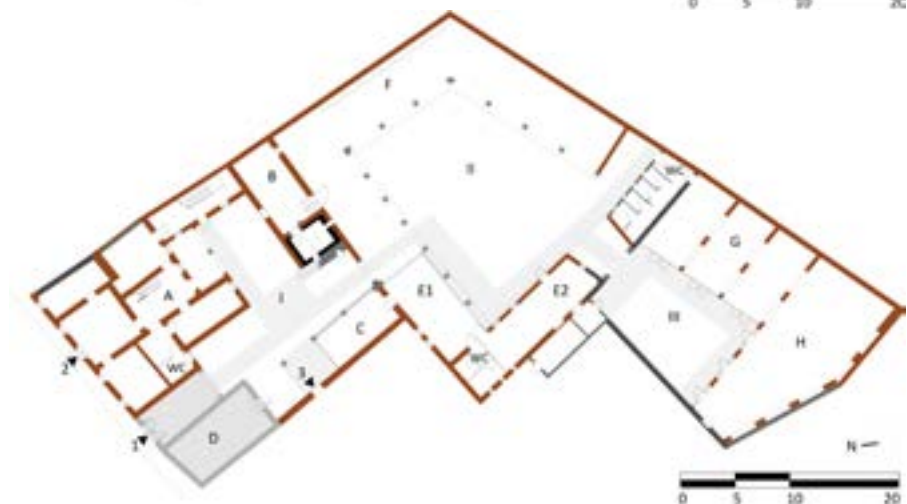
Figure 6: Project plan, ground floor.

Courtyard I: A) exhibition rooms and tourist agency; B) storerooms; C) tasting rooms; D) Villa Fenu; 1) portal and entrance hall to the courtyard; 2) main entrance; 3) connection to Villa Fenu.

Courtyard II: E1) cafeteria and E2) kitchens; F) exhibition area. Courtyard III: G) workshop and laboratories; H) conference room. Red: *ladiri* masonry; black: concrete; dark grey: stone masonry; grey: fired bricks and hollow bricks

The restoration was based on different approaches in each part of the complex (Figs. 5 and 6); raw earth was used even in partially or completely rebuilt parts.

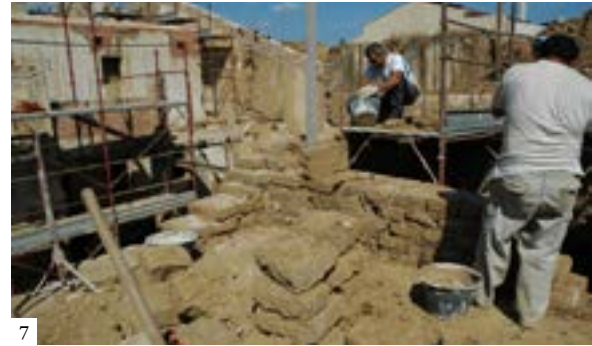
Figure 7: In the reconstruction work of building B, the reuse of original *ladiri* in good condition was frequent. The earth derived from the demolition, heterogeneous and with spurious materials, was not reused within the construction site, but was instead reused to fill the land where the earth used for the new bricks was extracted from. (Ignazio Garau)

between opposite walls. Damaged wall portions were demolished and rebuilt with new *ladiri* (Fig. 7) measuring 10x20x40 cm, made by hand with a mix of earth and fibers and laid on an earth, lime, and sand mortar bed. Minimum requirements for *ladiri* were established, such as dimensional stability and compressive strength. Deteriorated masonry surfaces were restored by removing loose parts, reinforcing with wooden sticks or filling with brick flakes and a mixed mortar of natural hydraulic lime, slaked lime, and sand, as well as by applying a mixture of earth and natural fibers in thin layers. The most delicate parts, such as plinths, cornerstones, doorposts, jambs, lintels, and roof-beam bearings, were strengthened with fired bricks (Fig. 8).

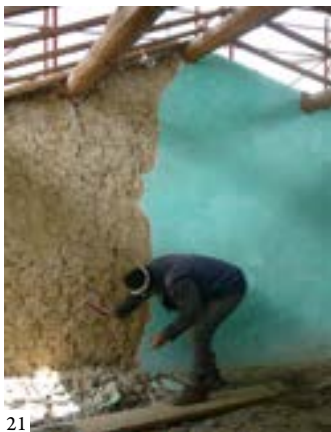
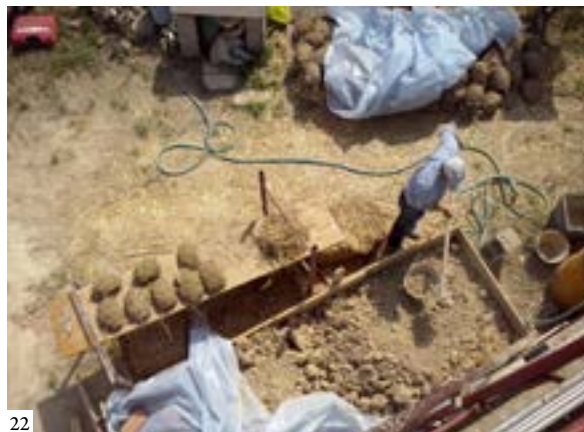
Figure 21: Removal of plaster in the west first floor room (CEDTerra)

Figure 22: *Massoni* production cycle: reuse of earth, recycled from demolished parts and other collapsed buildings, making loaves and curing (CEDTerra)

Figure 23: Laying of *massoni* by workshop participants: they can be thrown with force, to allow the release of excess water, or laid on beds of dry straw and pressed to adhere and penetrate each pore (CEDTerra)

The inner surfaces of the walls were in good condition but loose parts had to be removed from the outer walls (Fig. 21). Cracks and gaps were consolidated and new *massoni* were laid, made from a mixture of earth, sand, water, straw, and pure gypsum. For every 5 kg of mud mixed with straw, one 20x12 cm loaf-like brick was obtained. The bricks were left to cure overnight wrapped in straw and then laid (Figs. 22 and 23). A structural framework of twigs facilitated bonding with the existing masonry. The connection between the west and east blocks and the repair of the damaged chimney were executed using wooden frames filled with the *massoni* mixture, with wooden formwork. A wood bar was used to level the surface. Two tie-rods were fitted along the long side of the house.

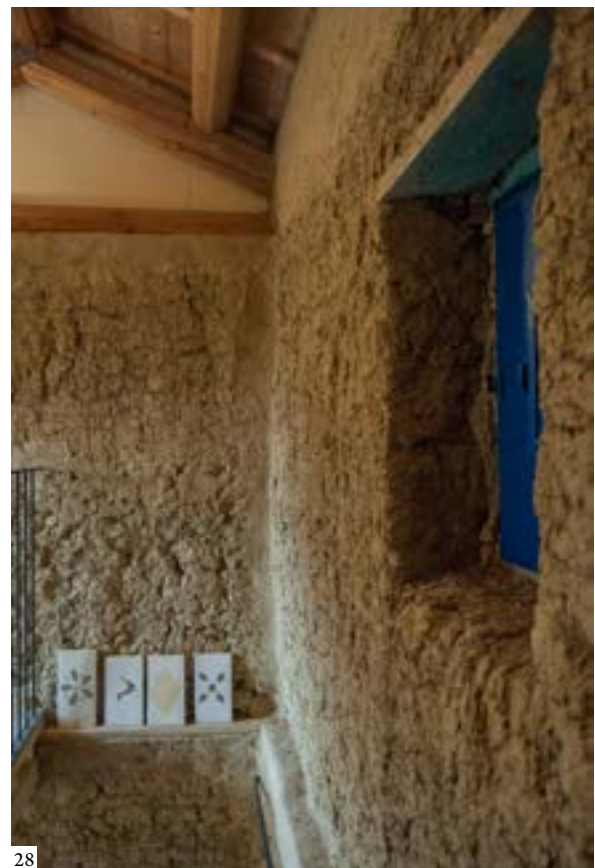
28

Figure 28: *Massoni* walls left without plaster on first floor to the west
