Raw Earth Construction Perspectives in Italy: An Overview Through the Rehabilitations of Casa Fenu in Villamassargia, Sardinia, and Casa di Teresa in Casalincontrada, Abruzzo

Martina Bocci

A detailed analysis of the rehabilitation processes of two publicly owned buildings in Sardinia and Abruzzo is taken as a basis for describing the background, difficulties and possible future developments of raw earth as a building material in Italy. Earthen construction techniques, despite a rich tradition and extensive documentation, are still considered outdated, and their use today requires a fortunate confluence of contextual factors. Archival research, literature review and a study of manuals were coupled with an examination of urban plans and public policies, as well as interviews with experts and stakeholders. This multi-approach research shows that there is a strong need to appropriate traditional knowledge so as to translate local skills into viable solutions able to meet today's needs. The key issue may be investment in training and dissemination. The mindset of the artisan, that of the *homo faber* (Sennet 2008), needs to be more widely associated with action toward sustainable loca

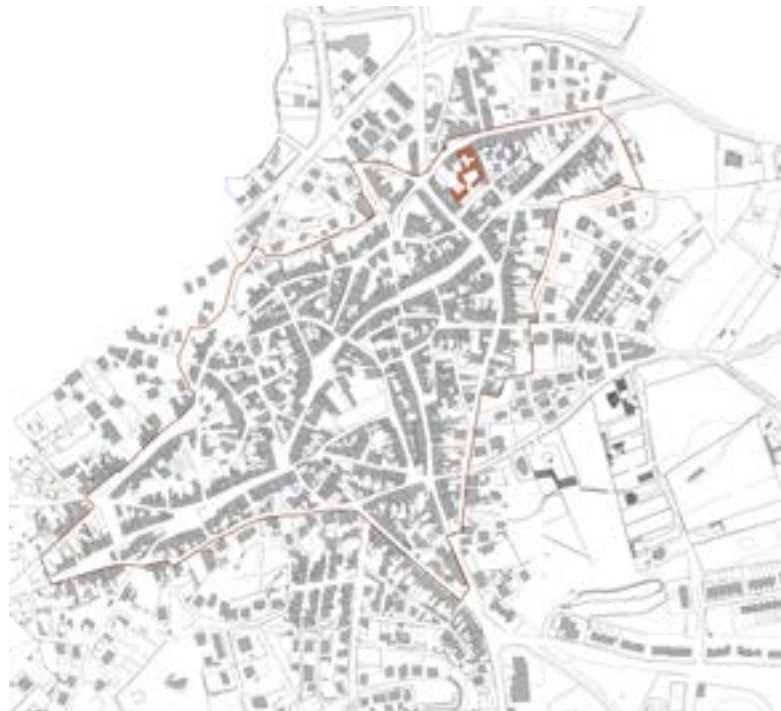
Figure 1: Historic centre of the medieval town of Villamassargia, in which 79% of the buildings are in *ladiri*. The Casa Fenu complex is marked in red.

In the late 20th century, an increasing need arose for a systematic and urgent recovery of earthen heritage to help strengthen the identity of rural areas, linked to the knowledge handed down by older inhabitants and builders. Among the public initiatives that have marked the resurgence of raw earth in Sardinia and Abruzzo are respectively the rehabilitation of the Casa Fenu complex in Villamassargia (Fig. 1) by Ignazio Garau² (1949-2018), and that of Casa di Teresa in Casalincontrada (Fig. 2) by Gianfranco Conti.³

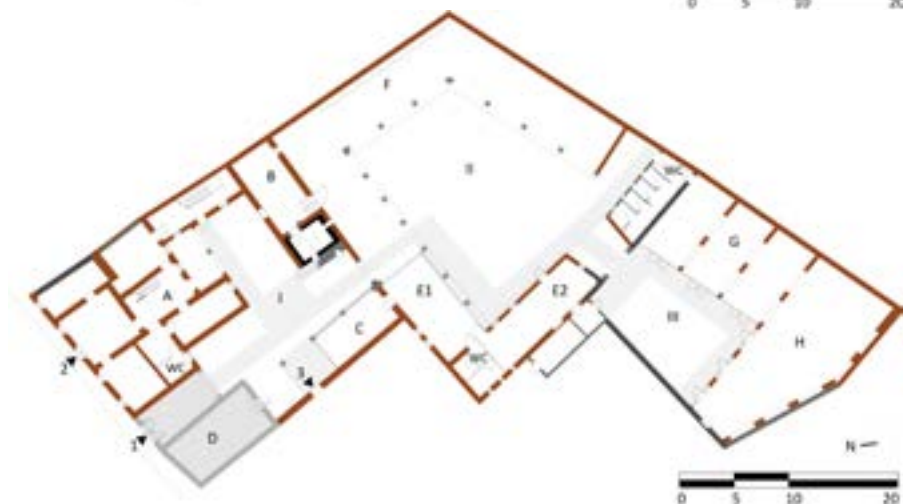
Figure 6: Project plan, ground floor.
 Courtyard I: A) exhibition rooms and tourist agency; B) storerooms; C) tasting rooms; D) Villa Fenu; 1) portal and entrance hall to the courtyard; 2) main entrance; 3) connection to Villa Fenu.
 Courtyard II: E1) cafeteria and E2) kitchens; F) exhibition area.
 Courtyard III: G) workshop and laboratories; H) conference room.
 Red: ladriri masonry; black: concrete; dark grey: stone masonry; grey: fired bricks and hollow bricks

The restoration was based on different approaches in each part of the complex (Figs. 5 and 6); raw earth was used even in partially or completely rebuilt parts.
