Raw Earth Construction Perspectives in Italy: An Overview Through the Rehabilitations of Casa Fenu in Villamassargia, Sardinia, and Casa di Teresa in Casalincontrada, Abruzzo

Martina Bocci

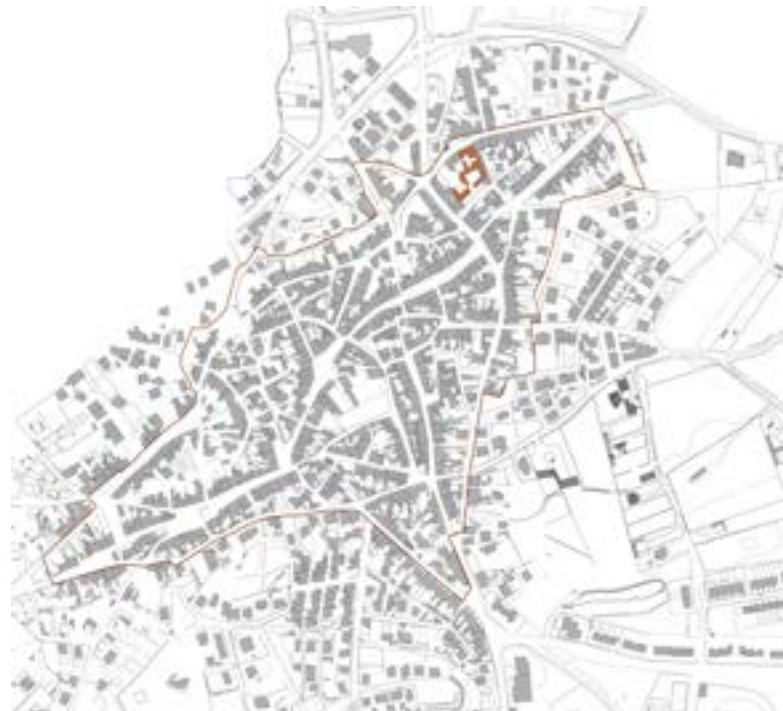
Figure 1: Historic centre of the medieval town of Villamassargia, in which 79% of the buildings are in *ladiri*. The Casa Fenu complex is marked in red.

In the late 20th century, an increasing need arose for a systematic and urgent recovery of earthen heritage to help strengthen the identity of rural areas, linked to the knowledge handed down by older inhabitants and builders. Among the public initiatives that have marked the resurgence of raw earth in Sardinia and Abruzzo are respectively the rehabilitation of the Casa Fenu complex in Villamassargia (Fig. 1) by Ignazio Garau<sup>2</sup> (1949-2018), and that of Casa di Teresa in Casalincontrada (Fig. 2) by Gianfranco Conti.<sup>3</sup>

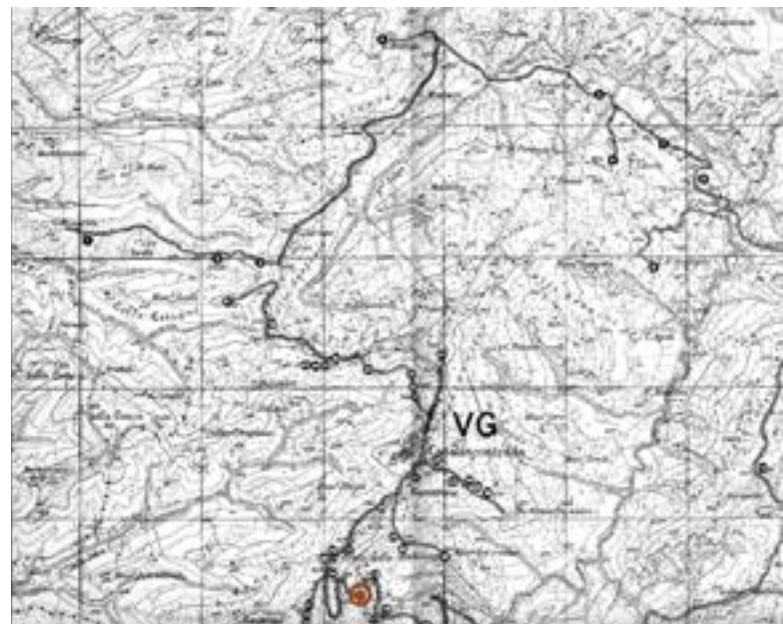
Figure 2: Earth houses tour in and around Casalincontrada. The Casa di Teresa is marked in red (CEDTerra)

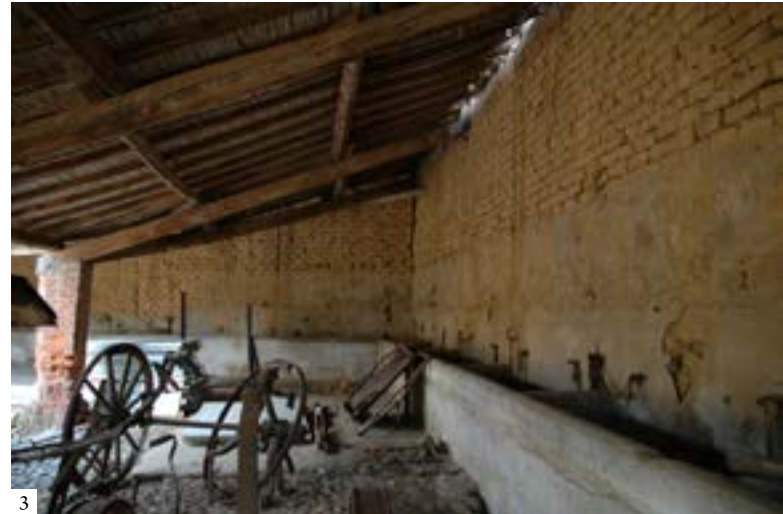
3

Figure 3: Outer walls of the oxen courtyard (II) in 2005 (Ignazio Garau)

Originally at the heart of a large farm of about 250 hectares, the family-owned Casa Fenu complex combines a dwelling with the functional needs of rural husbandry, with a sequence of three mixed-use courtyards connected by arched portals of fired brick (Fig. 3).

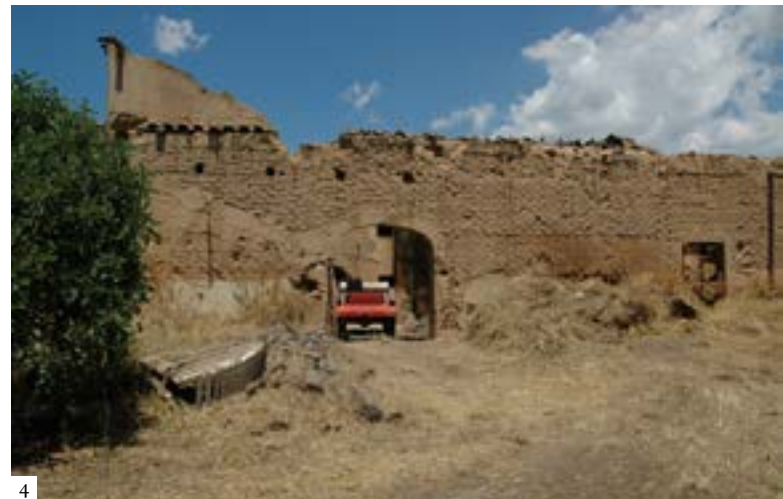
4

Figure 4: The arch between courtyards I and II in 2005 (Ignazio Garau)

The ox yard (II) was the center of the complex, with a portico for sheltering animals and storing materials (Fig. 4).

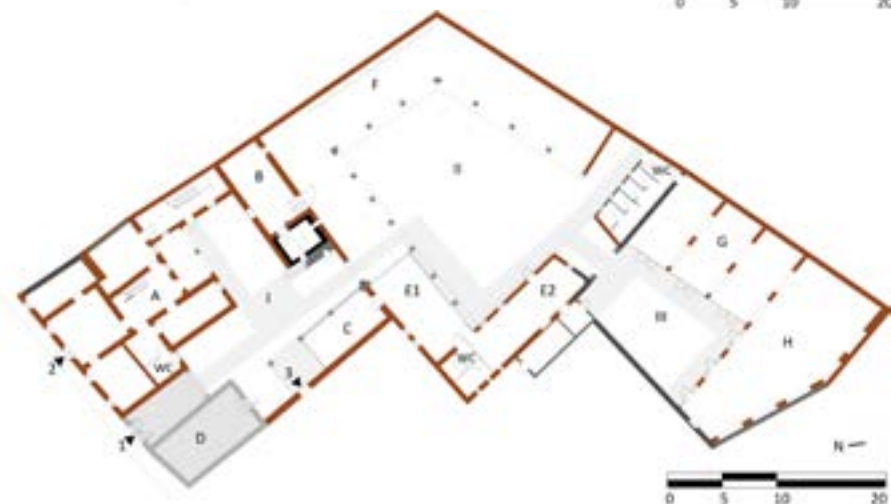
Figure 6: Project plan, ground floor.  
 Courtyard I: A) exhibition rooms and tourist agency; B) storerooms; C) tasting rooms; D) Villa Fenu; 1) portal and entrance hall to the courtyard; 2) main entrance; 3) connection to Villa Fenu.  
 Courtyard II: E1) cafeteria and E2) kitchens; F) exhibition area.  
 Courtyard III: G) workshop and laboratories; H) conference room.  
 Red: ladriri masonry; black: concrete; dark grey: stone masonry; grey: fired bricks and hollow bricks

The restoration was based on different approaches in each part of the complex (Figs. 5 and 6); raw earth was used even in partially or completely rebuilt parts.

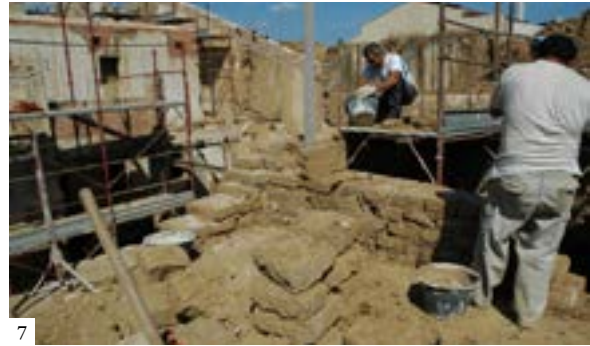
7

Figure 7: In the reconstruction work of building B, the reuse of original *ladiri* in good condition was frequent. The earth derived from the demolition, heterogeneous and with spurious materials, was not reused within the construction site, but was instead reused to fill the land where the earth used for the new bricks was extracted from. (Ignazio Garau)

between opposite walls. Damaged wall portions were demolished and rebuilt with new *ladiri* (Fig. 7) measuring 10x20x40 cm, made by hand with a mix of earth and fibers and laid on an earth, lime, and sand mortar bed. Minimum requirements for *ladiri* were established, such as dimensional stability and compressive strength. Deteriorated masonry surfaces were restored by removing loose parts, reinforcing with wooden sticks or filling with brick flakes and a mixed mortar of natural hydraulic lime, slaked lime, and sand, as well as by applying a mixture of earth and natural fibers in thin layers. The most delicate parts, such as plinths, cornerstones, doorposts, jambs, lintels, and roof-beam bearings, were strengthened with fired bricks (Fig. 8).

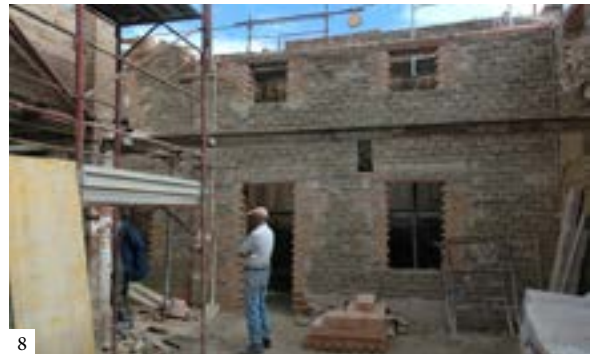
8

Figure 8: The openings were consolidated: reveals and lintels were installed, sometimes with a new element on the inner side, or fired brick platbands, replacing the eroded or fractured bricks (Ignazio Garau)

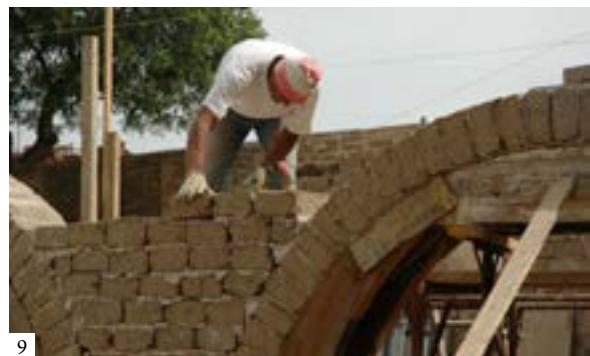
9

Figure 9: Laying of *ladiri* in the construction of the portion of the wall between two arches (Ignazio Garau)

Given their advanced state of decay, the remaining structures around courtyard III were demolished and reconstructed using *ladiri*. Fourteen arches (spanning about 2.5 m) in four parallel walls were built with unfired bricks (Fig. 9). Fired bricks were also used at certain points to counteract the thrust and to support the roof trusses (Fig. 10)

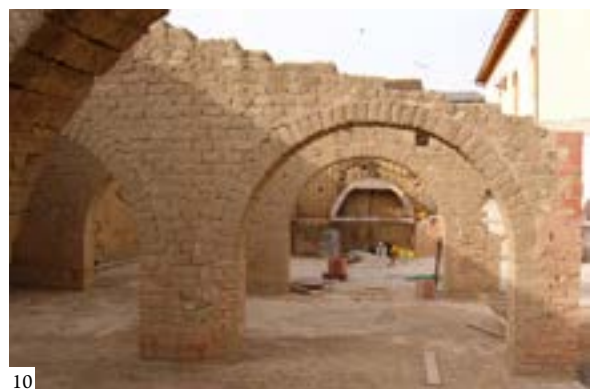
10

Figure 10: View through the arches of courtyard III (Ignazio Garau)

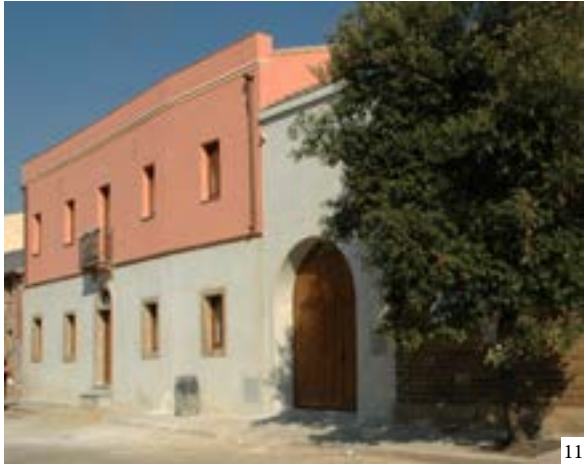
11

Figure 11: The colour of the main façade was chosen to match the shades found in other buildings in Via Santa Maria (Ignazio Garau)

A plaster made of earth, sand, and lime, plus natural fibers such as hay and straw, was applied on all walls. This was rendered with slaked lime and sand and finished with a smooth coat of long-aged slaked lime. The interior walls were limewashed, with color from natural earth pigments. The exterior walls were finished with two coats of a breathable, weather-resistant mixture of slaked lime, mineral additives, natural earths and oxides (Fig. 11).

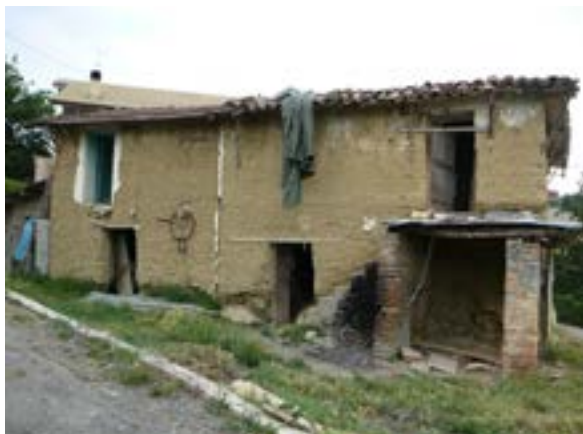
Figure 17: La Casa di Teresa before the intervention, view of the south-east elevation. (CEDTerra)

Before the restoration, the building retained most of its original elements, but due to its abandonment and lack of maintenance since 1967, the incorrect dimensioning and anchoring of the walls, the absence of protective render, and the partial collapse of the roof, it was progressively deteriorating. The chimney had been seriously damaged by a fire and heavy-vehicle traffic. Unsound materials had been

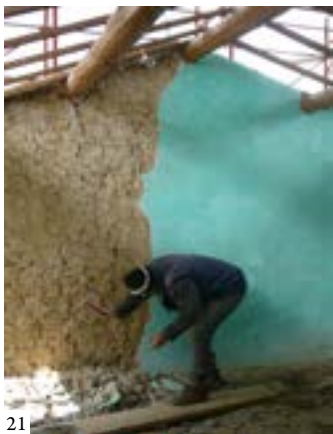
21

Figure 21: Removal of plaster in the west first floor room (CEDTerra)

The inner surfaces of the walls were in good condition but loose parts had to be removed from the outer walls (Fig. 21). Cracks and gaps were consolidated and new *massoni* were laid, made from a mixture of earth, sand, water, straw, and pure gypsum. For every 5 kg of mud mixed with straw, one 20x12 cm loaf-like brick was obtained. The bricks were left to cure overnight wrapped in straw and then laid (Figs. 22 and 23). A structural framework of twigs facilitated bonding with the existing masonry. The connection between the west and east blocks and the repair of the damaged chimney were executed using wooden frames filled with the *massoni* mixture, with wooden formwork. A wood bar was used to level the surface. Two tie-rods were fitted along the long side of the house.

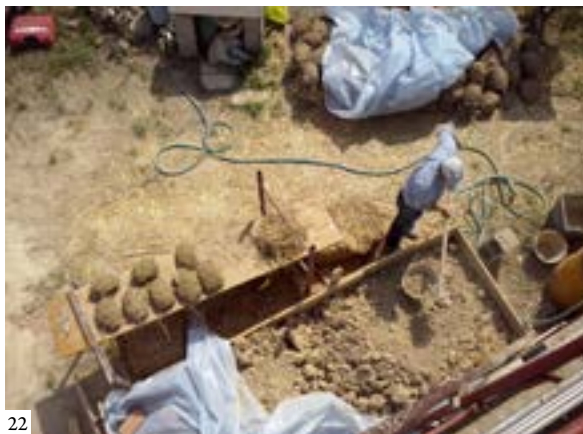
22

Figure 22: *Massoni* production cycle: reuse of earth, recycled from demolished parts and other collapsed buildings, making loaves and curing (CEDTerra)

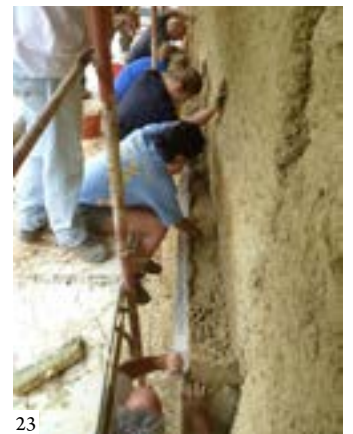
23

Figure 23: Laying of *massoni* by workshop participants: they can be thrown with force, to allow the release of excess water, or laid on beds of dry straw and pressed to adhere and penetrate each pore (CEDTerra)

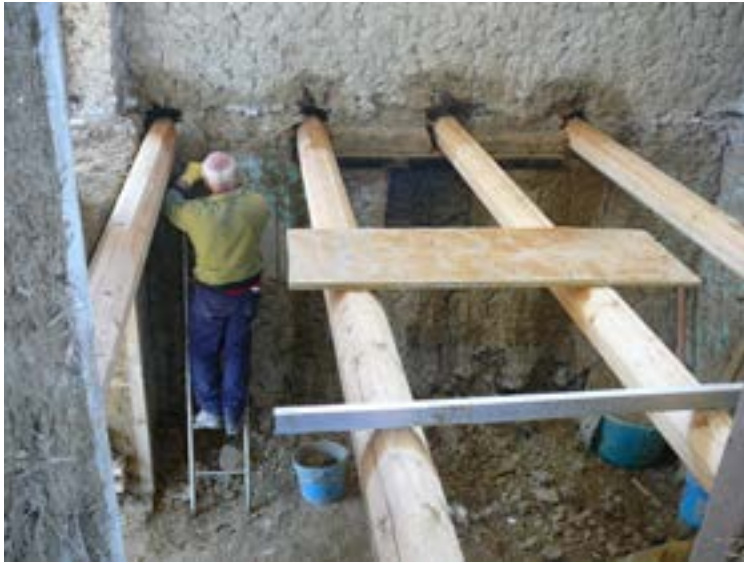
Figure 24: Laying the new beams in the west room (CEDTerra)

The intermediate floors were rebuilt, maintaining the original position of the beams in the east room and rotating them in the west room so as to tie the walls together and to

better distribute the loads (Fig. 24). Joists placed above the beams support the brick flooring.

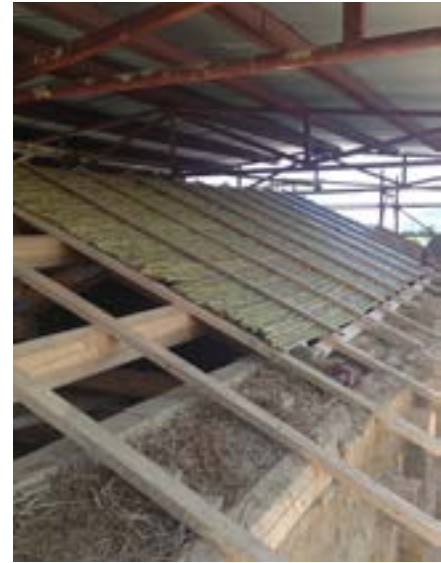
Figure 25: Laying of the laths made during the 2015 workshop (CEDTerra)

Ring beams at the top of the walls distribute the loads of three trusses supporting the main beams and rafters. On the east half of the roof, laths covered with 10 cm of straw and earth were laid, and on the west half, wooden boards waterproofed with a membrane (Fig. 26). A layer of pressed

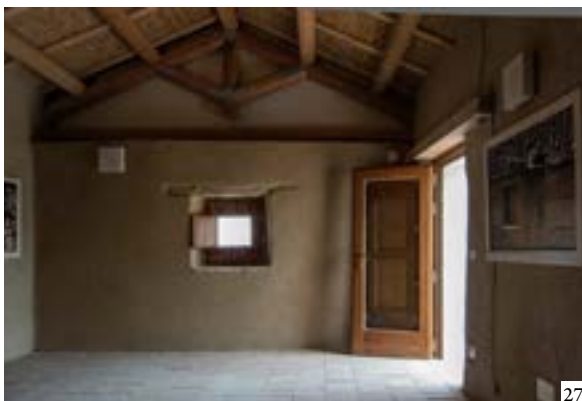
27

Figure 27: New internal staircase in the west portion. The tie-rod added during the renovation runs along the wall

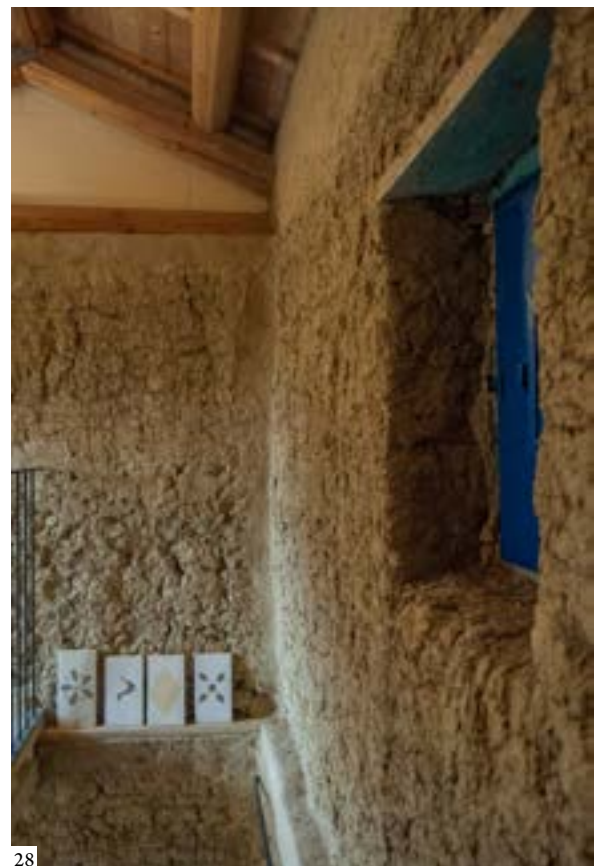
28

Figure 28: *Massoni* walls left without plaster on first floor to the west
