# Unmanned Aerial Vehicles (UAV) Photogrammetry in the Conservation of Historic Places: Carleton Immersive Media Studio Case Studies

**Abstract:** The increasing commercialization of unmanned aerial vehicles (UAVs) has opened the possibility of performing low-cost aerial image acquisition for the documentation of cultural heritage sites through UAV photogrammetry. This paper presents two case studies that illustrate the use of the DJI Phantom 4 normal UAV for aerial image acquisition, and the results that can be achieved using those images. A general workflow procedure of oblique image capturing and data processing of large data sets has been illustrated in the Prince of Wales Fort case study to create photogrammetric models and to generate orthophotos for condition assessment applications. The second case study provides insight on the possibility of using UAVs for post-disaster documentation when the accessibility and the availability of high cost equipment is of major concern. The results that were obtained from UAV photogrammetry of Nyatapola Temple and Bhairabnath Temple in Taumadhi Square in Nepal, which were damaged by the 2015 Gorkha earthquake, are presented and discussed.

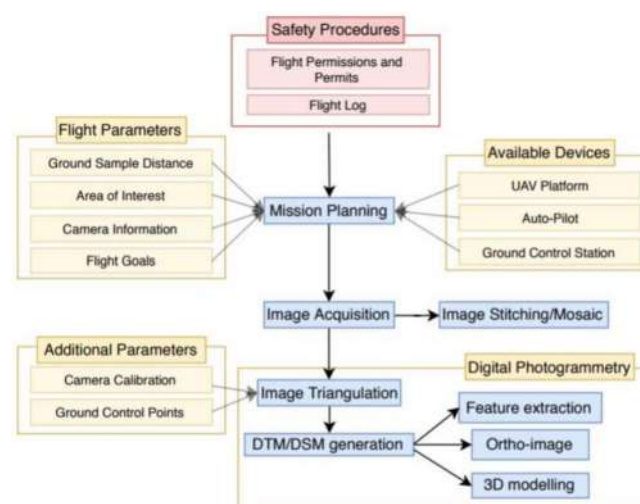
Figure 1. Unmanned aerial vehicles (UAV) Acquisition Workflow—adapted from [3].

Figure 1 is an adapted workflow from [3] that serves as a basis for UAV image acquisition and processing. It is important to note that a separate category, “Safety Procedures”, was added to mission planning in the adapted figure. This is because safety should always be at the forefront of any UAV mission. By understanding the safety procedures and protocols, it helps to minimize the possibility that the UAV will cause damage to both humans on the ground (i.e., the drone becomes out of control and

injures someone) and other aircraft in the sky. Additional information, such as completing a Flight Log after each flight, is also included in this category. The basic flight logbook contains pertinent information about the flight (i.e., flight pattern, time of flight, battery life, wind speed, temperature, etc.).

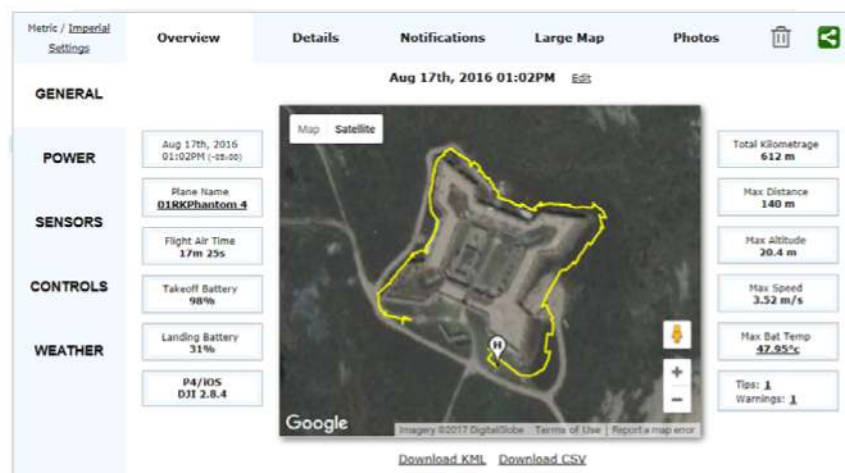
Figure 4. Example of flight path pattern for Prince of Wales Fort—Screenshot from airdata.com [23].

The photos and video footage was manually inspected and named in Adobe Bridge based on the date and flight number for posterity record keeping purposes. Additionally, the metadata from the UAV was imported to the online inventory [airdata.com](http://airdata.com) [23]. [Airdata.com](http://airdata.com) provides a way of quantifying the metadata by displaying attributes from the conducted flights, such as the route that the UAV took to capture the images, the altitude that each of the images was taken at, and notifications about the battery life. Figure 4 illustrates an example flight path pattern in [airdata.com](http://airdata.com), while Figure 5 displays the photograph locations from the UAV. This information can be exported as a kml file to be used in a Google Maps application for the easy sharing of flight data.

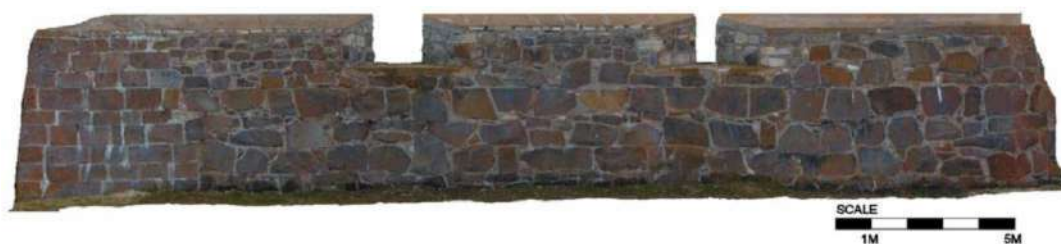
Figure 7. Orthophoto of Wall Section.

A series of orthophotos were created for individual wall sections of interest. The importance of adding the mesh back into the PhotoScan file was because of the usability of PhotoScan for orthophoto generation. The orthophotos that were created had an approximate GSD of 5 mm per pixel. This value is comparable to the theoretical GSD of the raw images that were used, because when calculations were made using an average flight distance of 12 metres away from the Fort walls, the resulting GSD was 5 mm or less. Though that result is higher than the 3 mm value for a 1:50 scale, as noted by Historic England's *Metric Survey Specifications for Cultural Heritage*, from visual inspection of the image, the mortar joints and the individual stones were all clearly visible to be traced for an elevation drawing [24]. Figure 7 shows the generated orthophoto.

From the orthophotos that were generated from PhotoScan, a measured drawing application has been done in AutoCAD in order to draw out the individual stones that were to be used for condition

assessment purposes the next time that work is done at the site. As there was difficulty scaling the exported GeoTIFF orthomosaic file from PhotoScan, the point cloud generated for the site was used to scale the orthoimage in AutoCAD. The reason as to why the drawing was not drawn directly from the point cloud is because the orthoimage was easier to visualize and provided a more detailed view of the stone locations. The decided scale was 1:50, as it is a standard size for elevation drawings and all of the stones and mortar joints can be seen.
