New self-healing system for cracks repairing

Andrés Miguel Panza Uguzzoni¹, Giovanni Anglani², Paola Antonaci², and Jean-Marc Tulliani^{1*}

Abstract. Macrocapsules with an expanding mineral powder were set-up for sealing cracks into cement-based materials. The expanding mineral powder was composed of a commercial fast setting cement mortar, sodium polyacrylate and a commercial product used to produce sparkling water (based on sodium acid carbonate, malic acid and tartaric acid). An optimal proportioning of these components was determined as 10:1:1, respectively. These compounds were first mixed with polyethylene glycol and cast into cylindrical moulds. Then, the mix was heated at 230°C in an oven and the cylinders were demoulded thereafter. The obtained products could be delicately handled and were coated with an epoxy resin to produce waterproofed macrocapsules, while some uncoated cylinders were mixed with water and kept in closed containers for 14 days. Brazilian tests were performed on these hydrated cylinders to determine their indirect tensile strength. Finally, the coated macrocapsules were incorporated into mortar prisms, that were pre-cracked in three-point bending test

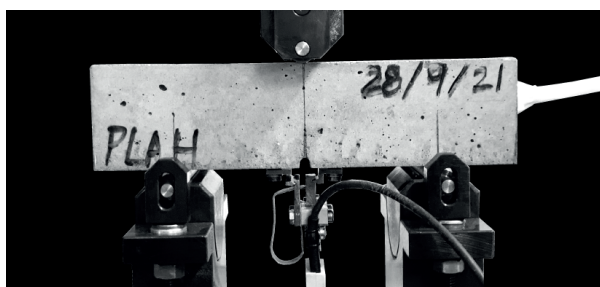
Fig. 3. Sample during the pre-cracking step; on the right side, the tube for the water flow test is visible.

The specimens were cracked in a three-point bending test with a span of 100 mm by means of a 250 kN closed-loop servo-controlled MTS hydraulic press. The target maximum crack mouth opening displacement (CMOD) under loading conditions was fixed at 600 μm (Fig. 3).

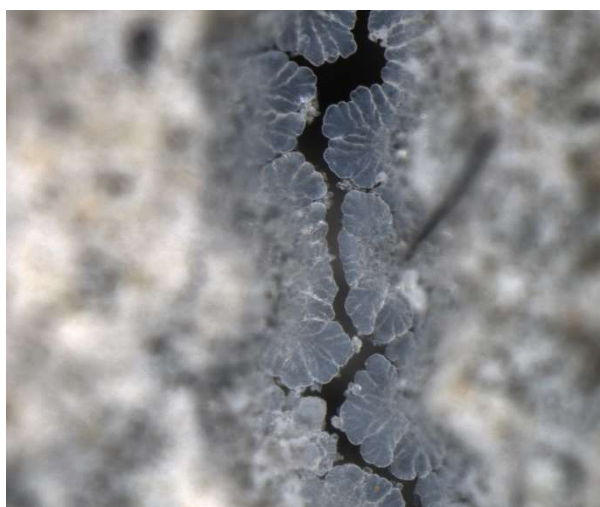
Fig. 9. Optical micrographs of a detail of a repaired zone.

The samples were also observed by means of a stereomicroscope (SMZ18, Nikon Corporation, Japan) after cracking and repairing (Fig. 8). The partial closure of the crack is evident and can explain the mechanical, as well as the water flow tests results (Fig. 9). In fact, the average crack aperture on 8 measurements was equal to $(346 \pm 10) \mu\text{m}$ after cracking, while after repairing, it decreased to $(26.5 \pm 19.9) \mu\text{m}$.
