New self-healing system for cracks repairing

New self-healing system for cracks repairing / Panza Uguzzoni, Andrés Miguel; Anglani, Giovanni; Antonaci, Paola; Tulliani, Jean-Marc. - In: MATEC WEB OF CONFERENCES. - ISSN 2261-236X. - ELETTRONICO. - 378:(2023), pp. 1-6. (Intervento presentato al convegno SMARTINCS'23 Conference on Self-Healing, Multifunctional and Advanced Repair Technologies in Cementitious Systems tenutosi a Ghent, Belgium nel May 22-23, 2023) [10.1051/matecconf/202337802014].

# New self-healing system for cracks repairing

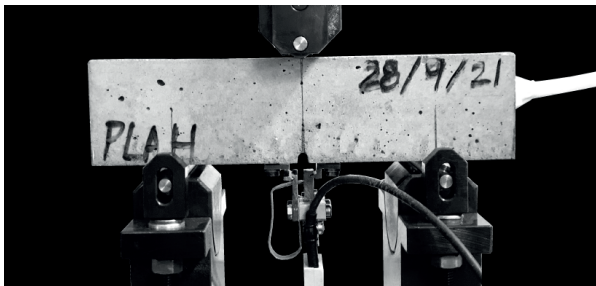
**Fig. 3.** Sample during the pre-cracking step; on the right side, the tube for the water flow test is visible.

The specimens were cracked in a three-point bending test with a span of 100 mm by means of a 250 kN closed-loop servo-controlled MTS hydraulic press. The target maximum crack mouth opening displacement (CMOD) under loading conditions was fixed at 600  $\mu\text{m}$  (Fig. 3).

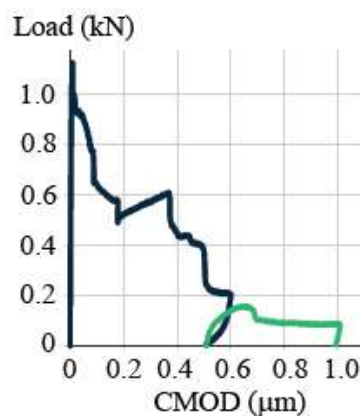
Figure 7 depicts an example of a load vs CMOD curve resulting from pre-loading and re-loading stages for a prism with a coated capsule. The load recovery indexes determined as per equation 1 were quite low and equal to 10.4% on average.

**Fig. 7.** Example of a load vs CMOD curve resulting from pre-loading (black curve) and re-loading (green curve) stages for a sample with a coated capsule.

Considering the trend of the load vs CMOD curve reported in Fig. 7, it is easy to infer that the capsule broke in the range of crack width from 0.2 to 0.4 mm where a certain instability of the load due to the control action of the testing machine is visible. On the contrary, the softening part of the curve in the samples without capsules was continuously decreasing after the peak load and showed no mechanical regain in the subsequent re-loading stage. Neither pull-out, nor debonding of the capsules from the mortar matrix were ever observed in the tested prisms.

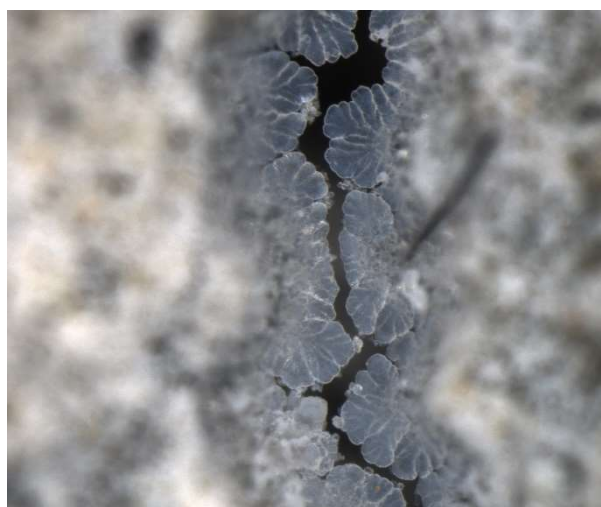
**Fig. 9.** Optical micrographs of a detail of a repaired zone.

The samples were also observed by means of a stereomicroscope (SMZ18, Nikon Corporation, Japan) after cracking and repairing (Fig. 8). The partial closure of the crack is evident and can explain the mechanical, as well as the water flow tests results (Fig. 9). In fact, the average crack aperture on 8 measurements was equal to  $(346 \pm 10)$   $\mu\text{m}$  after cracking, while after repairing, it decreased to  $(26.5 \pm 19.9)$   $\mu\text{m}$ .
