The ‘health record’ of the church of Santa Maria Assunta in Pontecurone: contamination between historical knowledge and non-destructive testing results

Giulia Beltramo, Monica Naretto, Monica Volinia

ABSTRACT

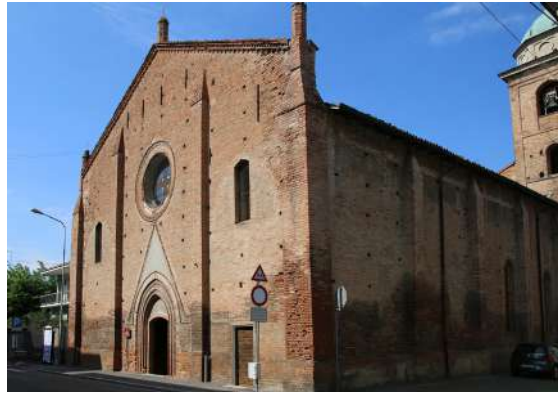
Fig. 1 The façade and the South-East flank of the church of Santa Maria Assunta in Pontecurone (2022).

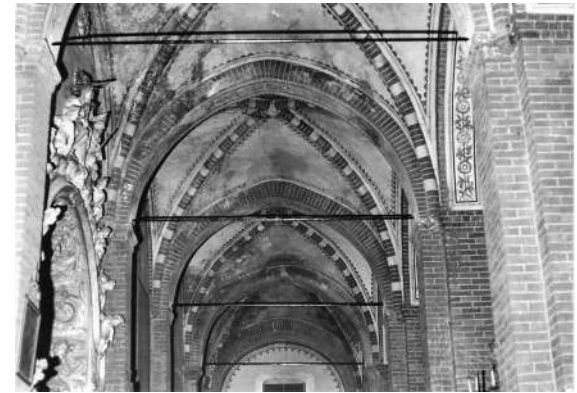
Fig. 2 The chains in the left nave during the restoration yard of 1974-1977 (Parish Historical Archive).

Subsequently, documents attest to the work on the bell tower, the insertion of chains in the naves and extraordinary maintenance works on the roof between 1974 and 1977. In 1979, the problem of dampness was again evident, so a ventilation space with vents along the perimeter walls was built in an attempt to restore the perimeter masonry from rising damp. Finally, the last structural intervention dates back to 1982: it involved the construction of reinforced concrete beams along the perimeter walls and the chaining of perimeter walls and arches of the minor naves with metal tie rods.

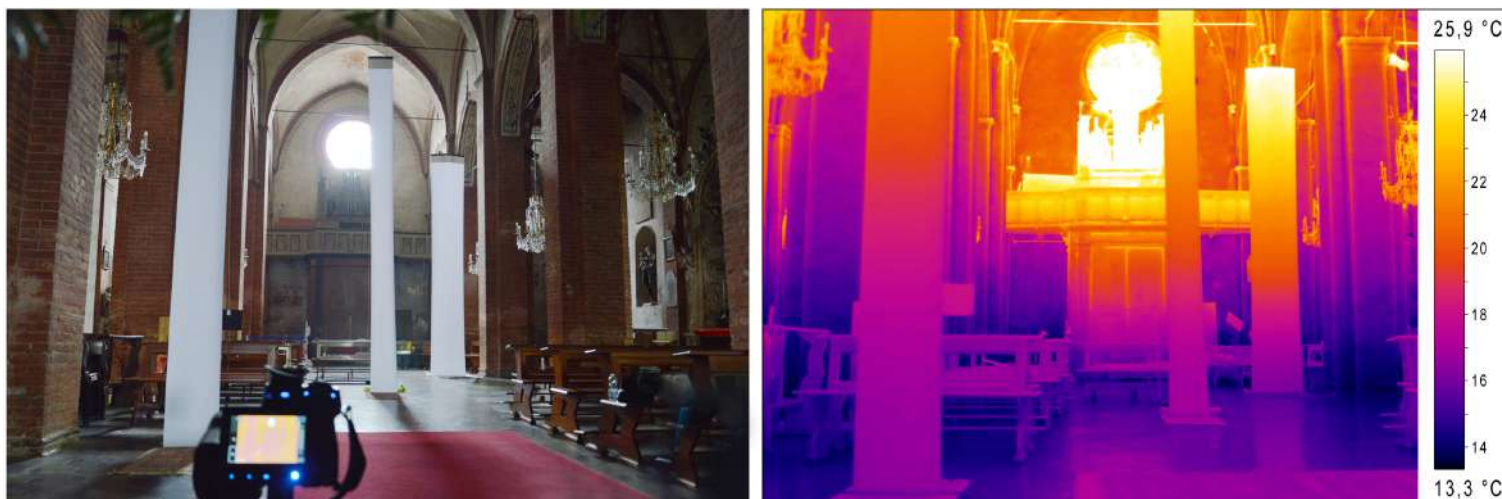
and map evaporative fronts caused by infiltration from the roof and rising dampness. Since the evaporation front is subject to variations, the IR evaluation took place in different seasons and was correlated with the weather and microclimate data acquired over the whole period.
