The 'health record' of the church of Santa Maria Assunta in Pontecurone: contamination between historical knowledge and non-destructive testing results

Giulia Beltramo, Monica Naretto, Monica Volinia

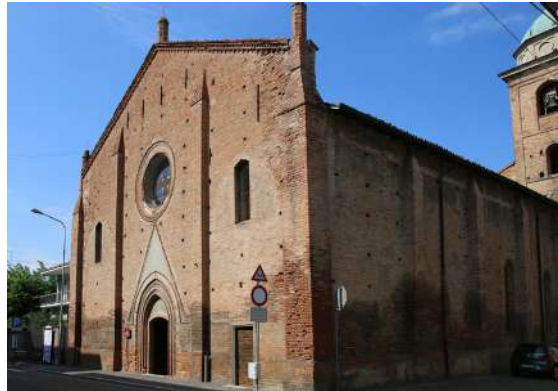
Fig. 1 The façade and the South-East flank of the church of Santa Maria Assunta in Pontecurone (2022).

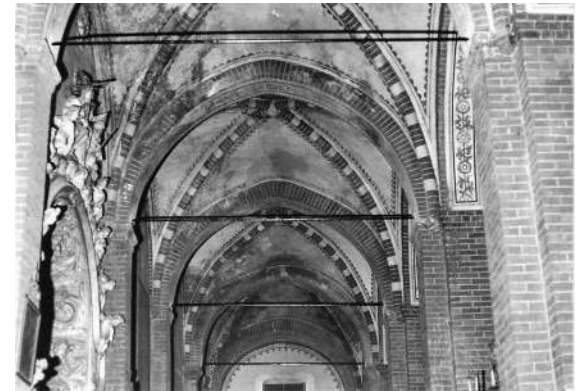
Fig. 2 The chains in the left nave during the restoration yard of 1974-1977 (Parish Historical Archive).

Subsequently, documents attest to the work on the bell tower, the insertion of chains in the naves and extraordinary maintenance works on the roof between 1974 and 1977. In 1979, the problem of dampness was again evident, so a ventilation space with vents along the perimeter walls was built in an attempt to restore the perimeter masonry from rising damp. Finally, the last structural intervention dates back to 1982: it involved the construction of reinforced concrete beams along the perimeter walls and the chaining of perimeter walls and arches of the minor naves with metal tie rods.

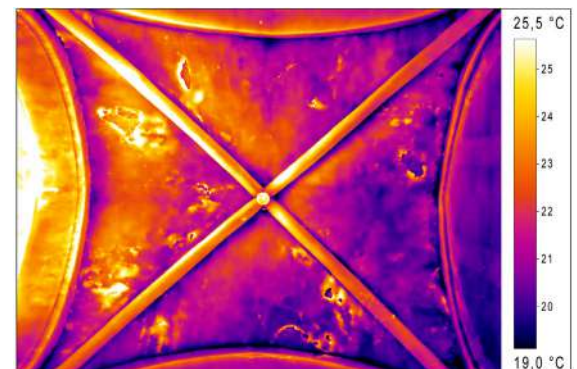
Thermographic acquisitions, conducted with protocols different (active or passive) depending on the objectives, made it possible to identify the textures of vaulted systems, locate cracks and plaster detachments (Fig. 3),

Fig. 3 Right side nave, 4th bay. Active IR scan: gaps and plaster detachments (February 24th, 2021).

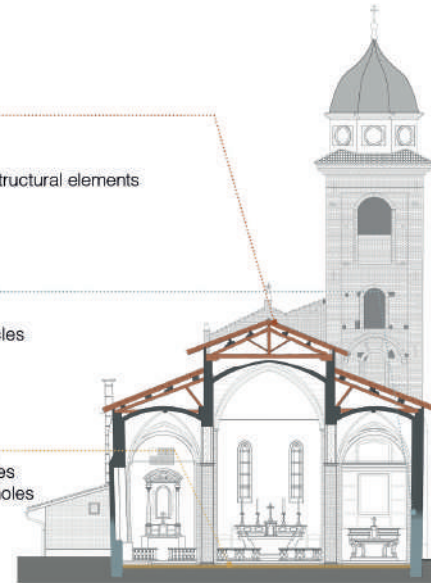
1. the degradation of the roofs (wooden structure and roof covering);
2. the permanent humidity in the walls;
3. the instability of the floor.

Roof decay

- infiltration of rainwater
- bird intrusion
- degradation of wooden structural elements

Floor instability

- lifting and fracturing of tiles
- presence of unrepaired holes

Fig. 5 The three main criticalities of the church summarised in the last section of the 'health record'.
