The 'health record' of the church of Santa Maria Assunta in Pontecurone: contamination between historical knowledge and non-destructive testing results

*14th International Conference on non-destructive investigations and microanalysis
for the diagnostics and conservation of cultural and environmental heritage*

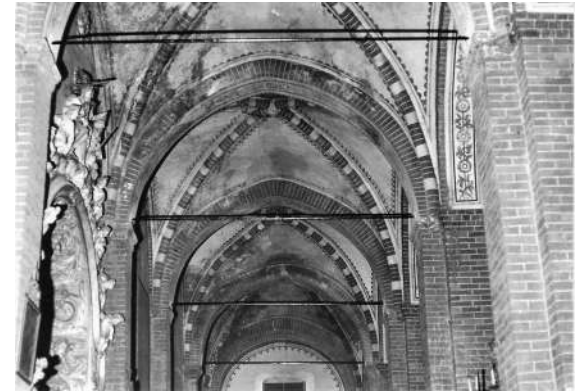
Fig. 2 The chains in the left nave during the restoration yard of 1974-1977 (Parish Historical Archive).

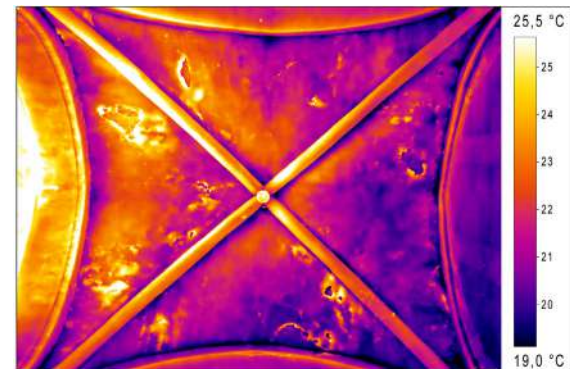
Thermographic acquisitions, conducted with protocols different (active or passive) depending on the objectives, made it possible to identify the textures of vaulted systems, locate cracks and plaster detachments (Fig. 3),

Fig. 3 Right side nave, 4th bay. Active IR scan: gaps and plaster detachments (February 24th, 2021).

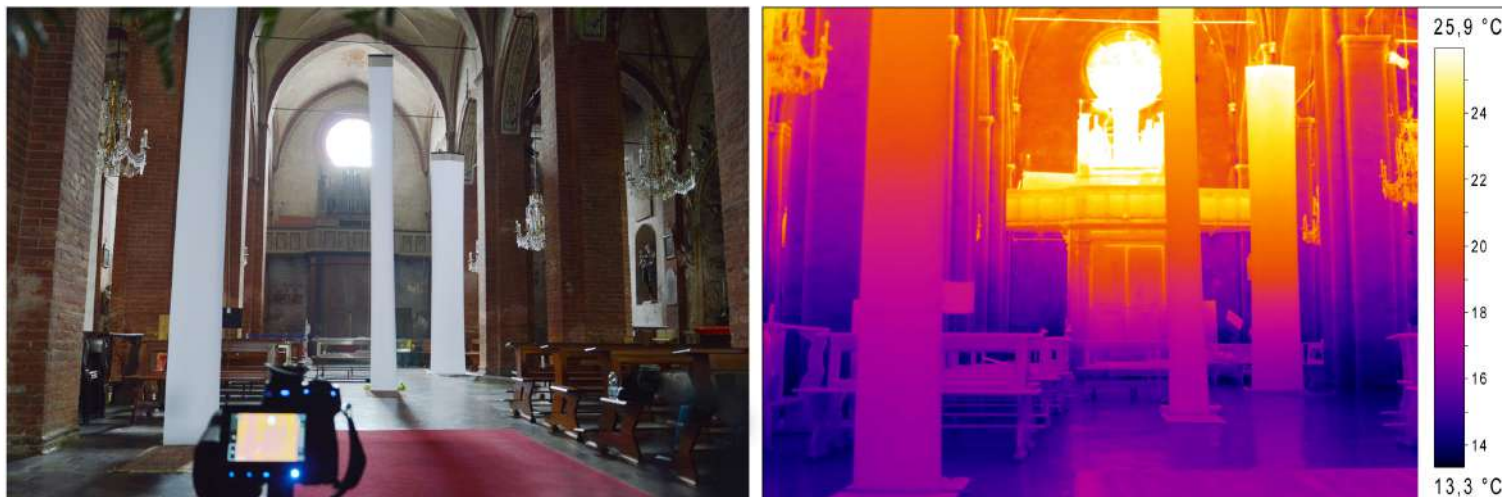
and map evaporative fronts caused by infiltration from the roof and rising dampness. Since the evaporation front is subject to variations, the IR evaluation took place in different seasons and was correlated with the weather and microclimate data acquired over the whole period.

Fig. 4 Central nave: Infrared microclimate analysis. Scan at 1h45' after the start of heating (April 14th, 2021).

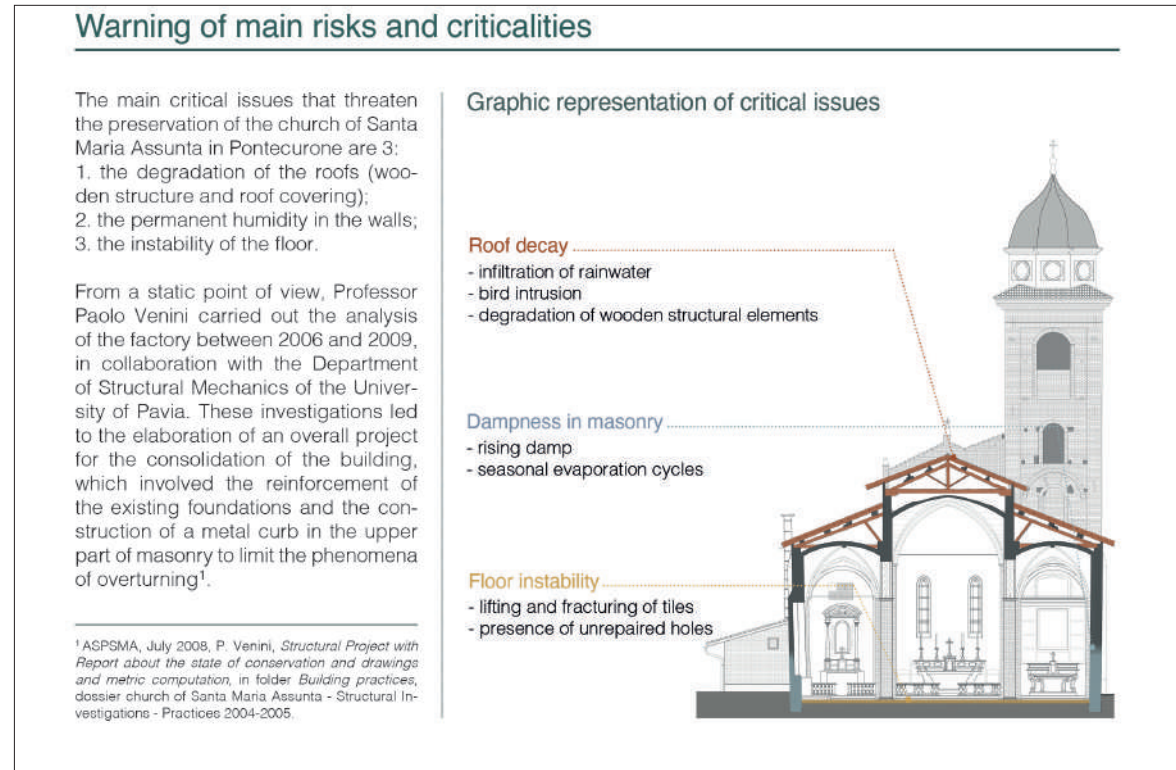
Fig. 5 The three main criticalities of the church summarised in the last section of the 'health record'.
